# Kootenay Connect: 7CW Columbia Wetlands: Summary (2023-2026) and Yr 7 Upland Wetlands Restoration Report

March 31, 2026

Columbia Wetlands Stewardship Partners

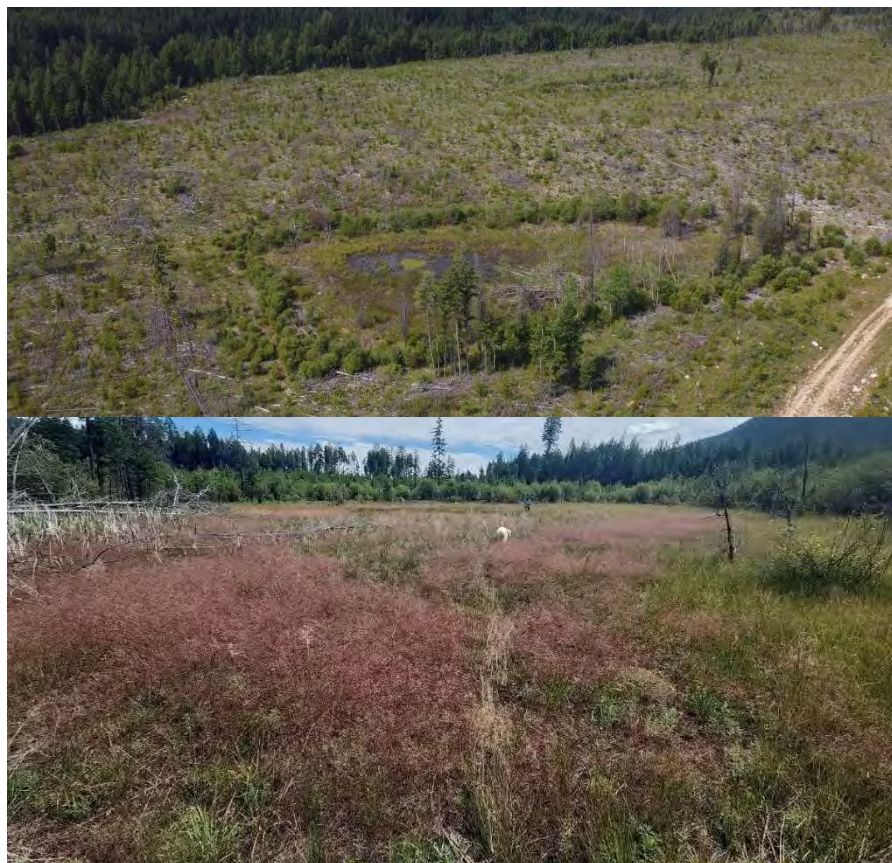
One of these wetlands is within a clear cut, and thus it is likely that this wetland will not persist due to the impacts of poor logging practices, as it will continue to dry (Figure 6). The high vulnerability of these systems can lead to rapid consequences due to changes on the landscape, and available information can be out of date within two years. This presents challenges for restoration planning, as the available data are often not recent enough to accurately reflect current wetland conditions. If available data on wetlands are old, in-person or drone visits are needed to determine if wetlands still possess the reported characteristics. This also highlights the importance of collecting baseline data, such as drone inventories and broad scale surveying, to be able to detect changes as climate change intensifies.

*Figure 6. Above, small wetland in the middle of cut block in summer 2023, with visible open water (A); below, the same small wetland in summer 2025, with no open water present (B).*

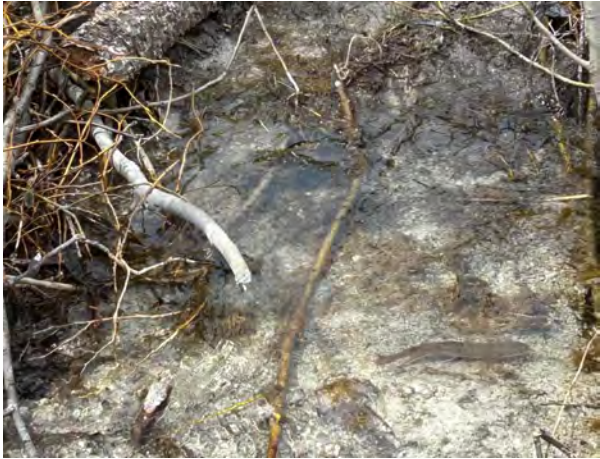
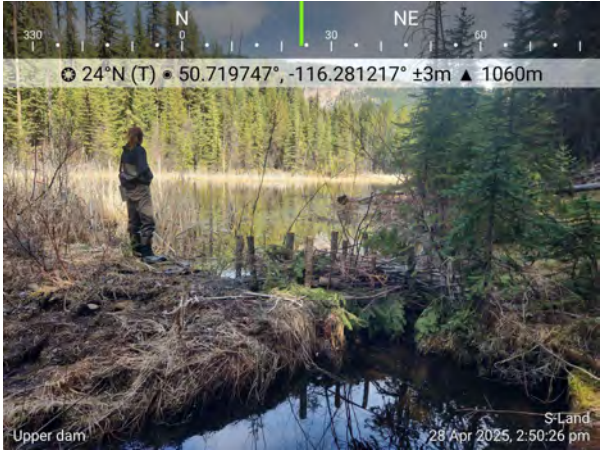
Downstream BDA		Upstream BDA	
Water Depth Upstream of BDA:	0.45 m	Water Depth Upstream of BDA:	0.26 m
Water Depth Downstream of BDA:	0.31 m	Water Depth Downstream of BDA:	0.11 m
Water Depth Over BDA:	0.05 m	Water Depth Over BDA:	-
<p><b>Notes:</b> The BDA is in good condition with no visible leaks or structural concerns. The upstream pool depth was measured at 0.45m deep and water clarity was very high, with no turbidity observed. The clay on top of the BDA remains solid and intact. We observed a Brook Trout (<i>Salvelinus fontinalis</i>) swimming from the downstream to the upstream side of the BDA, successfully navigating over the BDA. The elevation drop from the BDA crest to the downstream water surface is approximately 0.10m.</p>		<p><b>Notes:</b> The BDA is in good condition, with water visibly flowing through the mud layer beneath the overlying branches, with a consistent and steady flow. The drop from the top of the BDA to the downstream water surface is approximately 0.38m. While water is moving through the structure, the BDA is still effectively holding water upstream. Additionally, flow was observed flowing over the remnant natural dam adjacent to the BDA, with an average water depth of 0.08m across a span of approximately 3.2m.</p>

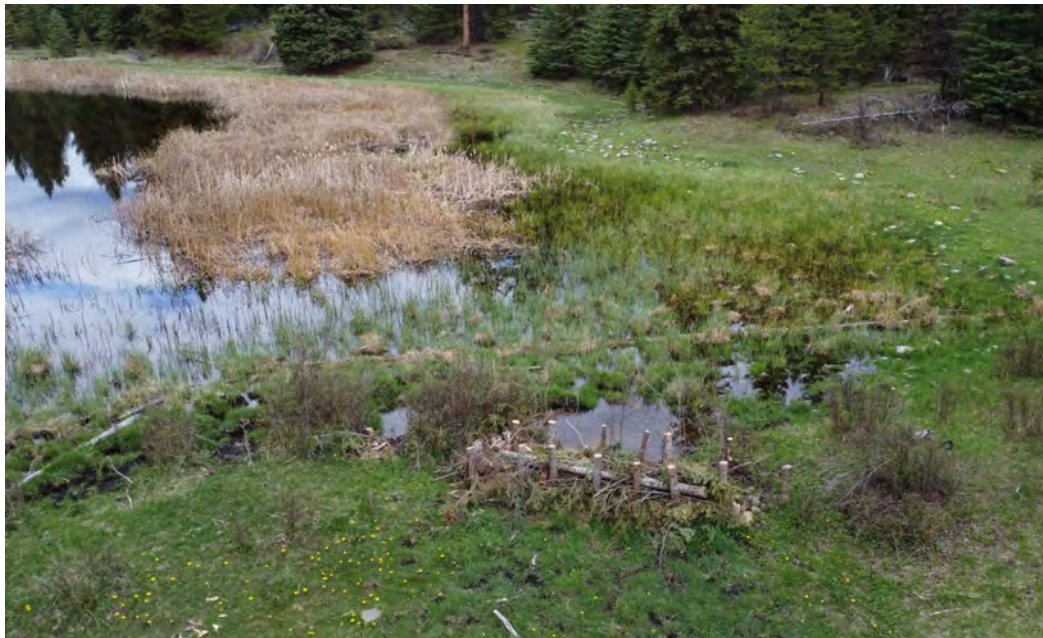
Figure 24. Downstream BDA was constructed at Beaver Channels in September 2024, showing water held behind the dam in May 2025. This area directly behind the BDA was not flooded in May 2024.

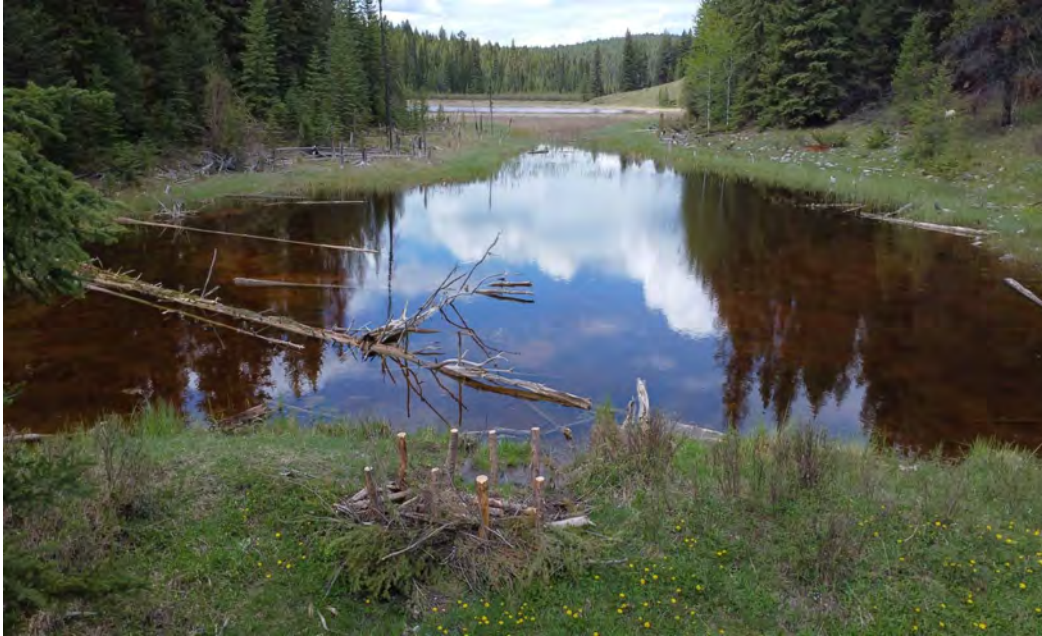
*Figure 25. Upstream BDA was constructed at Beaver Channels in September 2024, showing water being held by BDA in May 2025. This area directly behind the BDA was not flooded in May 2024.*

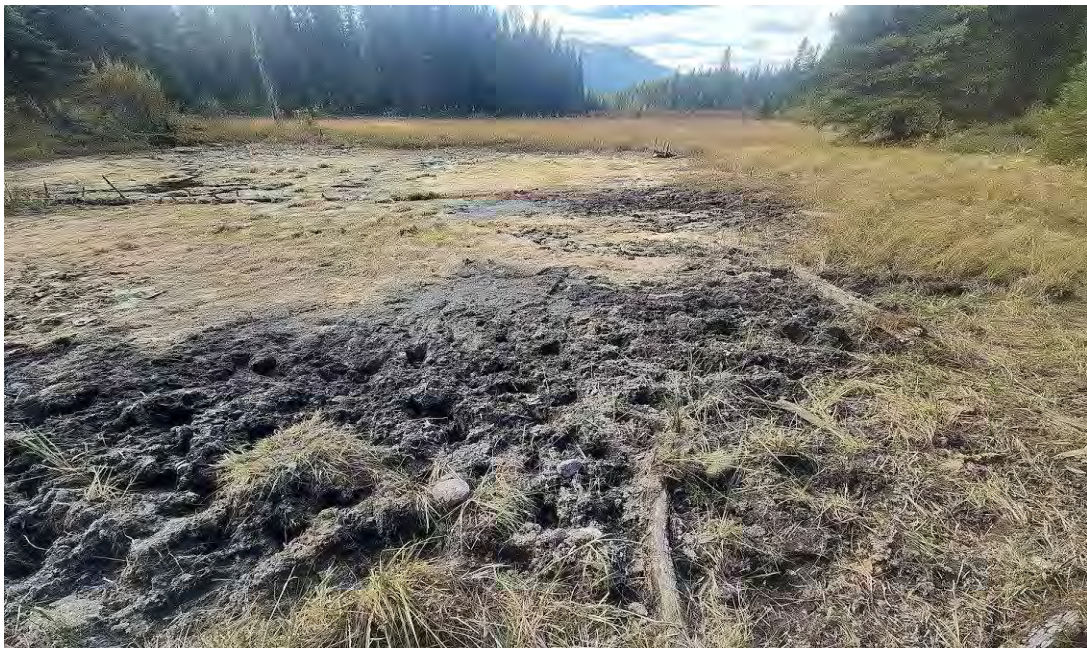
Figure 43. Dry open water pool above remnant beaver dam and DDA-05 in Double Dam wetland.

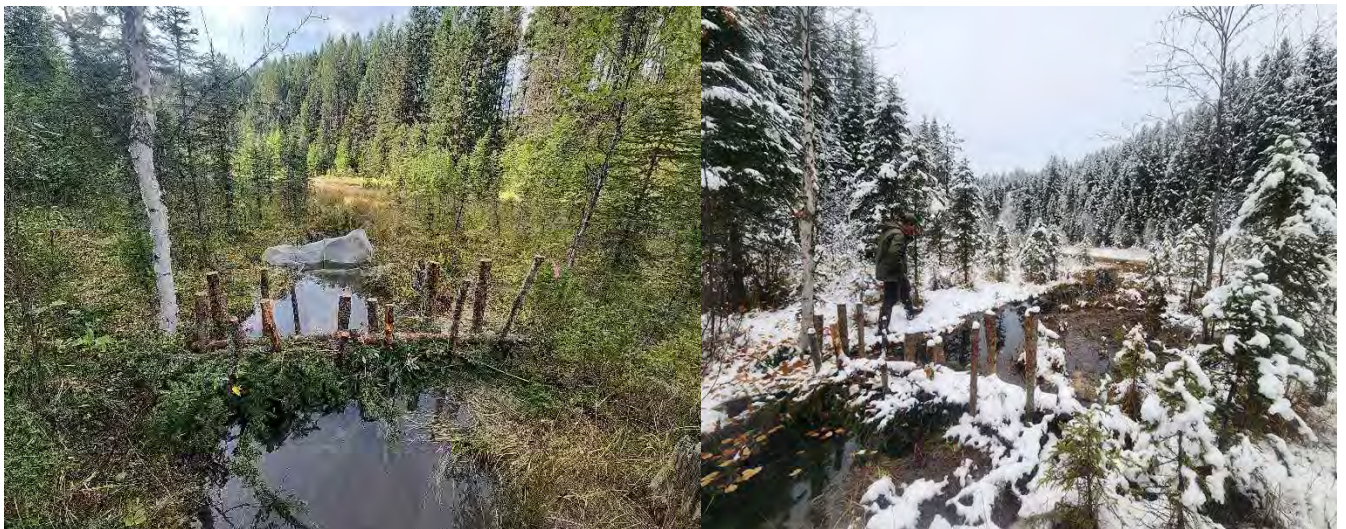
*Figure 68: Structure LIM-10 immediately post-construction and six weeks later on October 29th, 2025 in Limbo Wetland..*

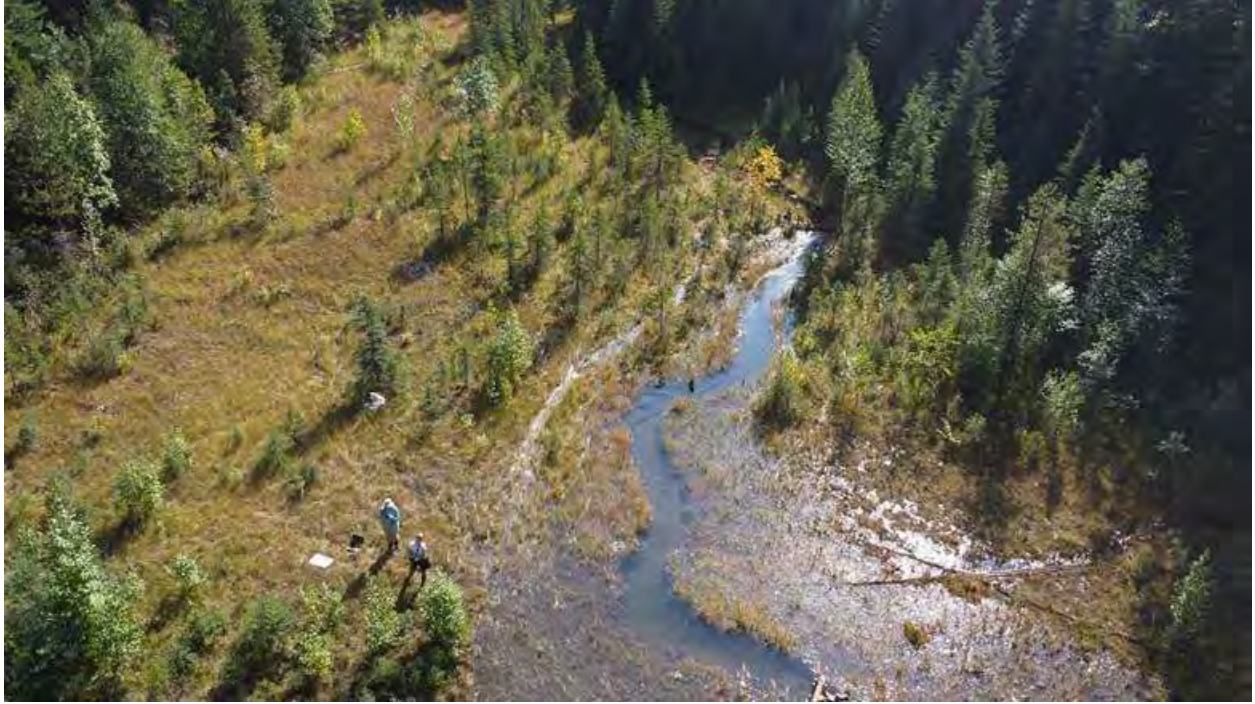
*Figure 72: Drone image highlighting flooding achieved upstream of LIM-10 in Limbo Wetland.*

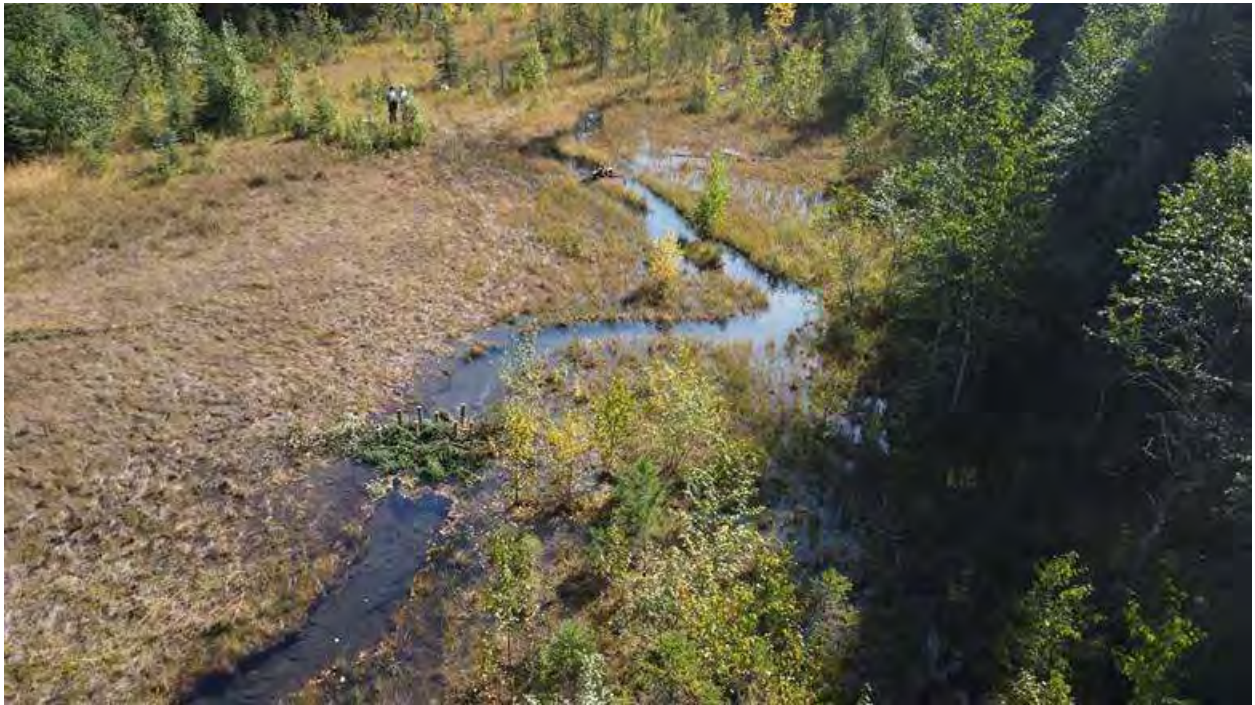
*Figure 73: Drone image highlighting flooding achieved around LIM-07 in Limbo Wetland.*

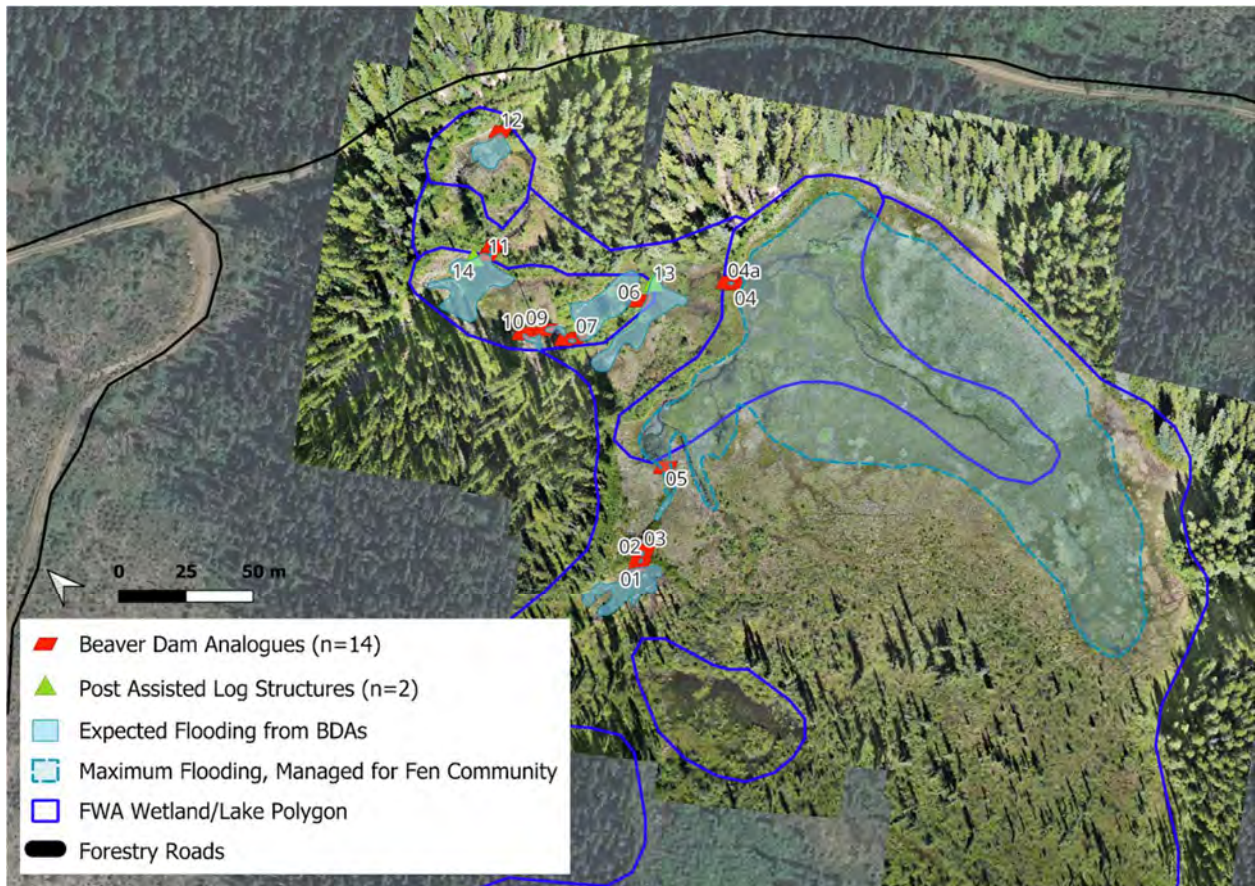
Figure 75: Restoration design for CWSP Site 'Rocky Point' near Parson, BC. There is a fen community within this site that shows signs of drying. This restoration site will be adaptively managed to provide the most water to the fen community without over-flooding it. This restoration site also aims to add depth to existing areas of open water where there is visible evidence of draw-down.
