Summary of Activities for the Creston Valley Wildlife Management Area 2020-2021 (Year 2)

Environment and Climate Change Canada – Canada Nature Fund: Community-Nominated Priority Places for Species at Risk

Kootenay Connect: Creston Valley Focal Area

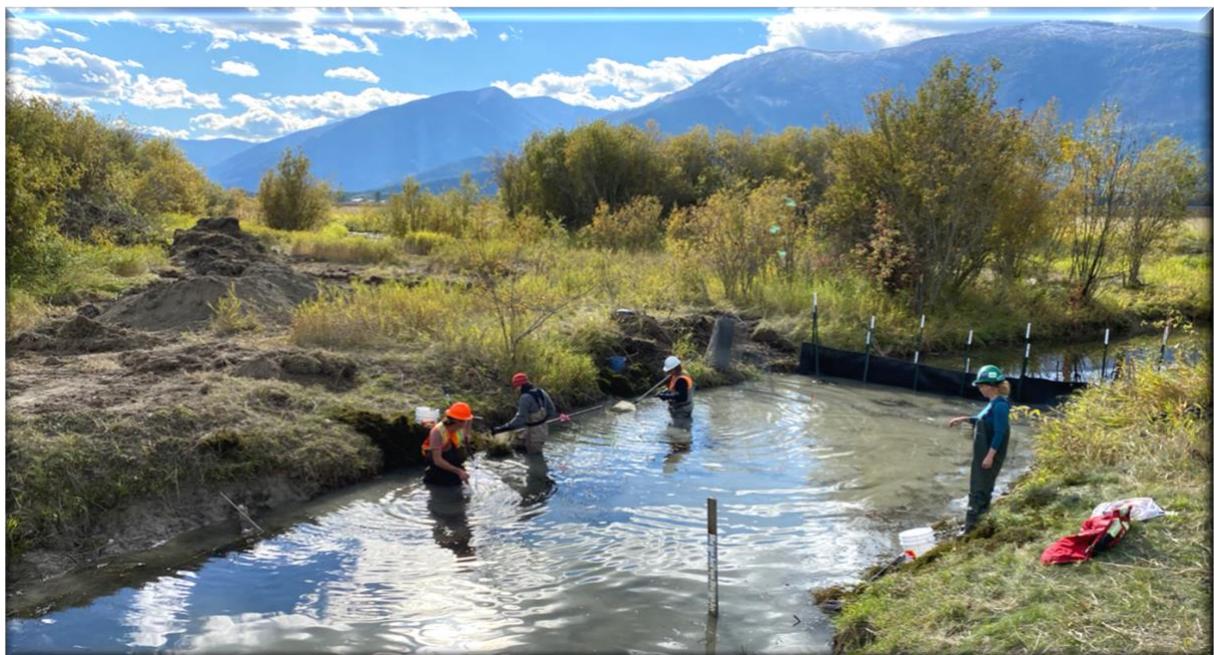
Figure 2 Fish and amphibian salvage, October 15th, 2020.

October 15-16: A herptile (amphibian and reptile) and fish salvage (Figure 2) was conducted in the channel west of the dike to allow for dewatering and the temporary construction of a coffer dam. Only exotic fish of the following species were captured during the salvage: largemouth bass, pumpkinseed, yellow perch, and black bullhead. Two amphibian species (northern leopard frog and Columbia spotted frog) and two reptile species (Western painted turtle and common garter snake) were found during monitoring near the work site and all but one individual were moved to a release site away from project activities (one individual was deceased upon detection; Table 2).

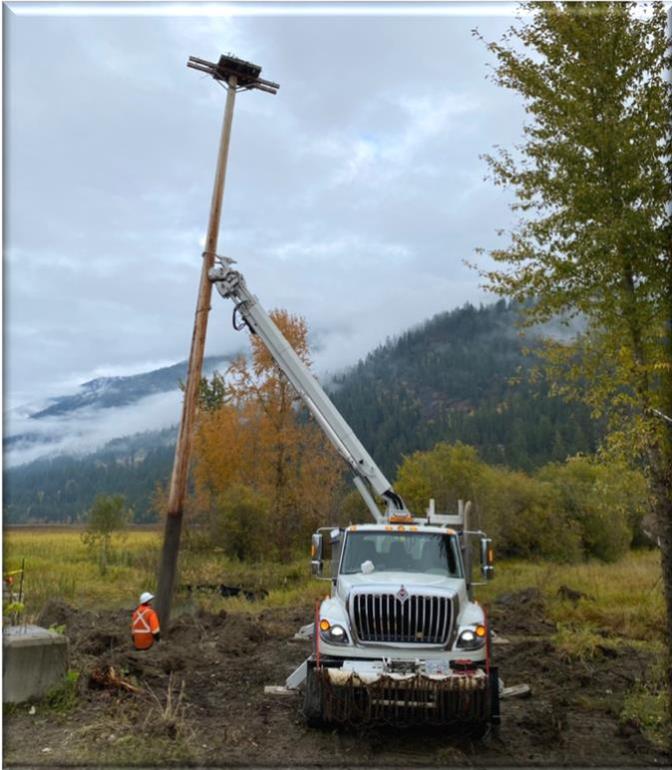
Figure 3 Osprey nest-platform relocation, October 19th, 2020.

October 19-20: A FortisBC-Electricity crew relocated an Osprey nest-platform outside of the construction zone (Figure 3). The old pumphouse and sluices gates were demolished (Figure 4), and the underground culvert removed (

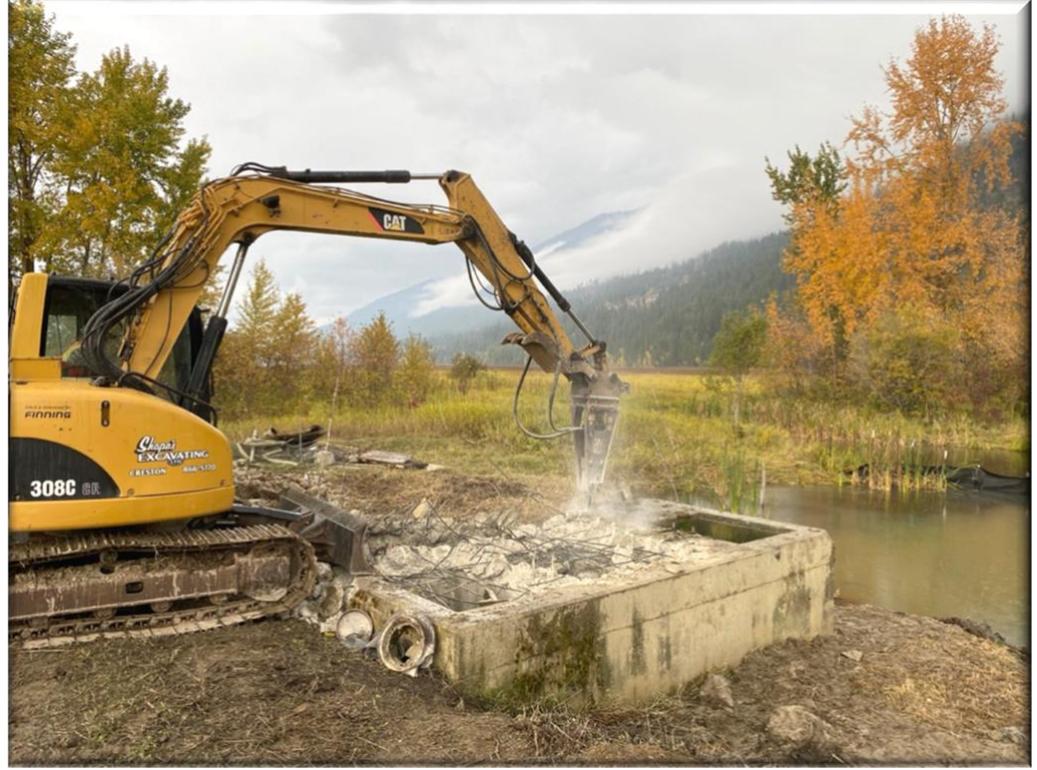
Figure 4 Pumphouse demolition, October 19th, 2020.

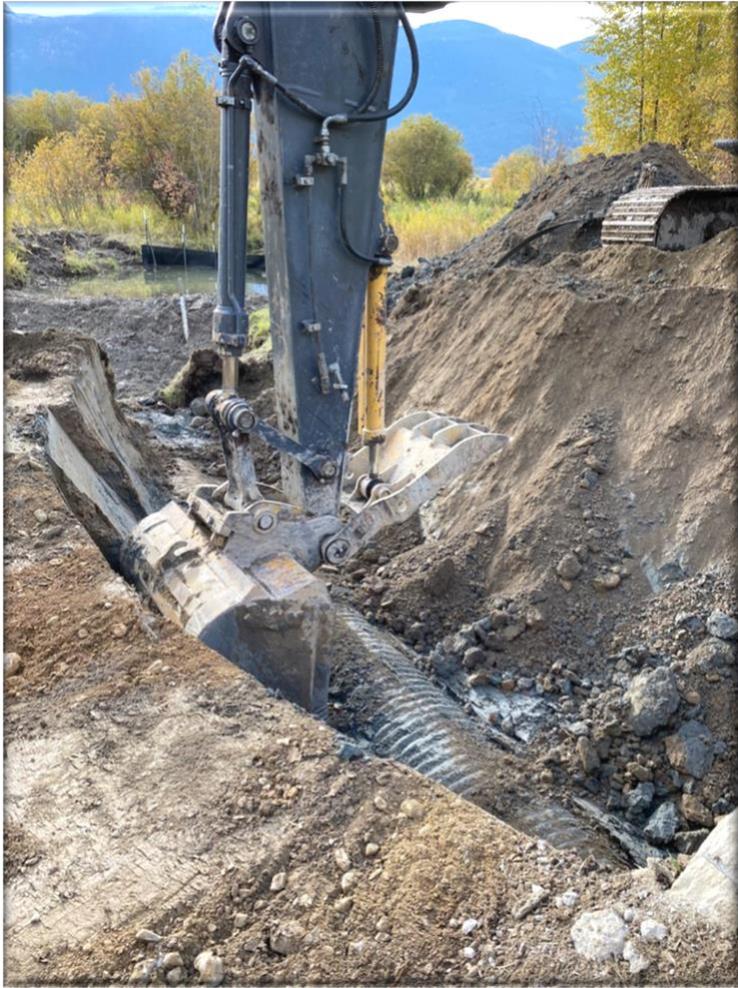
Figure 5 Removal of old culvert, October 20th, 2020.

Figure 5). Herptile monitoring and salvage activities were ongoing, and northern leopard frog, Columbia spotted frog, and common garter snakes were relocated away from project activities (Table 2).

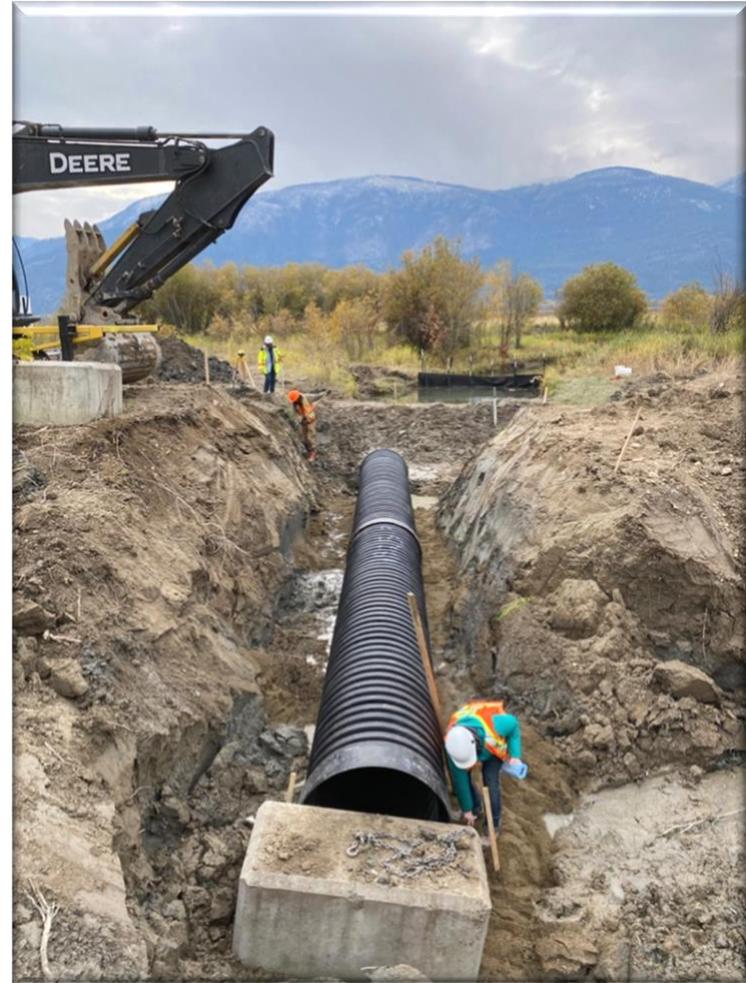
Figure 6 Culvert installation, October 22nd, 2020.

October 21-23: The installation of the new water control began, and a trench was dug for placement of the new high-density polyethylene culvert (

Figure 6). Two six-meter-long sections of culvert were laid into the trench and gradually buried over. Soils around and over the culvert were gradually compacted using “jumping jacks” units (Figure 7). A sand filter

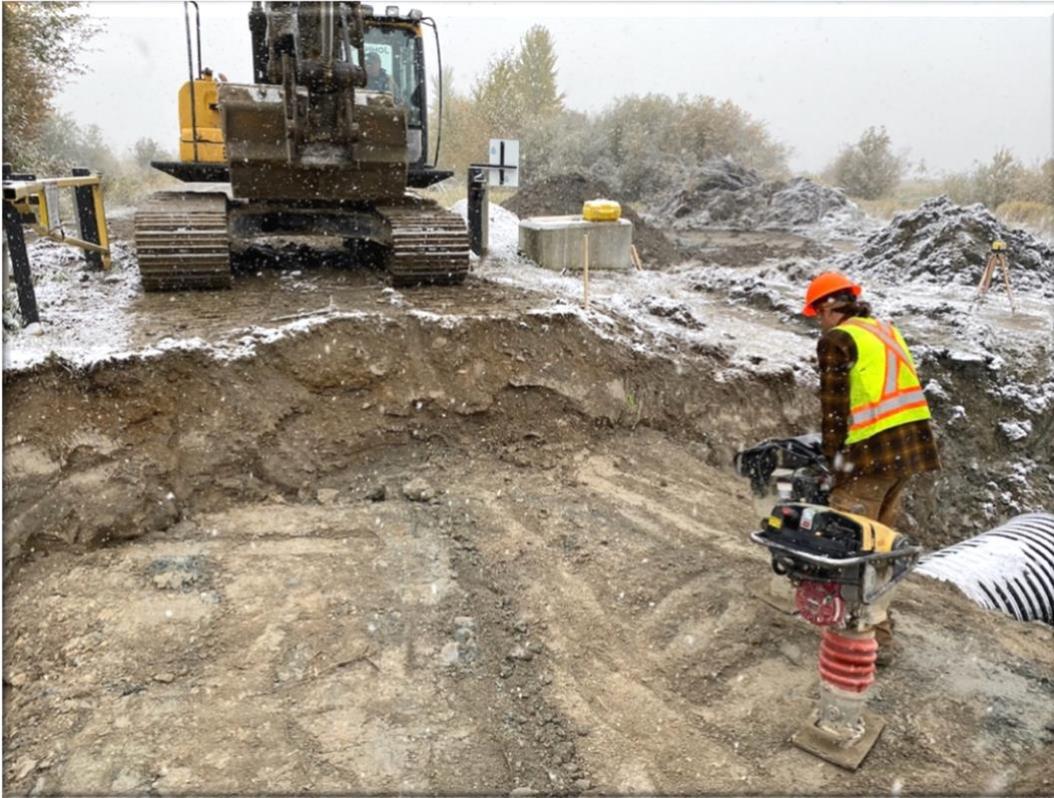
Figure 7 Compacting soils with “jumping jacks” units, October 23rd, 2020.

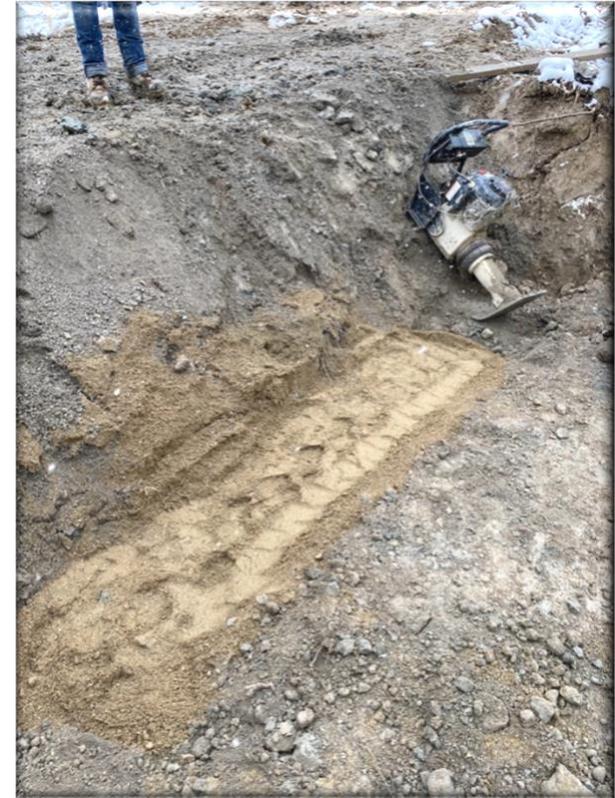
Figure 8 Sand filter at east end of culvert, October 23rd, 2020.

diaphragm was constructed at the east end of the pipe (Figure 8). No amphibians or reptiles were found near the work site on these three days (Table 2).

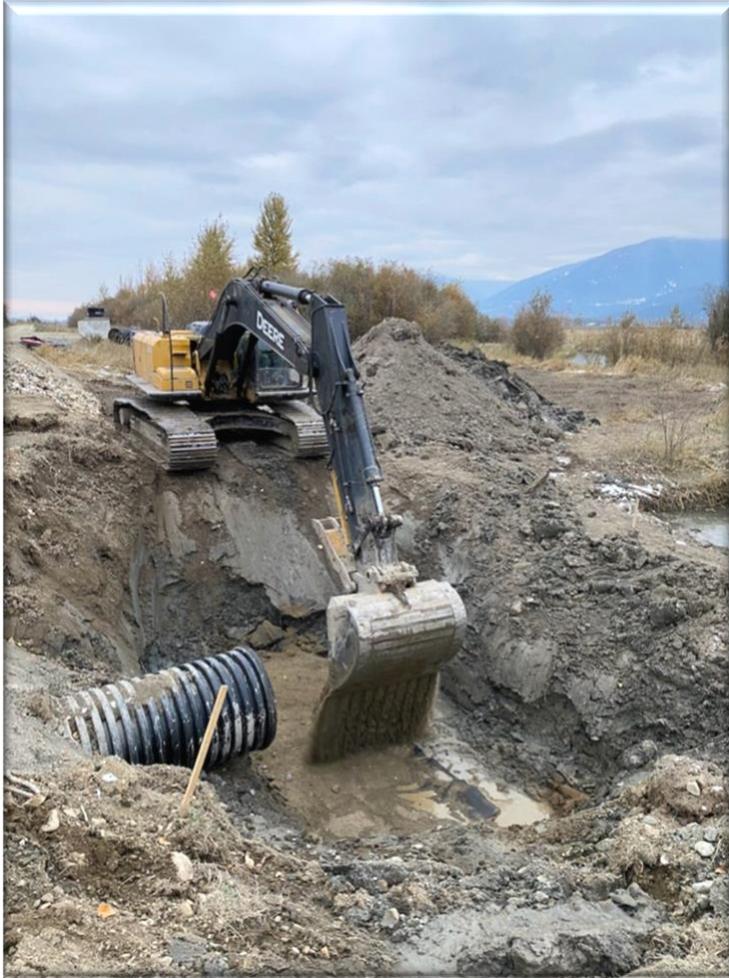
Figure 9 Building gravel/rock pad for concrete headwall support, October 27th, 2020.

October 26-27: Rock/gravel pads (2) to support the concrete headwalls (outlet structures) were constructed (Figure 9) and the two concrete headwalls were lifted and slid into place at each end of the culvert, using a 75-ton crane (

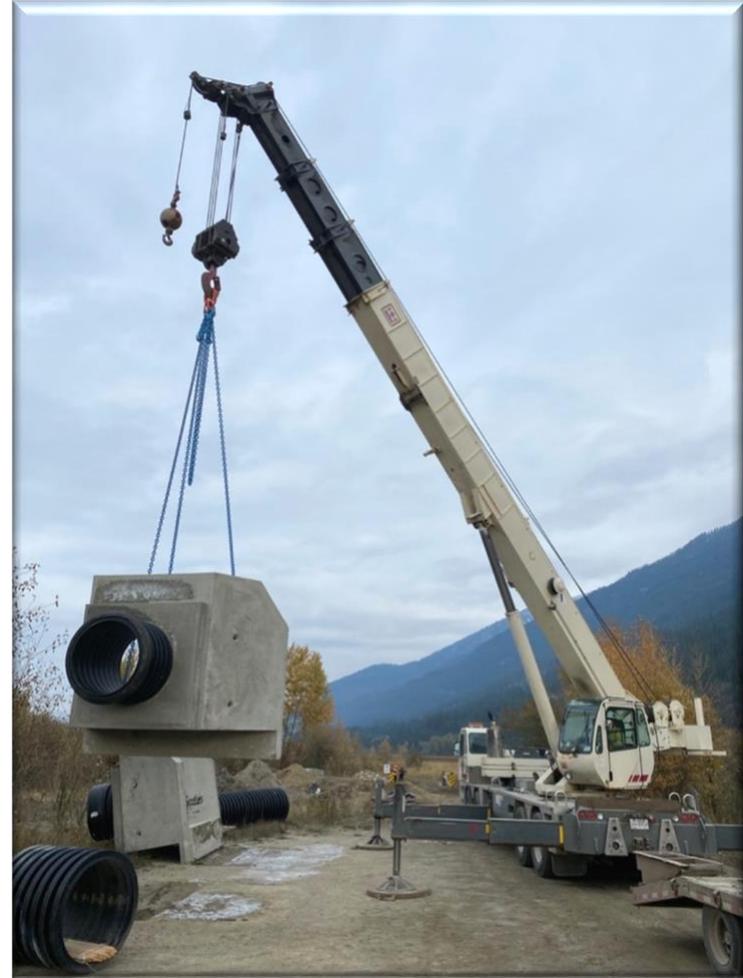
Figure 10 Lifting of concrete headwall, October 27th, 2020.

Figure 10). Herptile monitoring and salvage activities were ongoing, and a northern leopard frog was relocated away from project activities (Table 2).

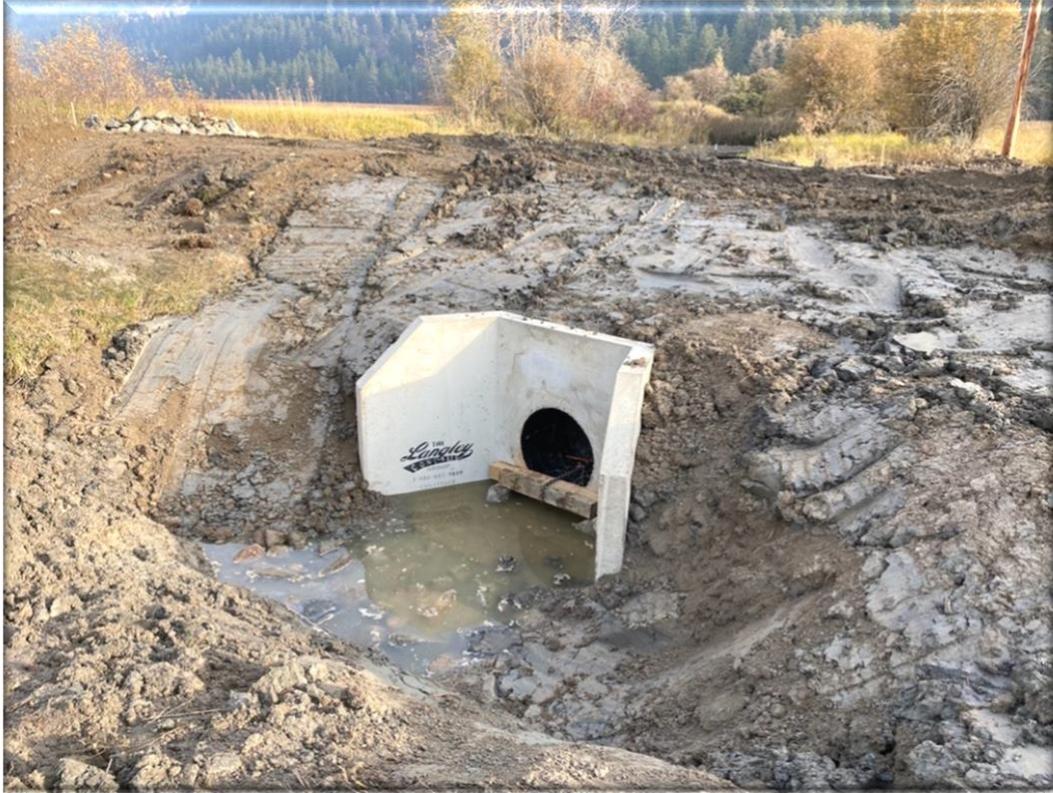
Figure 11 Filled and compacted soil over culvert and around concrete headwalls, October 29th, 2020.

October 28-29: Finished filling and compacting soils to grade along trench over culvert and around new concrete headwalls (Figure 11). Attached the new sluices gates to each of the two concrete headwalls and installed safety railing on top of headwalls (Figure 12). Herptile monitoring and salvage activities were ongoing; a group of common garter snakes were found near the work site and all but one of these individuals were safely released (one project mortality was recorded; Table 2).

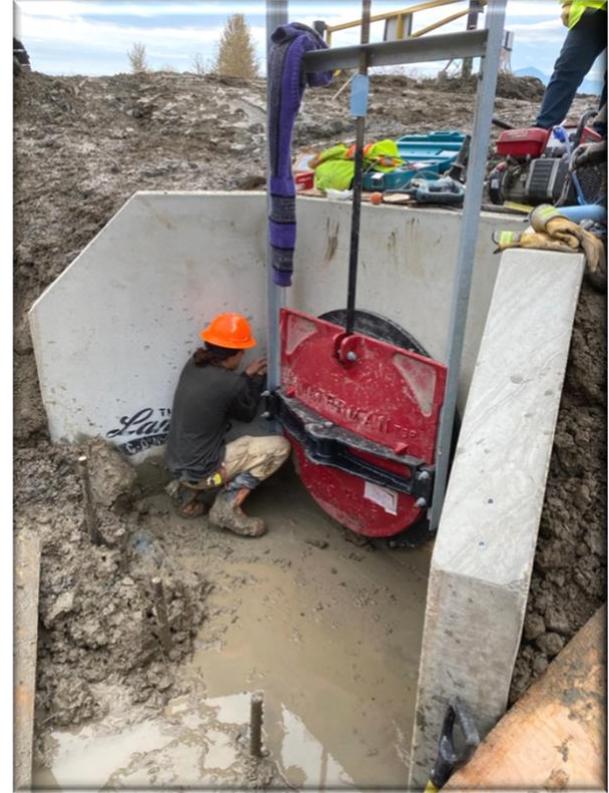
Figure 12 Anchoring sluice gate to one of two headwalls, October 29th, 2020.

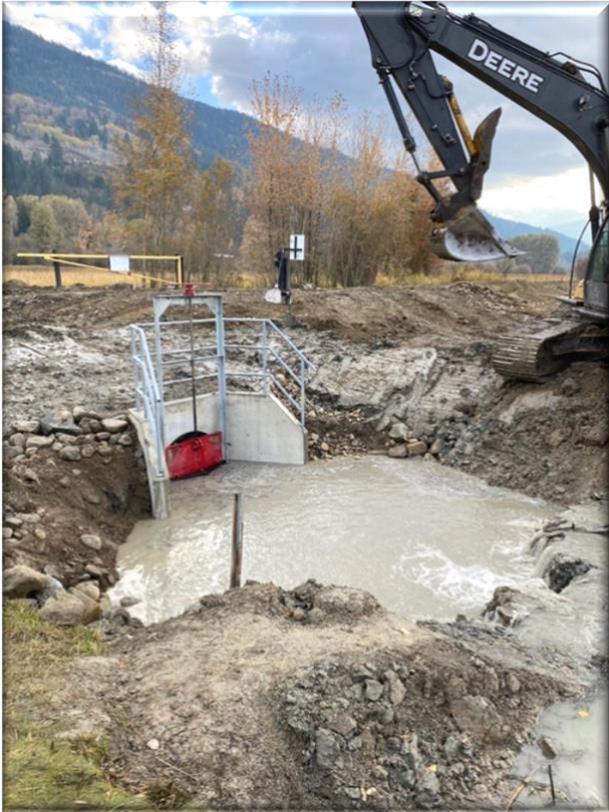
Figure 13 Removing coffer dams, October 30th, 2020.

October 30: Removed the coffer dams on both sides of the water control (Figure 13) and completed grading, levelling and cleaning up of project site (Figure 14), as well as seeding of all disturbed soil. Re-graveled the section of dike disturbed by project activities and digging. Re-opened dike to public (Figure 15). Herptile monitoring and salvage activities were ongoing and common garter snakes were relocated away from project activities (Table 2).

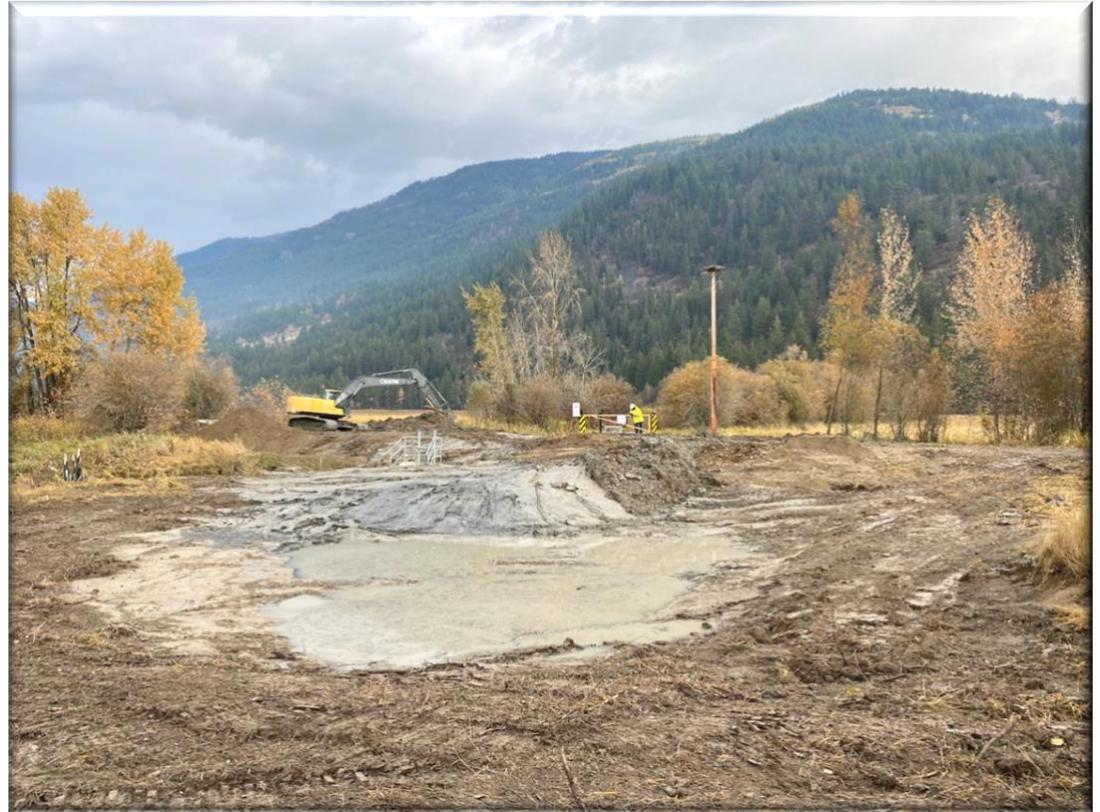
Figure 14 Levelling, grading and cleaning of project site, October 30th, 2020.

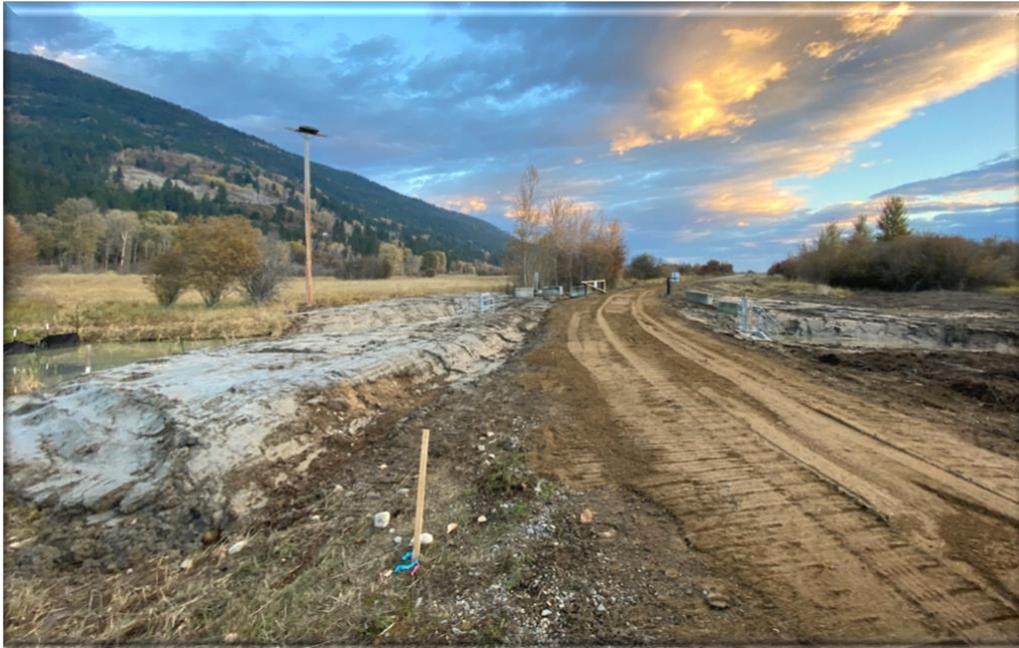
Figure 15 Re-gravelled section of dike at project site and re-opening of access to public, October 30th, 2020.

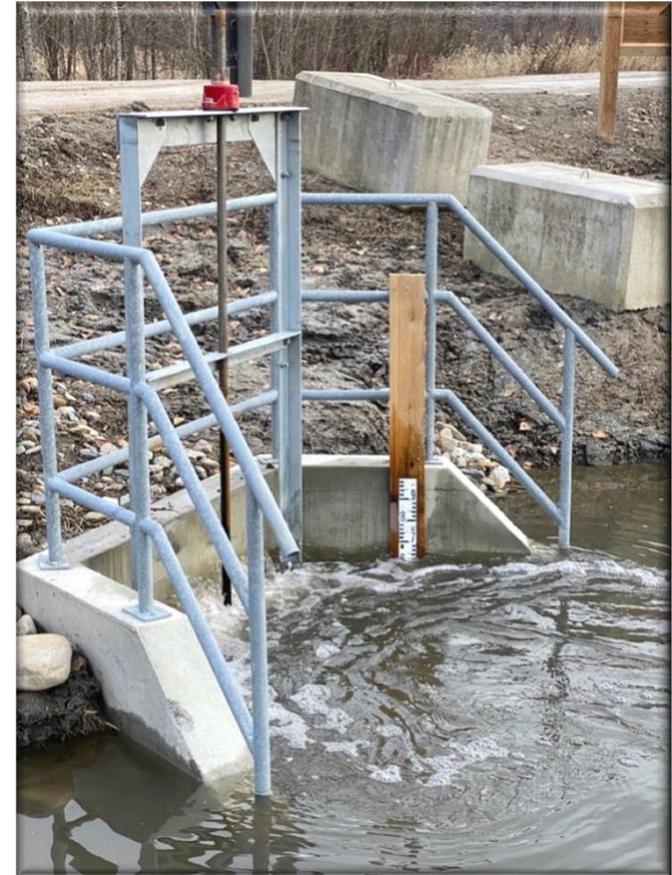
Figure 16 Water flowing into DLNA from Duck Lake, January 16th, 2021.

The two new sluice gates were opened for the first time on January 12th, 2021, to let water into the DLNA from Duck Lake. Both gates were opened approximately 30 cm and operated properly; water flowed

through to DLNA as expected (Figure 16). Water levels were brought up approximately 10 cm from January 12th to January 29th, 2021.

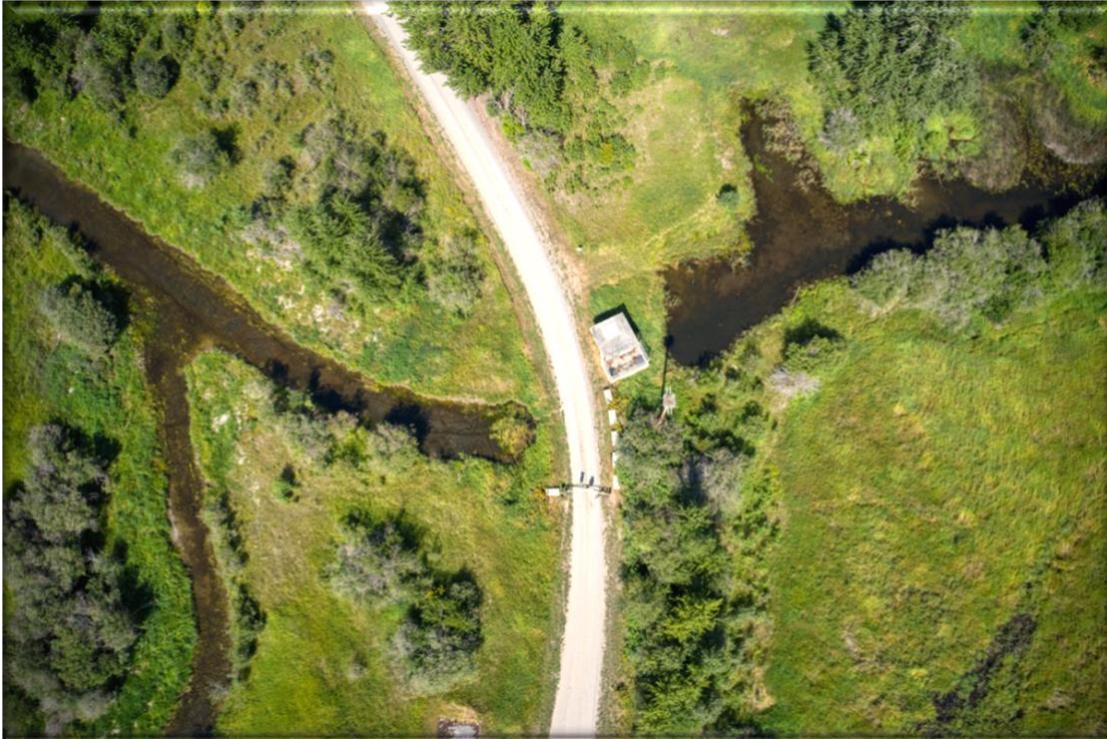
Figure 17 Aerial photo showing site before project was implemented, August 18th, 2020.

“Before and After” photos were taken with a small drone on August 18th (Figure 17) and November 14th (Figure 18); these photos show the removal of the old pumphouse and a minor re-configuration of the channel on the east side of the dike to accommodate the new water control.

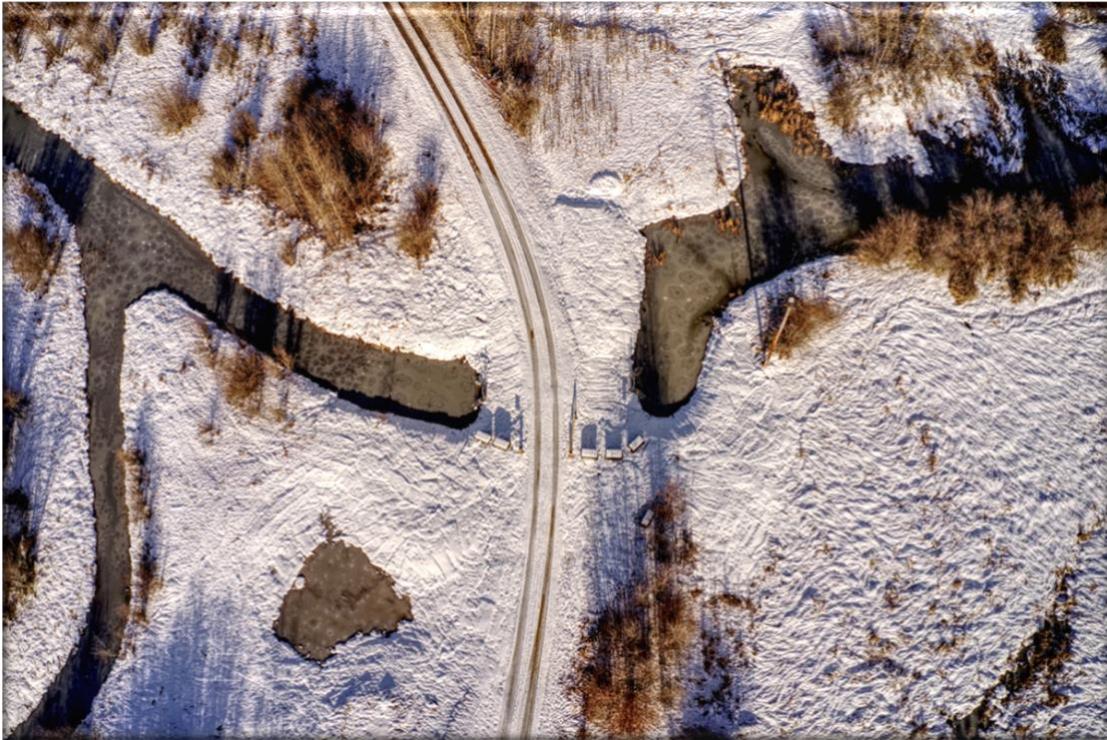
Figure 18 Aerial photo showing site after the project was completed, November 14th, 2020.
