BOOTLEG CONTRACTING
OUTDOOR SERVICES

Fence Assessment/Repair: Wycliffe Conservation Property Complex

Table 1: Fence Assessment Results for the 2024 Wycliffe Conservation Property Complex Fence Assessment/Repair Project

Table 2: Fence Assessment Follow Up Actions and Recommendations for the 2024 Wycliffe Conservation Property Complex Fence Assessment/Repair Project

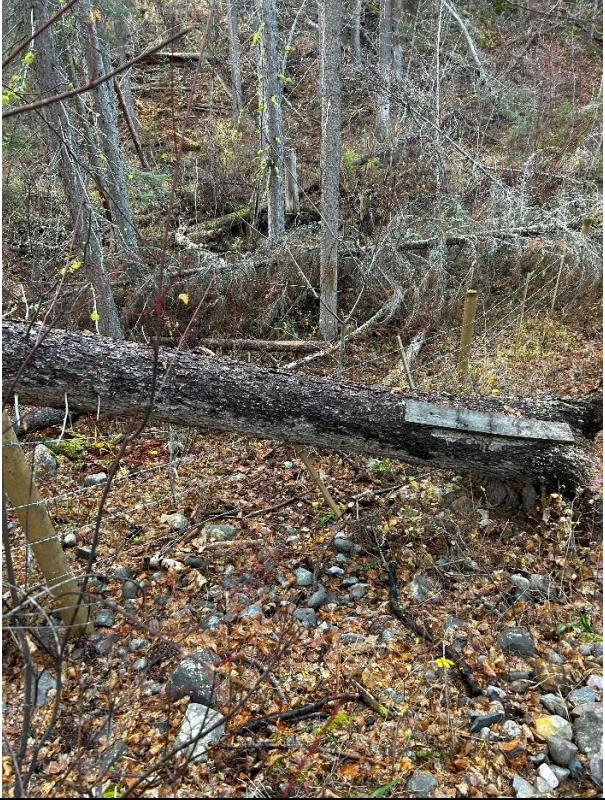
Fenceline Desc. (PID/Direction)	Follow Up Items	Location	Description/Recommendations
008-406-823 South Boundary NCC	Tree removal with chainsaw	49.630726N 115.893343W	<p>Chainsaw is required to remove large trees that are down on the fence. Location is where the fence crosses Luke Creek. Estimated 2 hours for 2 people to repair.</p>

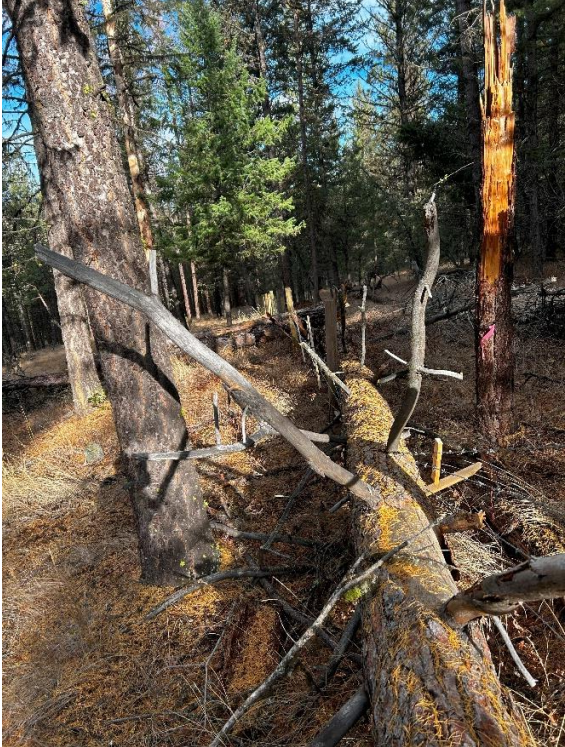
008-406-823 West Boundary NCC/BC Gov	Tree removal with chainsaw, and repair broken wire.	49.632491N 115.900920W	<p>Chainsaw is required to remove 3 large Py that have fallen on the fence. The wires are broken and will need to be spliced after tree removal. Estimated 3 hours for 2 people to repair.</p>

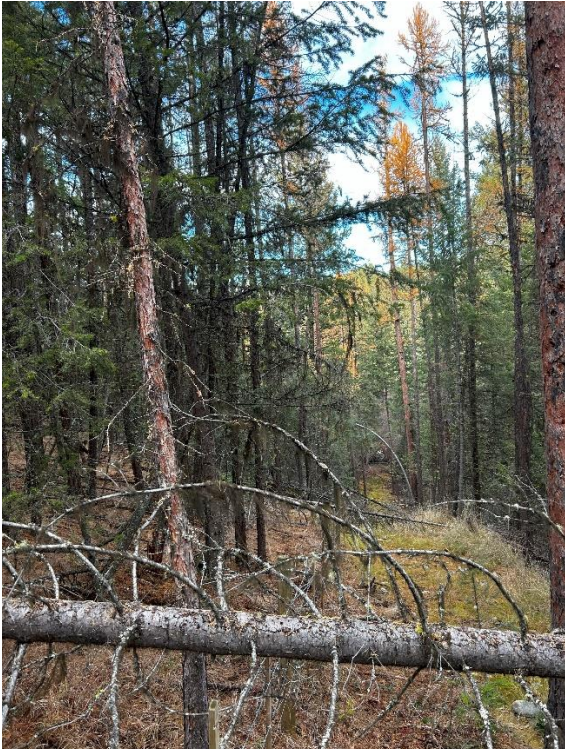
<p>005-564-8245 West Boundary (South end) NCC/BC Gov</p>	<p>Trees down on fence between the two following locations. Requires Chainsaw</p>	<p>Between 49.634788N 115.900891W And 49.636191N 115.900846W</p>	<p>Chainsaw required to remove ~10 trees off the fence between the two locations provided. Estimated 2 hours for 2 people to repair.</p>

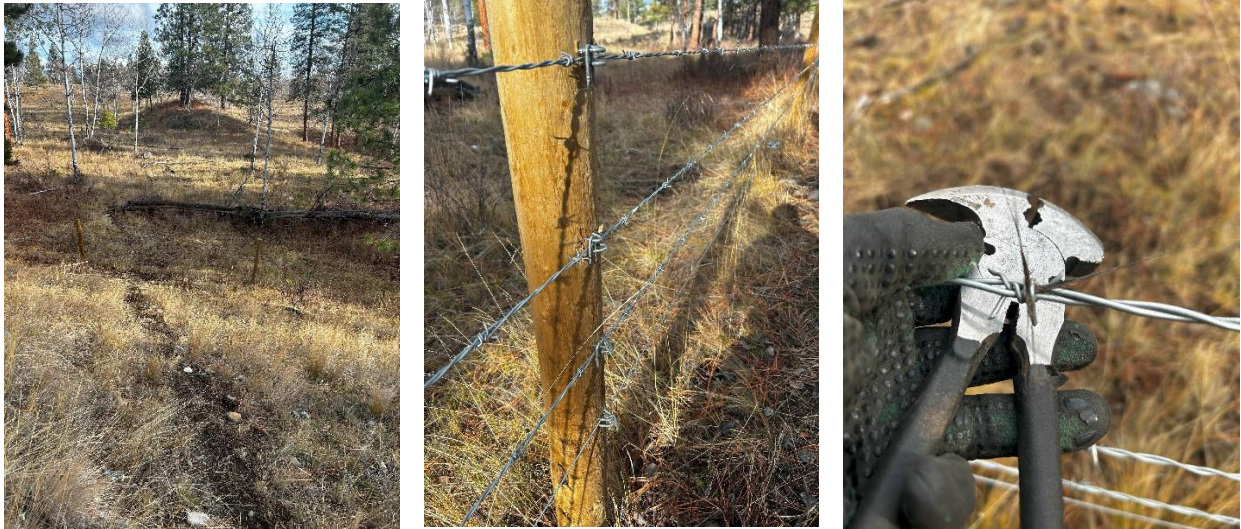
Figure 1-3: Photos of where a staple lock section was installed due to high wildlife traffic on PID 008-406-823, East Boundary, NCC

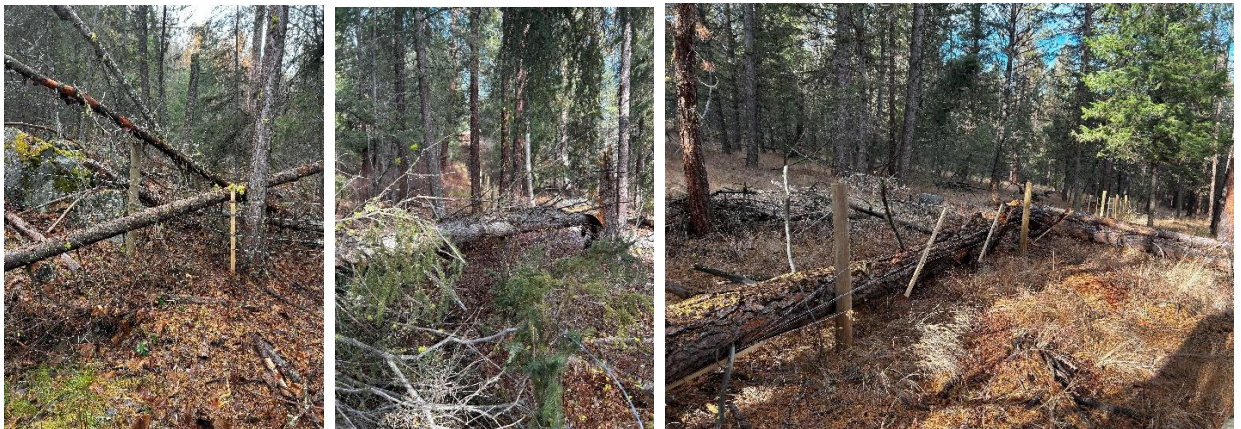
Figure 4-6: Additional photos of trees down on the section noted in Table 2, on PID 005-564-8245 West Boundary (South end) NCC/BC Gov.
