Environment and Climate Change Canada

Canada Nature Fund: Community-Nominated Priority Places for Species at Risk

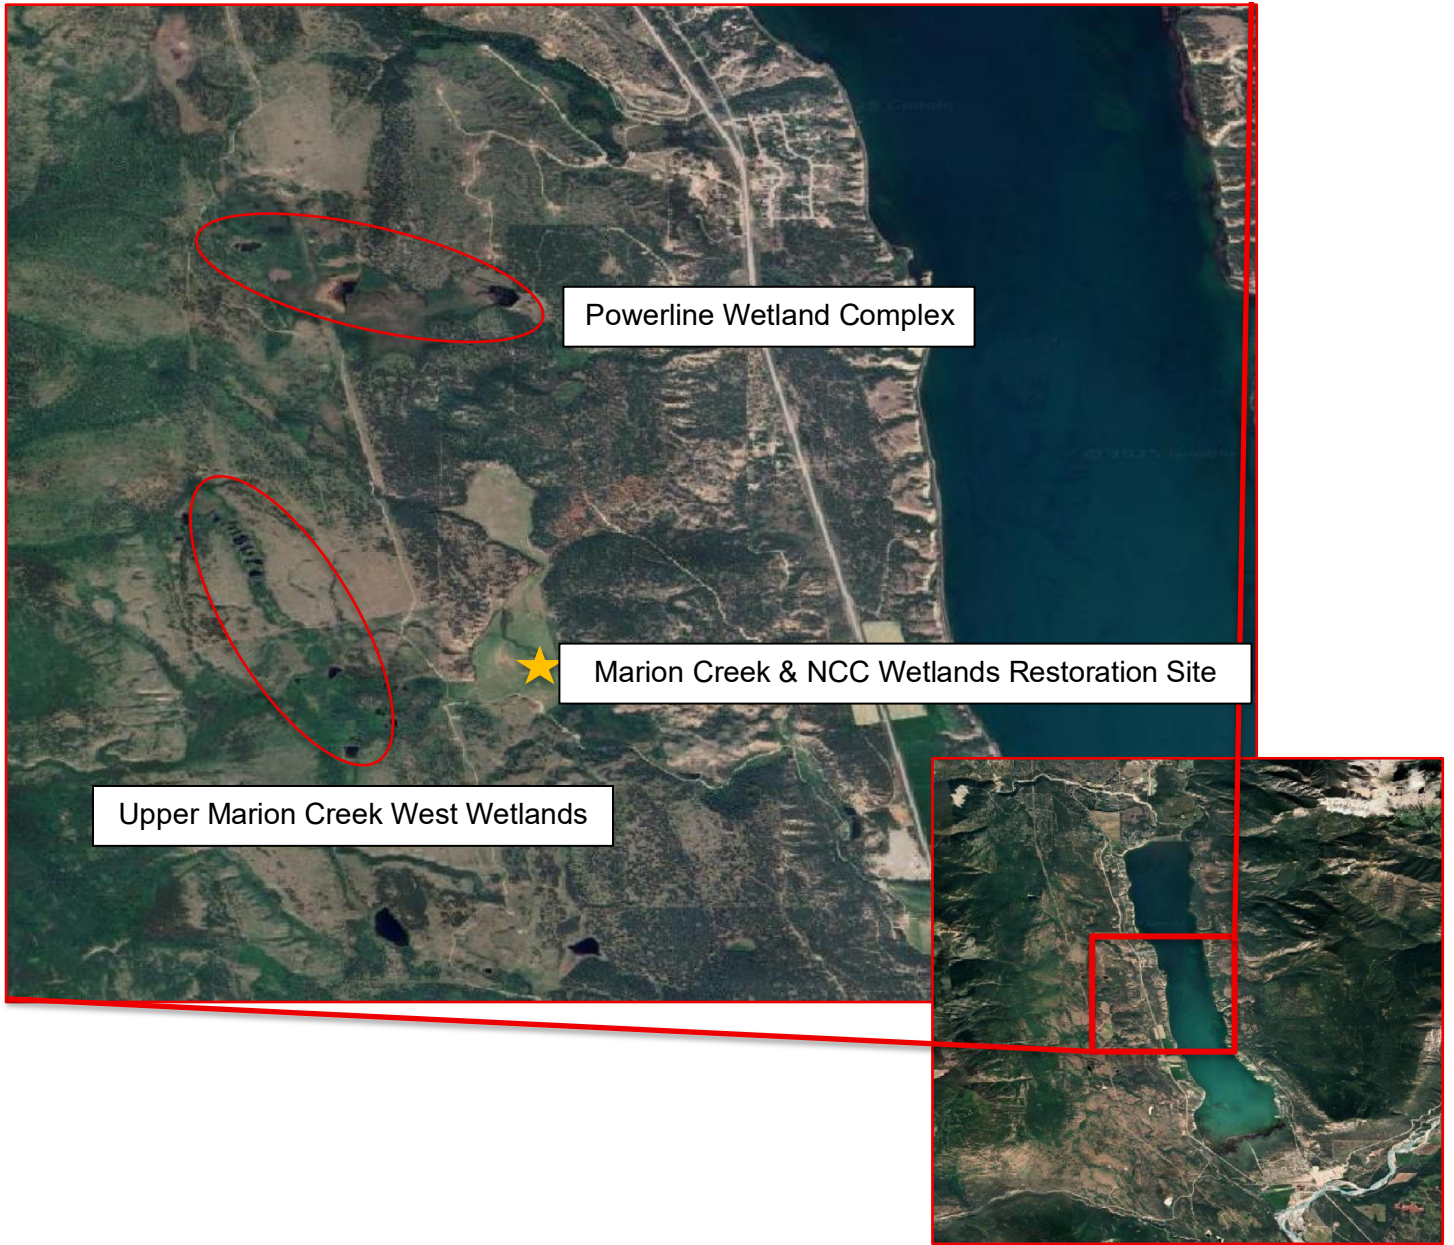
Figure 1: Locations of the Upper Marion Creek West Wetlands complex and the Powerline Wetland complex, on the benchland west of Columbia Lake

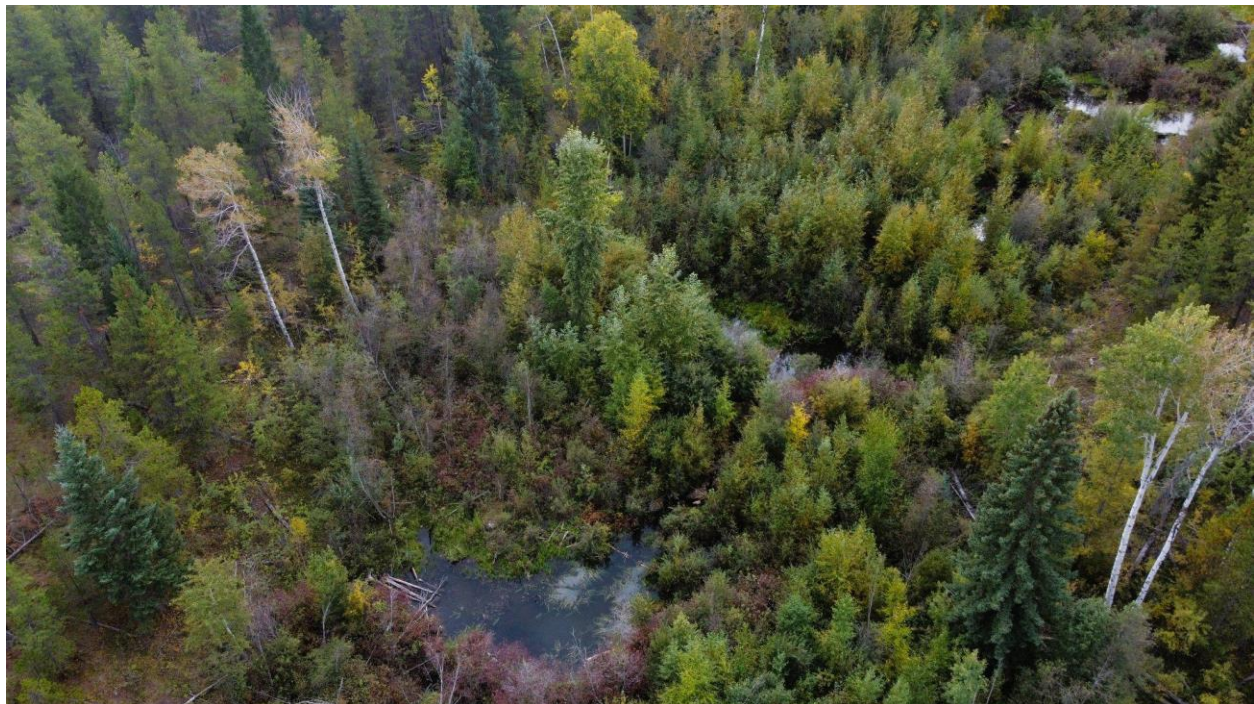
Figure 6: Drone photograph showing the predominantly wooded southerly area of the Marion Creek West Wetlands.

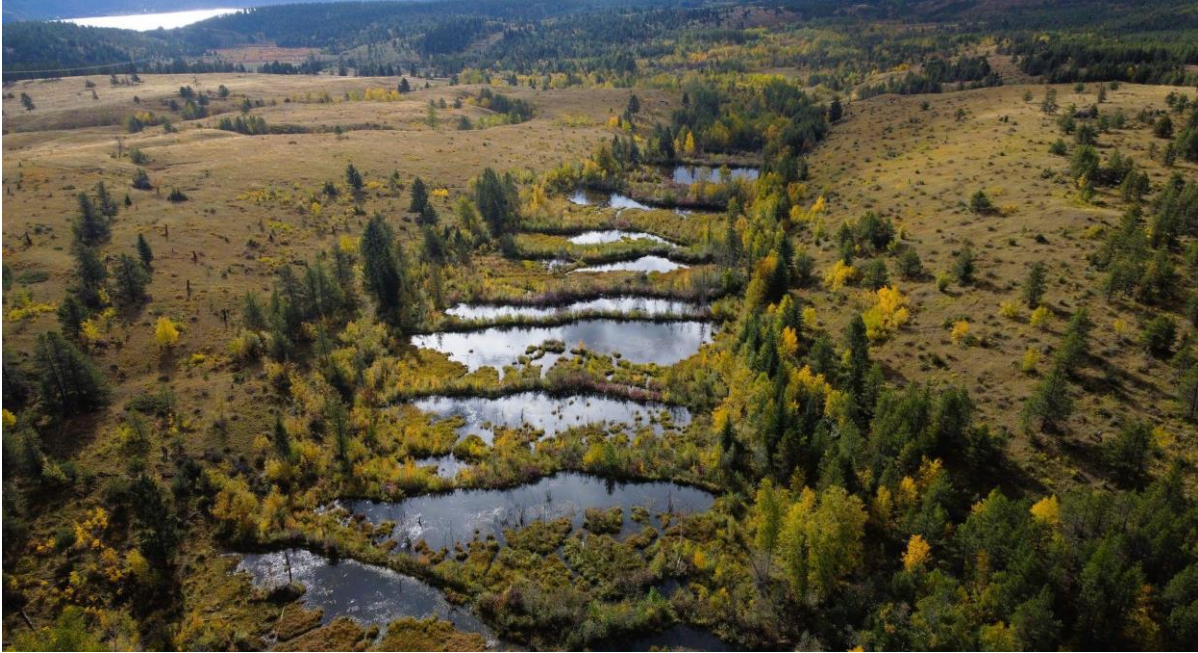
Figure 8: Drone photograph of series of beaver dams in the more northern area of the Marion creek West Wetlands.

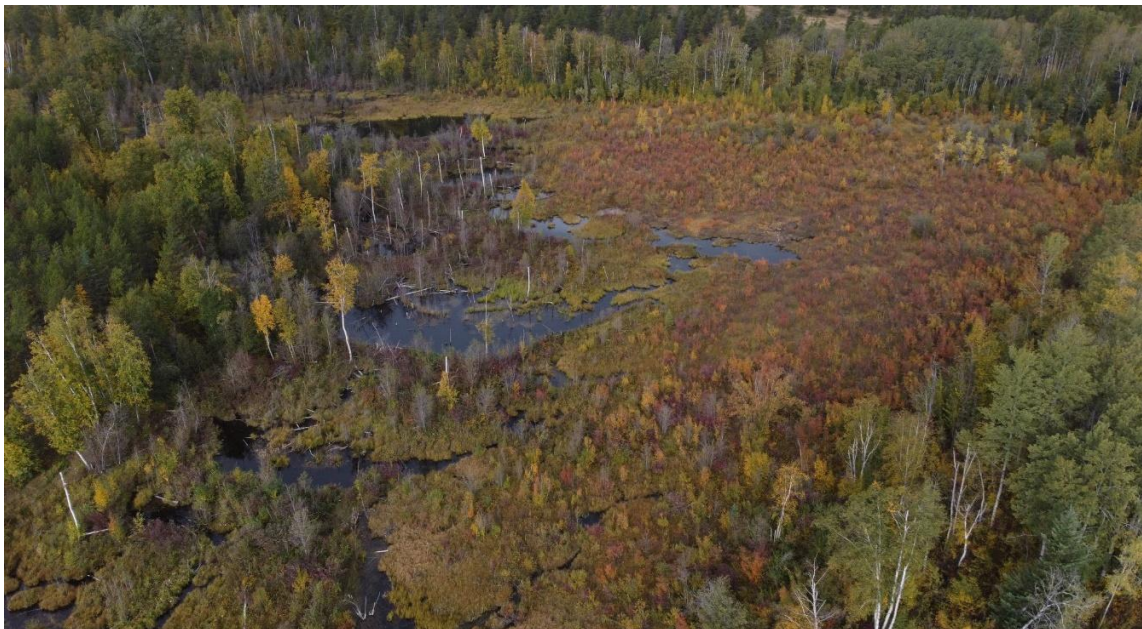
Figure 9: Drone photo showing wetland area between Dams 110 and 118; note mix of open water, fen, and marsh.

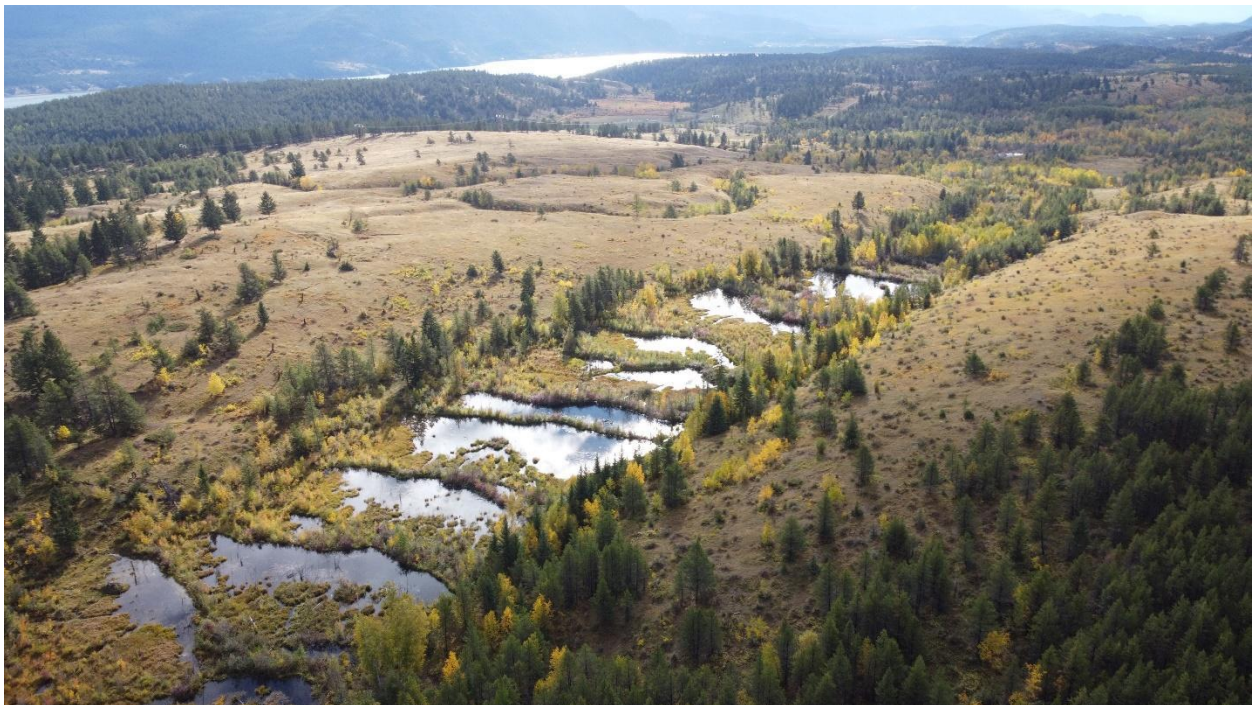
Figure 10: Aerial photo showing contrast between wetlands maintained by beaver dams along Marion Creek and surrounding landscape.

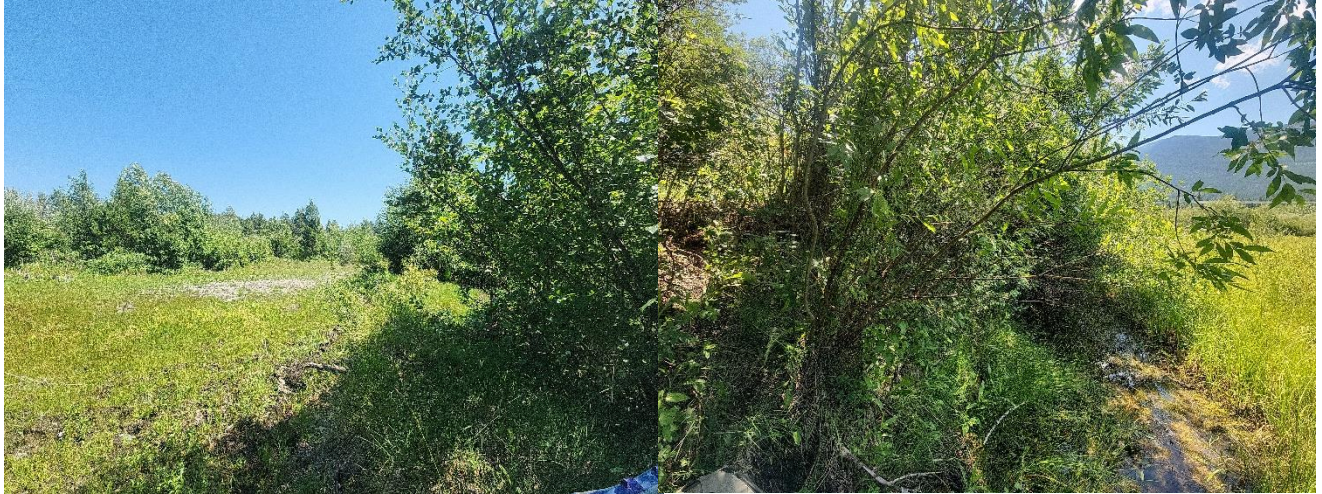
Figure 13: Observed indications of drying: no longer wet wetland area upstream of old beaver dam (dam marked by shrubs on right-hand side of photo); wetted area only present directly upstream of dam, while the rest of wetland is dry.

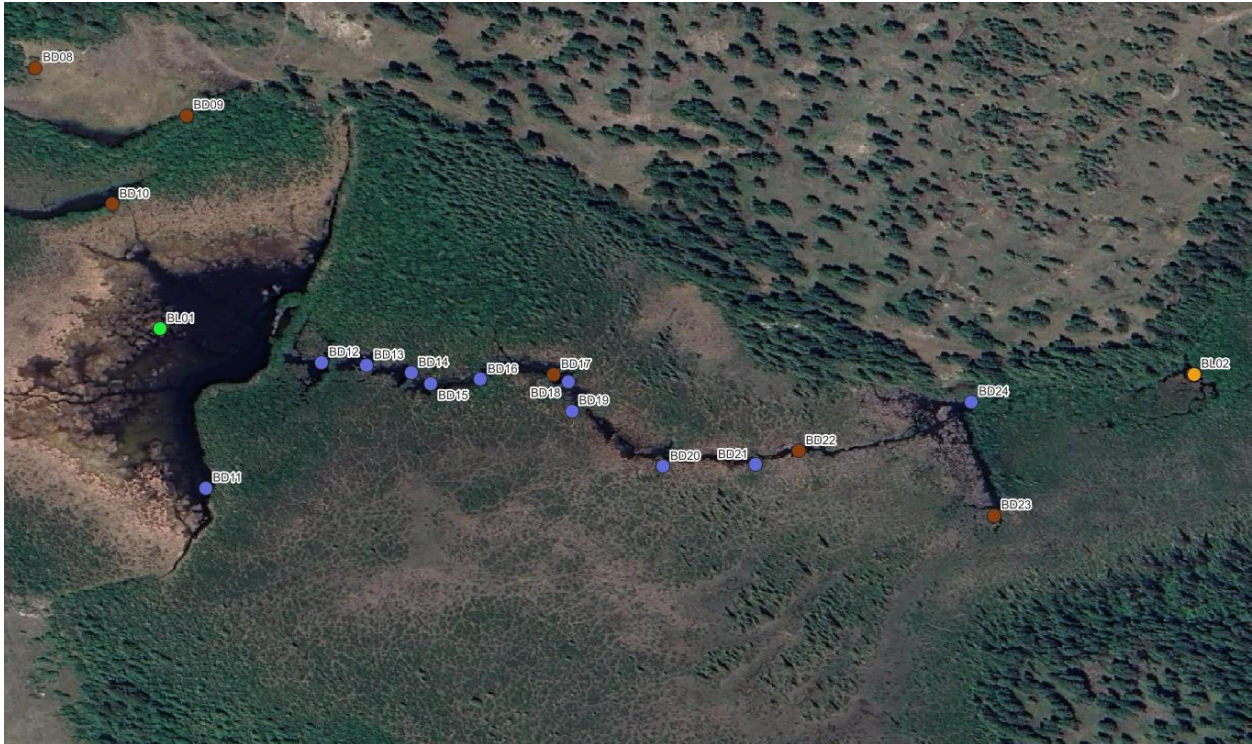
Figure 14: All 11 active beaver dams within the Powerline Wetlands complex were downstream of BD11, the longest dam in the area holding the most water.

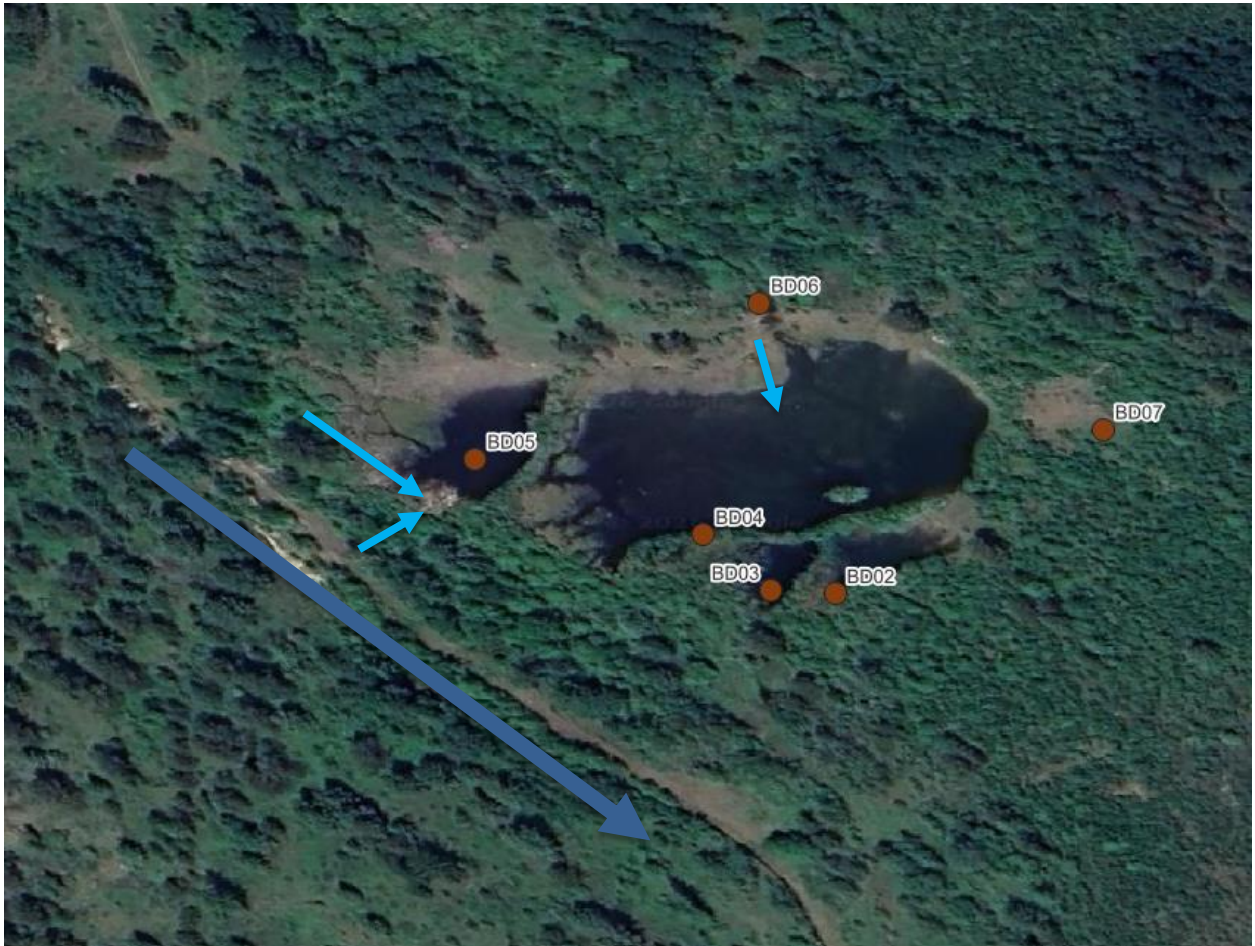
Figure 15: BD05 was the most upstream beaver dam found, with the land around this dam and wetland rising in all directions. The light blue arrows indicate water inflows to these wetlands; the dark blue arrow indicates the flow of water within the human constructed ditch that began on this hillside.

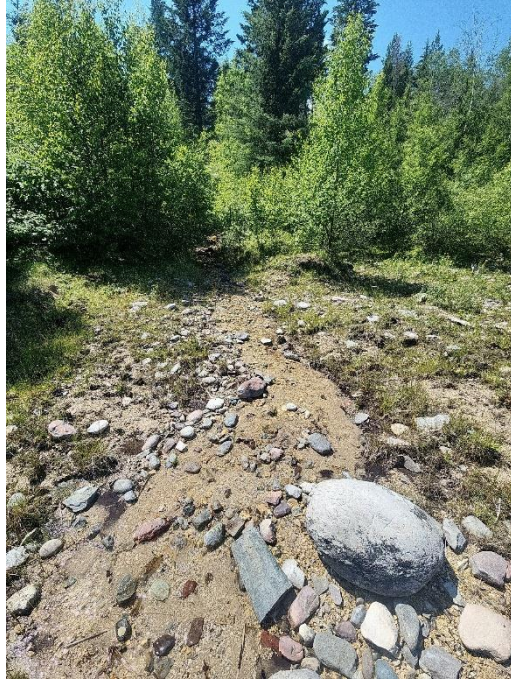
Figure 16: Water inflow to the wetland above BD5, rising from gently sloping hillside.

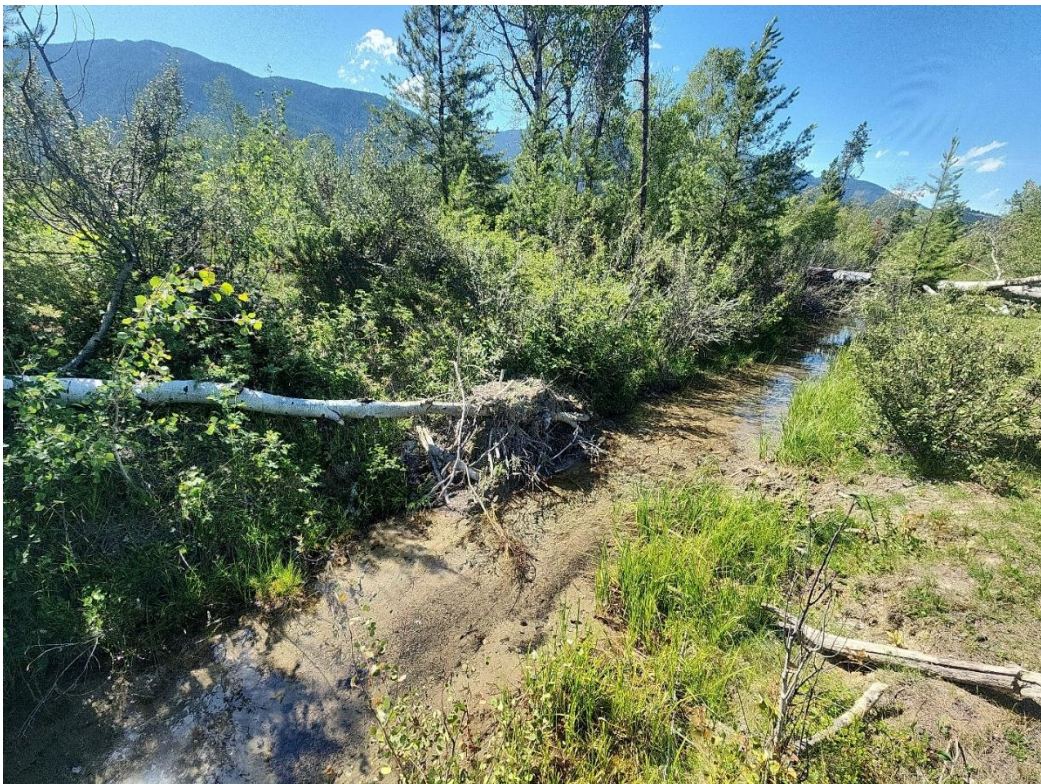
Figure 17: Downstream area of ditch, with signs of beaver-felled trees and beaver-constructed dams that have been removed. Water is flowing towards the photographer, in a southerly direction. The Powerline Wetlands complex is to the north.
