# Kootenay Connect: 7CW Columbia Wetlands: Summary (2023-2026) and Yr 7 Upland Wetlands Restoration Report

March 31, 2026

Columbia Wetlands Stewardship Partners

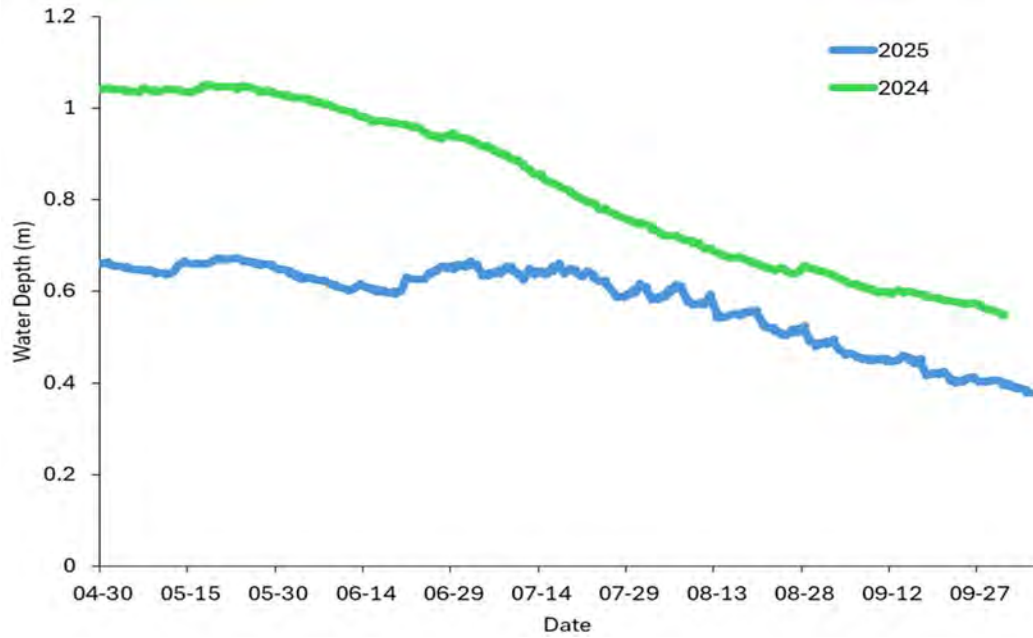
In 2025, both reference wetlands had lower water levels than in 2024 (Figures 2 and 3). The Westside Junction reference site is characterised by open water and abundant hydrophytic vegetation (e.g., cattails, sedges, and water lilies). The Coltsfoot reference site is dominated by Scrub Birch and sedges, with a stream running through the wetland; despite the presence of degraded, historic beaver dams, there is no open water present. The Westside Junction reference site shows more variation between 2024 and 2025. In 2024, water depth varied between 1.05 m and 0.55 m, and in 2025 between 0.67 m and 0.38 m. The Coltsfoot reference site had less variation, likely due to the lack of open water present, but still showed lower water levels in the stream channel in 2025, with a variation in depth of between 0.36 m and 0.03 m in 2024 and 0.18 m and 0.02 m in 2025. Despite the differences between these wetlands, this similar trend of lower water levels in 2025 indicates that it was a drier year across the whole landscape. In addition, we also noticed streams that were permanent in 2024 or 2023 became ephemeral in 2025, and heard multiple anecdotes about streams, wetlands, and lakes being drier in 2025 than in the living memory of local residents. This highlighted that the impacts of drought and climate change are already being felt in these wetlands, and that understanding and conserving them is important and urgent.

Figure 2. Water levels in 'Westside Junction' reference site in 2024 (green) and 2025 (blue).

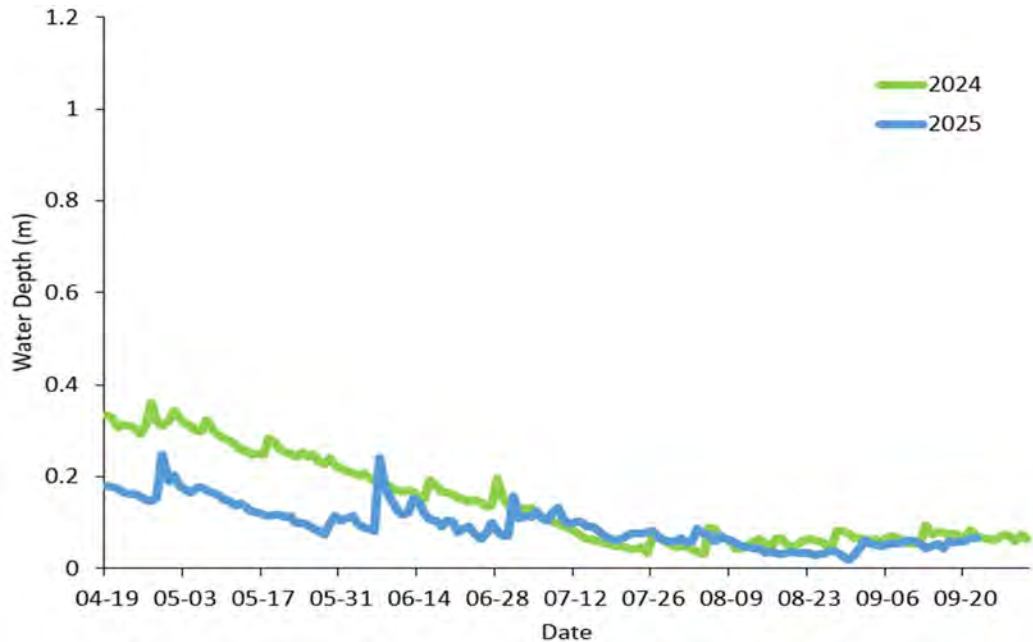
Figure 3. Water levels in 'Coltsfoot' reference site in 2024 (green) and 2025 (blue).

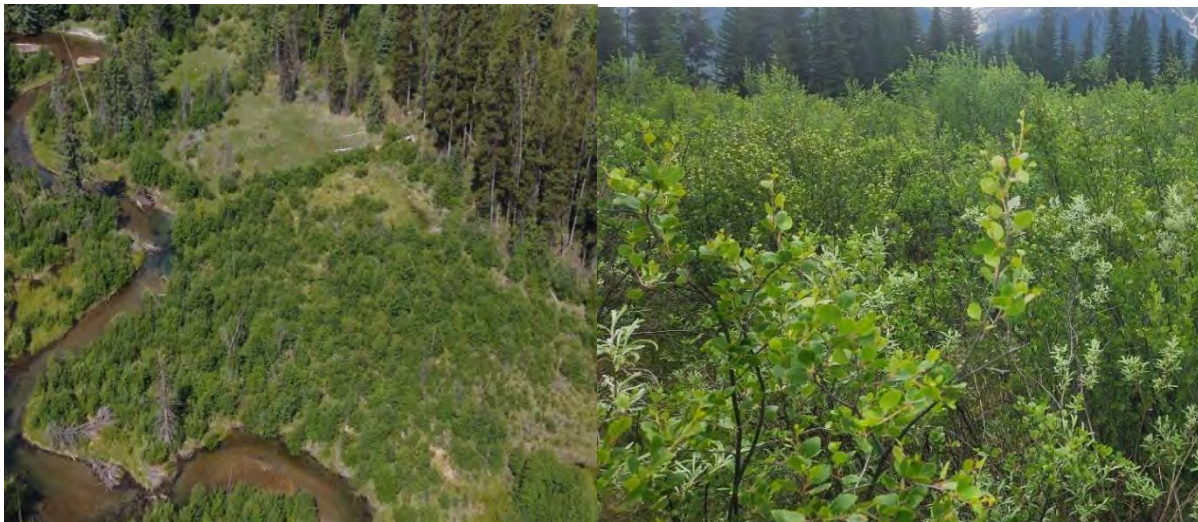
As mentioned, four wetlands had the same vegetation observations as both the drone and in-person, but different wetness indices. The 2023 analysis considered shrubs to be a sign of drying, as this is the case in many wetland systems (e.g. Capon, 2003; Klein *et al.*, 2005; Kotowski *et al.*, 2013) However, after spending more time studying the wetlands in this area, we have observed that many wetlands are naturally Scrub Birch or Willow species dominated (Figure 4), and that this is not necessarily an indication of drying, with many of these wetlands having saturated ground and herbaceous wetland vegetation as understory. Therefore, if we adjust the wetness index categories for drone classifications so wetlands with Shrub as the dominant ground cover, when accompanied by wetland vegetation, are considered Adequately Wet then the drone classification for these four sites align with the in-field classification.

*Figure 4. On the left, shrub-dominated areas of a wetland (A); on the right, the same shrub-dominated habitat from the ground (B). After working on the western bench of the Columbia Valley, we believe that this is a common wetland type in this region and is*

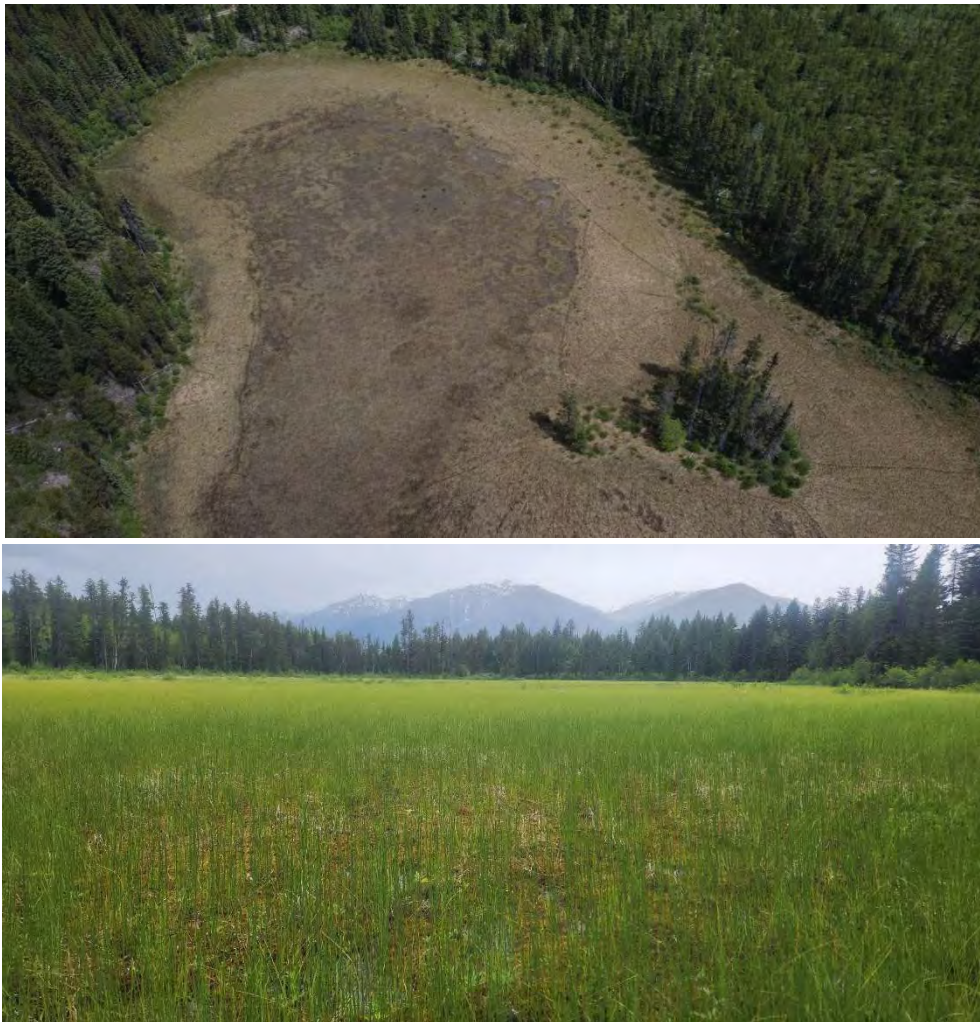
Two wetlands were classified differently between assessment methods due to differences in the timing of site visits. In one case, the wetland is a fen where standing water is not visible in drone imagery because dense wetland vegetation forms floating mats over the water surface. As a result, the presence of water can only be confirmed through on-the-ground observations within the wetland. Furthermore, the drone photos were taken in May, before wetland vegetation had sprouted and greened up (Figure 5A), and so the area looked like a dry mudflat; the in-person field visit took place in August, when the vegetation was lush and green (Figure 5B). The second site had open water when drone photos were taken in May 2023, but in August 2025 the open water areas were mudflat, and there was no saturated ground within the wetland. This highlights that time of year and year of survey are important factors to consider for both drone and on the ground surveying. Overall, 2025 was a much drier year than 2023 (see Section 3 for more details) and so more wetlands had ephemeral water.

*Figure 5. Above, drone photo of fen wetland from May 2023 (A), looking like a dry mudflat; below, the same wetland in August 2024, with wetland vegetation growing well (B). While there is no open water in the wetland, the ground is saturated and in some places the fen vegetation is growing in floating mats over water.*

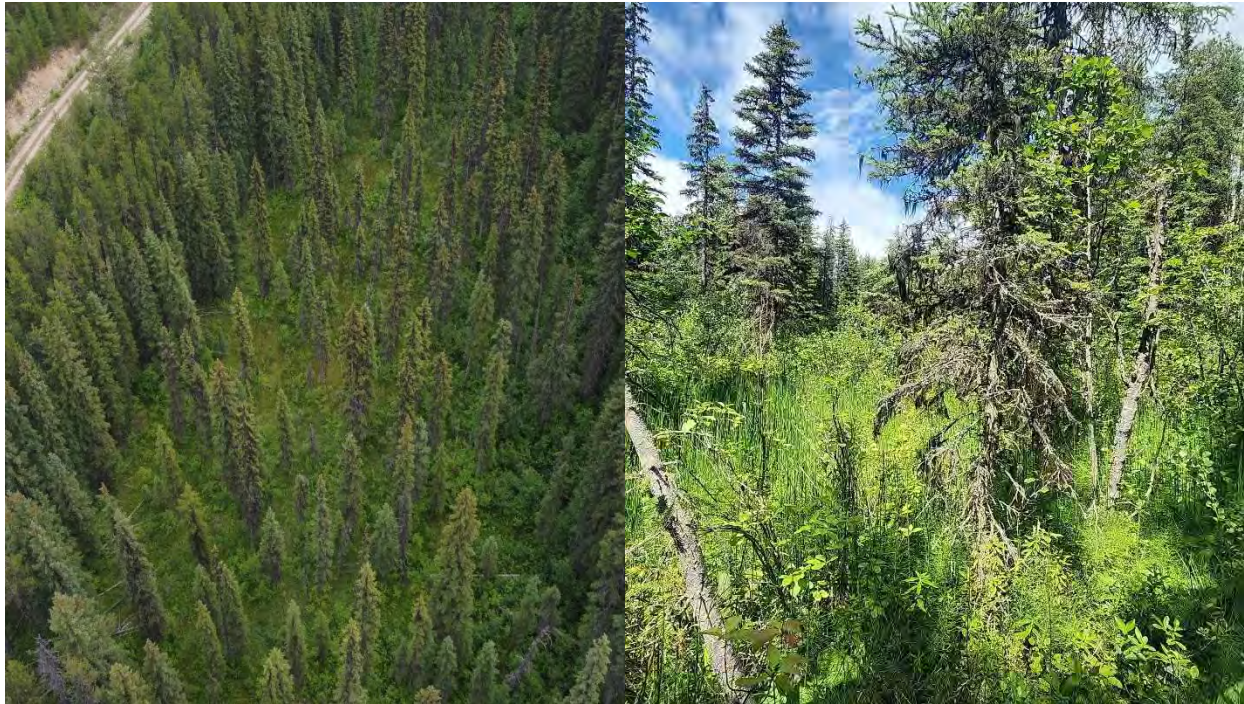
Three of these wetlands misclassified by drone inventory were conifer-dominated swamps, specifically classified in the BC Wetland Classes as Spruce – Horsetail (Ws07) (Figure 7). It is impossible for the drone to ‘see’ into these wetlands due to the presence of large conifers, so it is only by visiting them in-person that the presence of a stream and wetland vegetation understory can be determined. Therefore, these wetlands cannot be identified using a drone.

*Figure 7. On the left, drone photo of wetland with conifers as the dominant vegetation (A); on the right, the same wetland, with a visible understory of wetland vegetation (Horsetails and Labrador Tea) (B).*

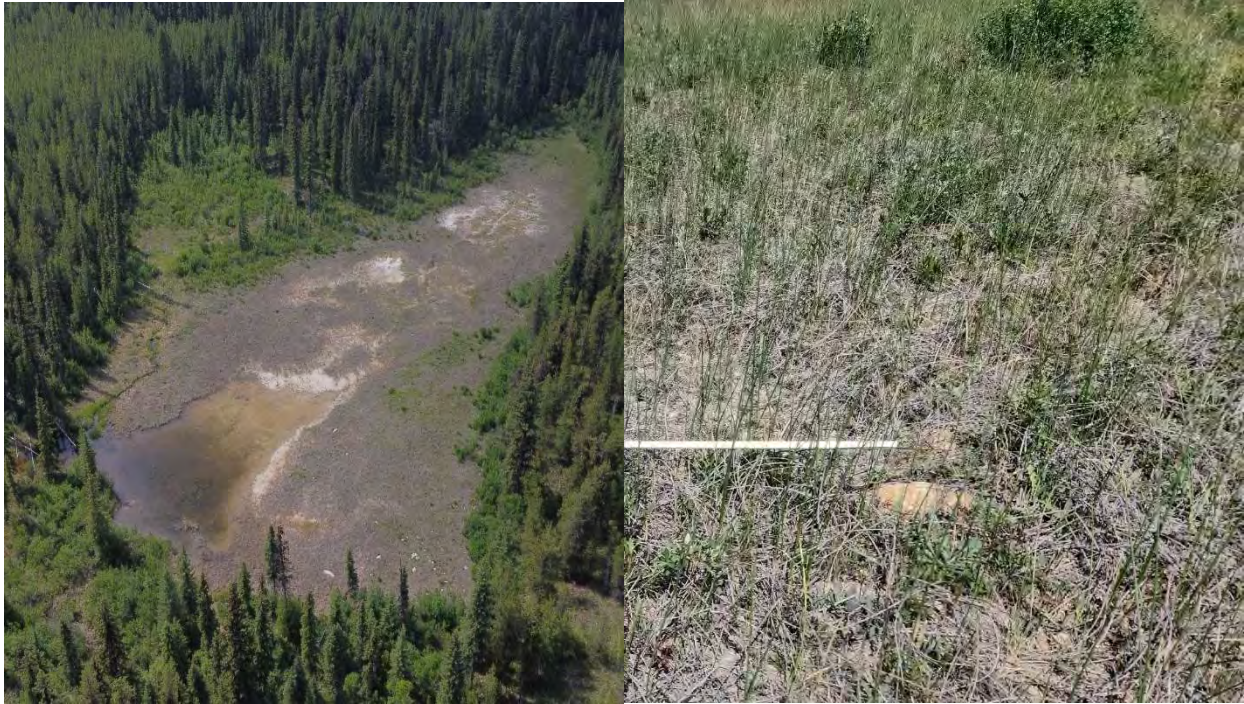
Finally, one misclassified wetland was determined to be dominated by wetland vegetation from drone photos (Figure 8A), but in-person visits determined that it was dominated by dryland herbaceous vegetation, with wetland vegetation as sub-dominant (Figure 8B). This is because it can be hard to identify herbaceous vegetation from drone photos when adjacent to wetland margins, and this wetland has open water and then an abrupt transition into dryland herbaceous vegetation.

*Figure 8. On the left, drone photo of this wetland, with hard-to-identify vegetation around open water (A); on the right, a close-up photo of this wetland, with a mix of upland herbaceous plants, small shrubs, and horsetail (B).*

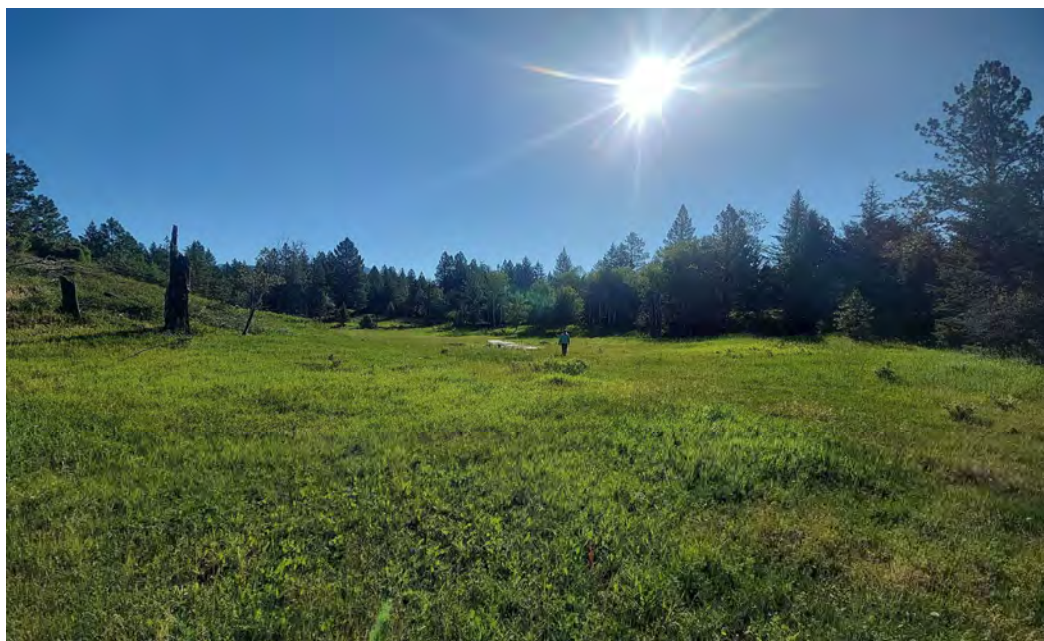
From our observations, we think that the current Wetland Restoration Feasibility Index overestimates restoration feasibility in some sites. For example, we visited 22 wetlands ranked High or Very High by the Index, which we ranked as Low or Moderate based on field observations, mostly due to a lack of water source. For example, Figure 11 shows a wetland that was ranked as High by the Wetland Restoration Feasibility Index, and was shown by the FWA to have a stream flowing into and out of it; as can be seen in this photo, there is no stream or any other water in this wetland, and the vegetation present is dryland grass species, not wetland vegetation.

*Figure 11. 'Wetland' area identified on the FWA and visited as part of ground truthing the Wetland Restoration Feasibility Index; ranked as 'High' feasibility for restoration and mapped as having a stream running through it. However, in the field we found no indication of a stream or other water source and no wetland vegetation was present, suggesting this area does not function as wetland, and we ranked it as 'Low' restoration feasibility.*

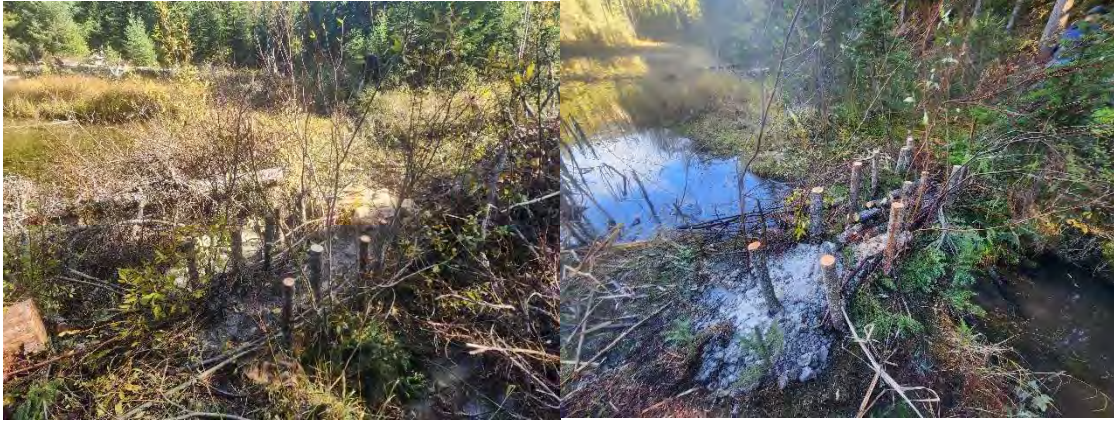
In S-Land, we built two BDAs in September 2024 (Figures 15 and 16) and monitored the post-construction impact of these BDAs through 2025. While in 2024 the stream flowing through this site was permanent, in 2025 it was ephemeral, with flow stopping sometime in late August and resuming in early October.

Figure 15. Photographs of the two Beaver Dam Analogues (BDAs) constructed in this wetland in September 2024. Left: Downstream BDA. Right: Upstream BDA.

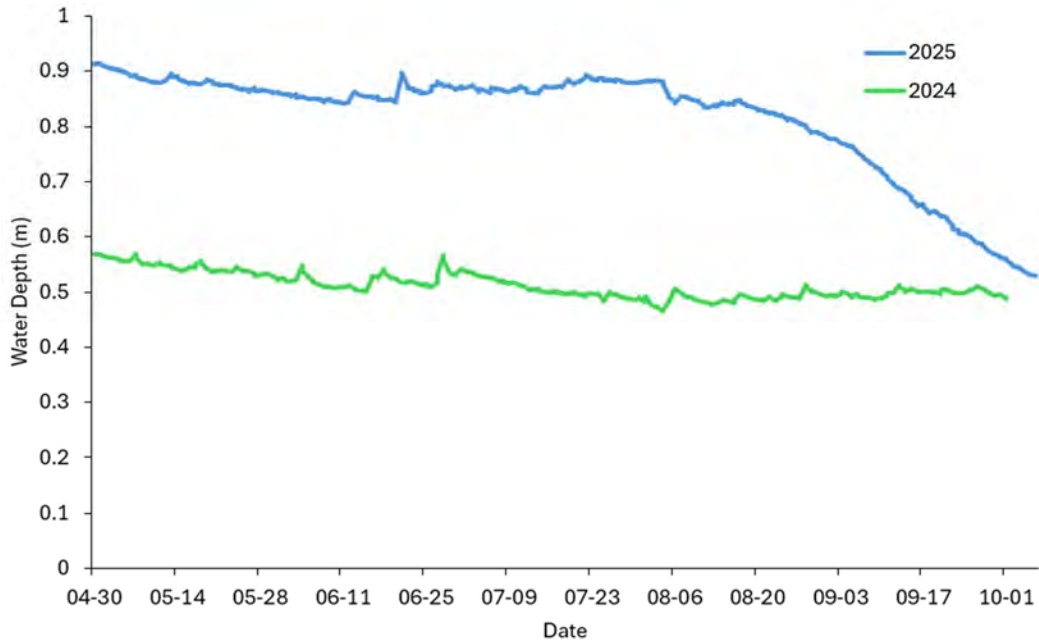
The drier conditions in 2025 can be observed at both of our installed water level loggers in the S-Land wetland, with clear decreases in water level above both BDAs in August (Figures 17 and 18). However, both wetland areas upstream of installed BDAs retained more water, despite drier conditions, than was recorded pre-restoration. From April to the beginning of August 2025, the downstream BDA retained approximately 0.3 m more water than pre-restoration conditions recorded in 2024 (Figure 17). In April and June, the Upstream BDA retained only

Figure 17. Water levels in 2024 (green) and 2025 (blue) above downstream BDA in S-Land..

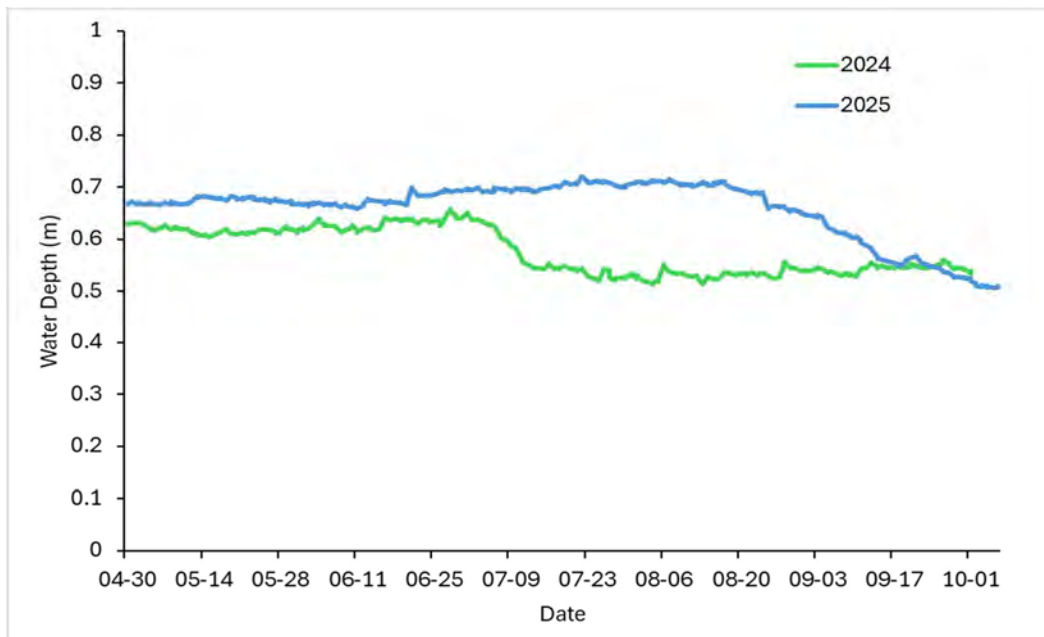
slightly more water than pre-restoration; however, from mid-June to mid-August, the wetland area retained significantly more water in 2025 (0.7 m) than in 2024 (0.5 m) (Figure 18) Thus, both of these BDAs succeeded in our goal of retaining more water in this wetland post-restoration.

Figure 18. Water levels in 2024 (green) and 2025 (blue) above upstream BDA in S-Land.

While water levels above both BDAs declined in August, we suspect that had these BDAs not been present, the areas would have been even drier and water would not have persisted as

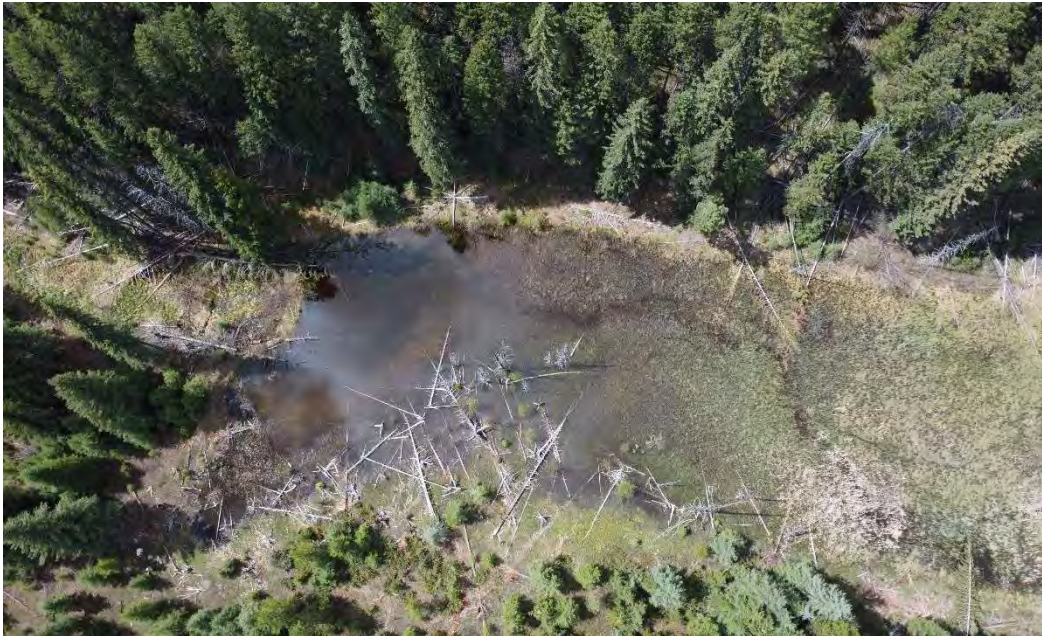
long. Considering the lower water levels recorded in Westside Junction and Coltsfoot wetlands during 2025 (Figures 2 and 3), it appears that even in the face of overall dry conditions, these BDAs are retaining water and maintaining wetland habitat (Figure 19). We also observed that more streams became ephemeral in 2025 than in 2024. The stream flowing into the S-Land wetland was one of those streams; our September visit to site noted that the stream channel above the wetland no longer had a strongly flowing stream in it, and instead there were pools of standing water and areas where the streambed was completely dry.

*Figure 19. Flooded area in the lower section of the S-Land wetland observed during monitoring in May 2025.*

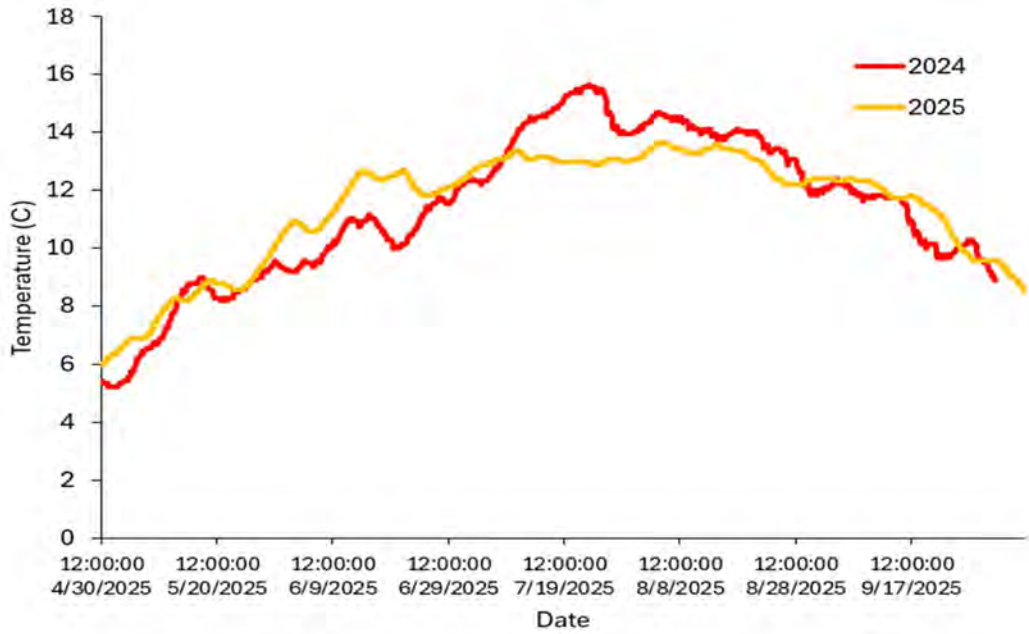
The installed water level loggers also recorded water temperature every four hours. Water temperatures varied in ponds above both BDAs in 2024 and 2025. Generally, they both had low temperatures and ranged from 6°C in April to 14°C in July (Figures 20 and 21). Water temperatures in 2025 showed less variation, with the water warming earlier and remaining warmer longer, but not reaching the same maximum temperatures. In 2024, the maximum temperature at both loggers was nearly 16°C, whereas in 2025 it did not go above 14°C at both locations, despite the warmer and drier summer.

Figure 20. Water temperature recorded from April to October 2024 and 2025 in S-Land wetland above Downstream BDA.

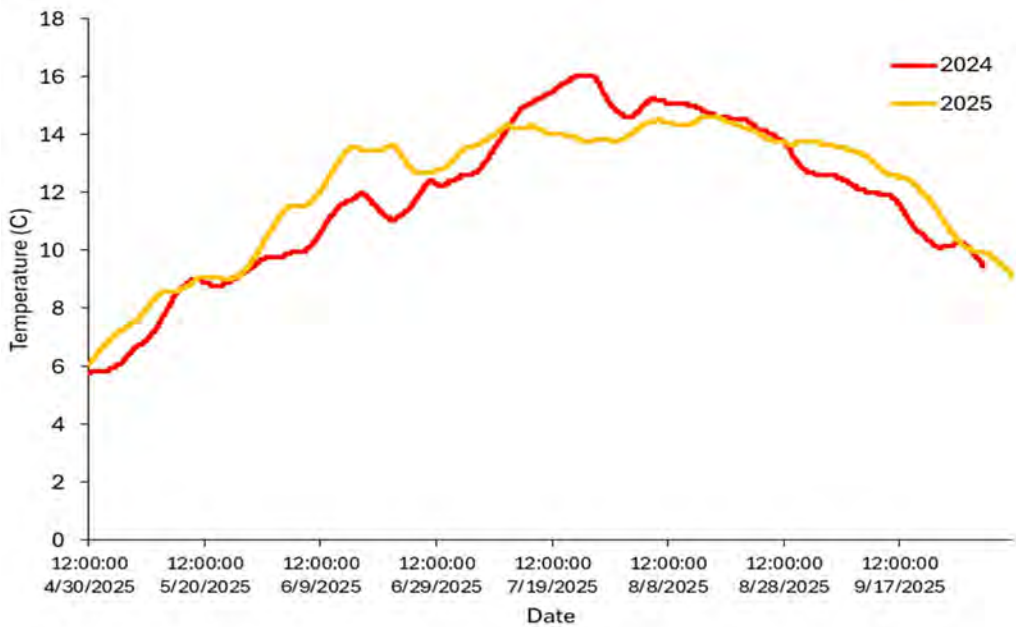
Figure 21. Water temperature recorded from April to October 2024 and 2025 in S-Land wetland above Upstream BDA.

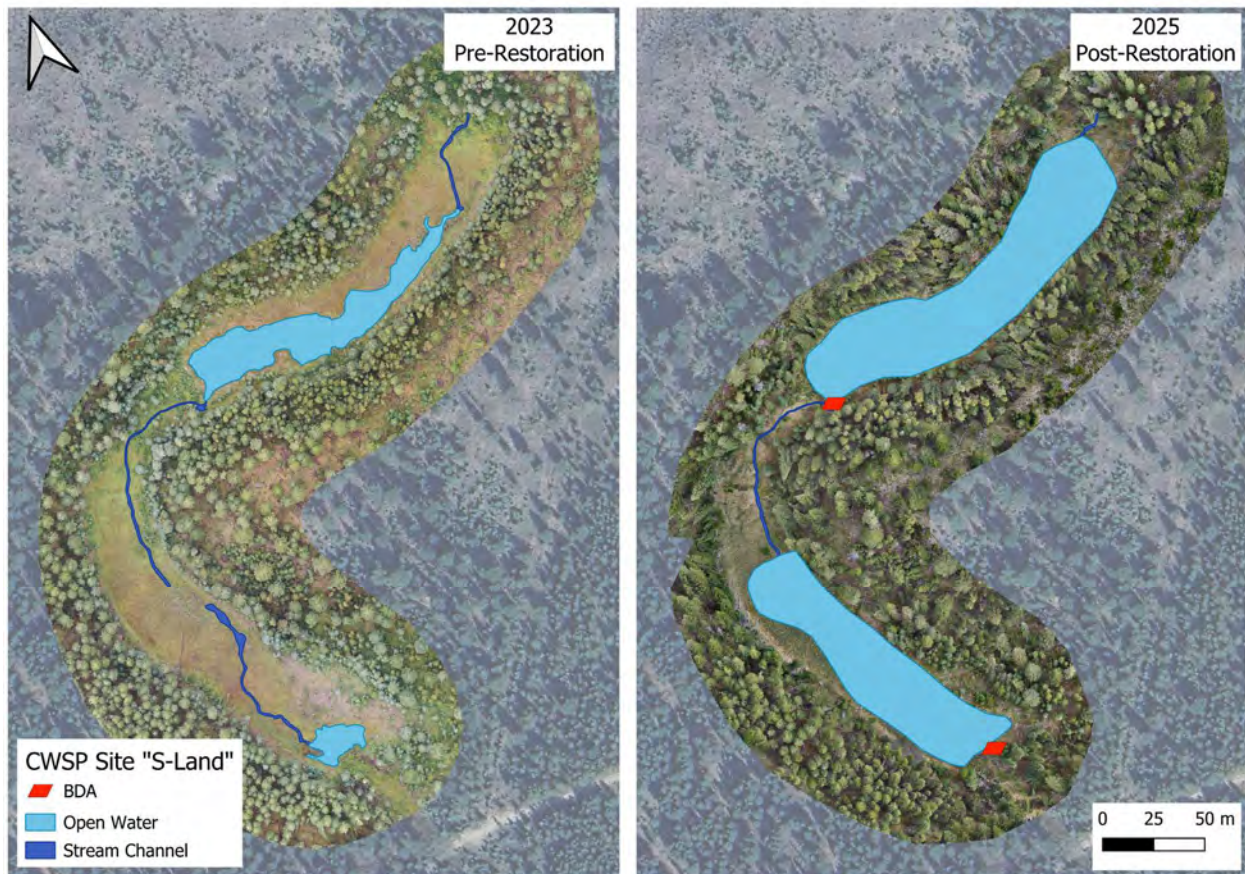
We mapped open water flooded areas in Summer 2023 (pre-restoration) and Fall 2025 (post-restoration) to exhibit the extent of flooding achieved by the installed BDAs (Figure 22). The pre-restoration estimate of flooded areas within this wetland was ~ 2700 m<sup>2</sup>. After the installation of BDA structures, the new estimate of flooded area was ~ 10,291 m<sup>2</sup>; however, the flooded extent varies throughout the year due to water inputs. We plan to map flooded areas again in spring 2026, at what we assume will be the maximum flood extent. The flood water also extends into the vegetated portions of the wetlands and we will be documenting the vegetative response in 2026.

Figure 22. Areas of open water/flooding in S-Land were mapped in the field using GIS applications (Avenza, ArcGIS Field Maps).

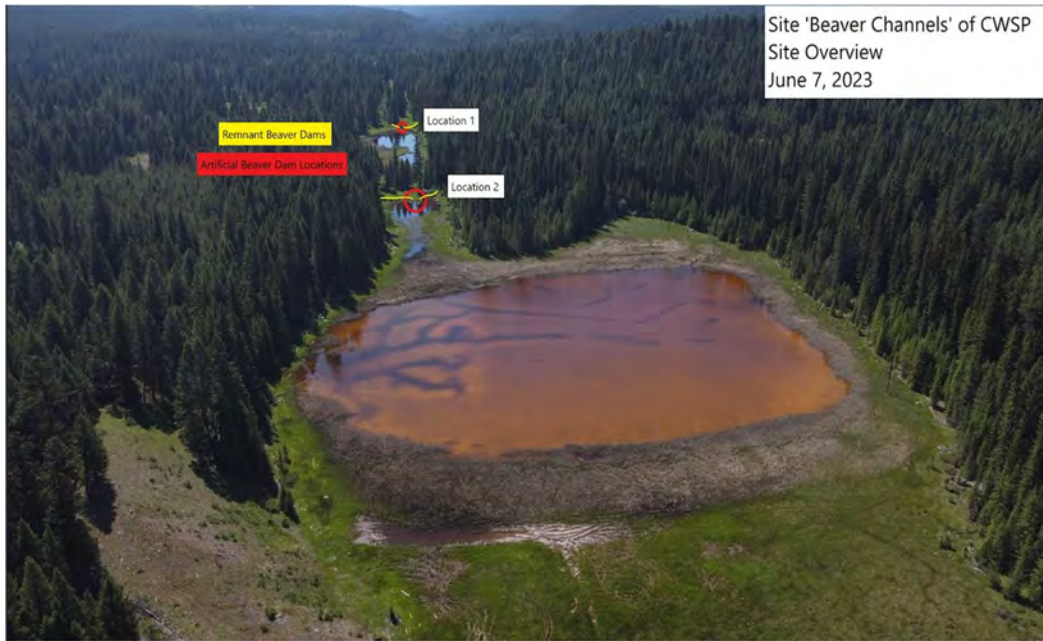
In Beaver Channels we built two BDAs in September 2024 (Figure 23 shows both locations; Figures 24 and 25 show the individual BDAs). The creek at this site is ephemeral, typically drying up by May, so the observed increase in wetland area during 2025 was also ephemeral.

Figure 23. Drone photo of 'Beaver Channels' wetland, showing locations of the two BDAs built in 2024.

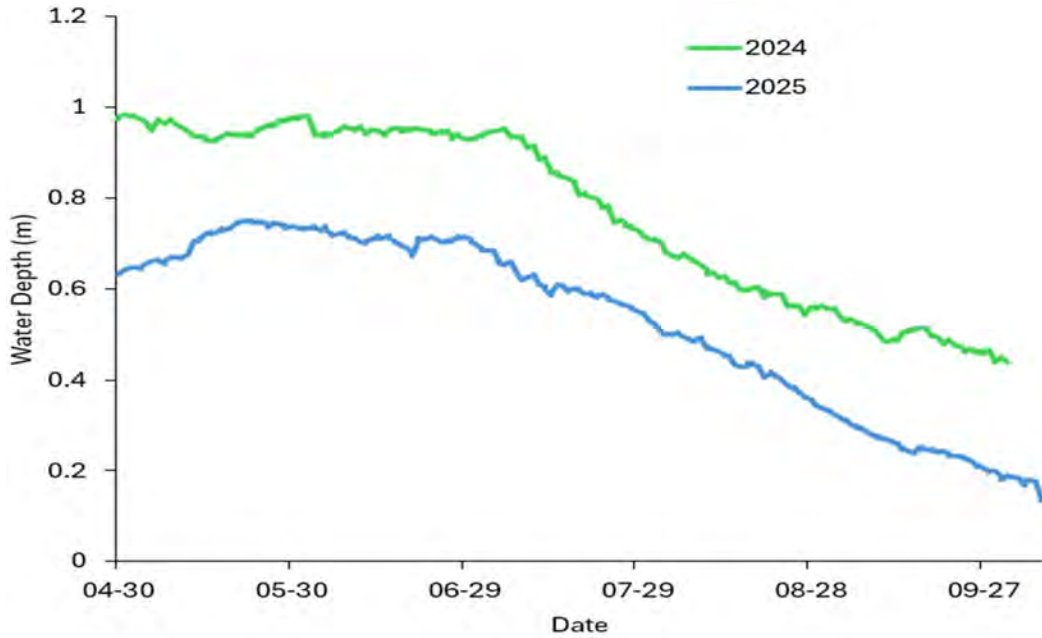
In wetland areas above both BDAs, the water levels declined through the monitoring period both pre- and post-restoration, which is due to this system being ephemeral (Figures 26 and 27). In the wetland area above the downstream constructed BDA, water levels were lower in 2025 than 2024 (Figure 26). Levels both began and ended the monitoring period lower, thus this decreased water in 2025 is likely due to lower water inputs during the winter (i.e., precipitation) and not an effect of our activities.

Figure 26. Water levels recorded from April to October 2024 and 2025 in the Beaver Channels wetland above the Downstream BDA.

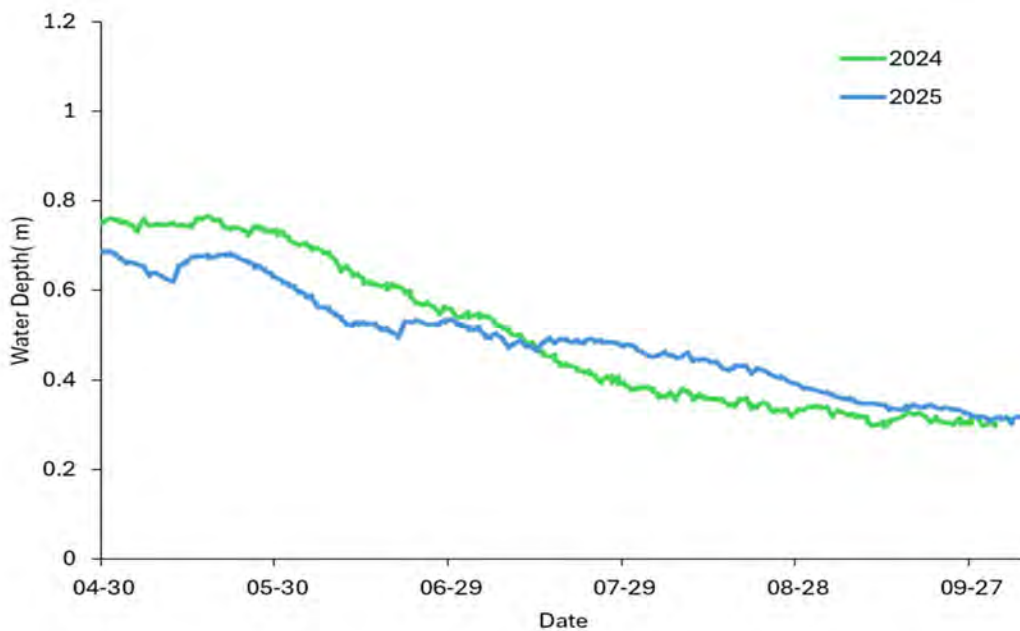
In the wetland area above the upstream constructed BDA, water levels in 2025 began lower than in 2024; however, by mid-July the post-restoration (2025) water levels were higher. These higher water levels persisted until the end of the monitoring period in early October, when water levels between the two years were very similar (Figure 27).

Figure 27. Water levels recorded from April to October 2024 and 2025 in the Beaver Channels wetland above the Upstream BDA.

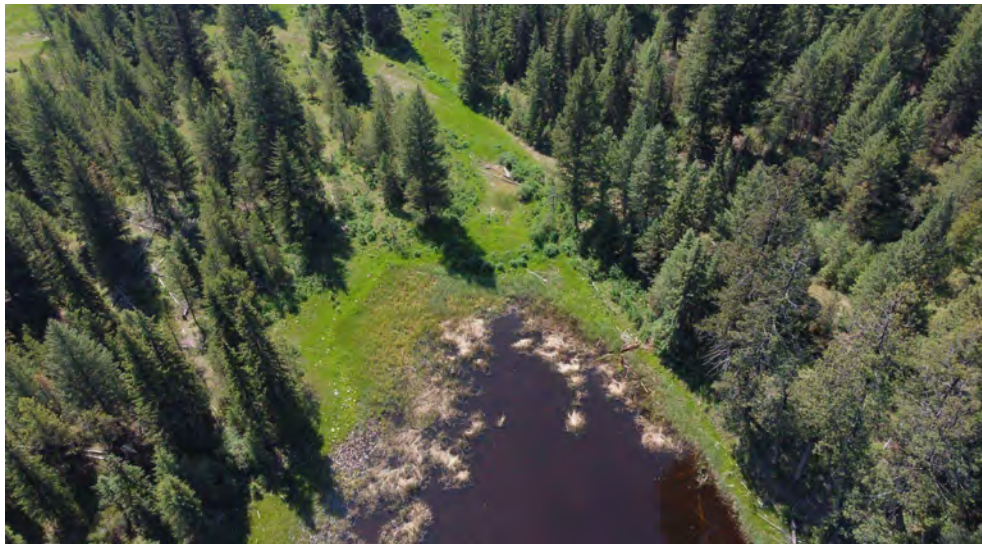
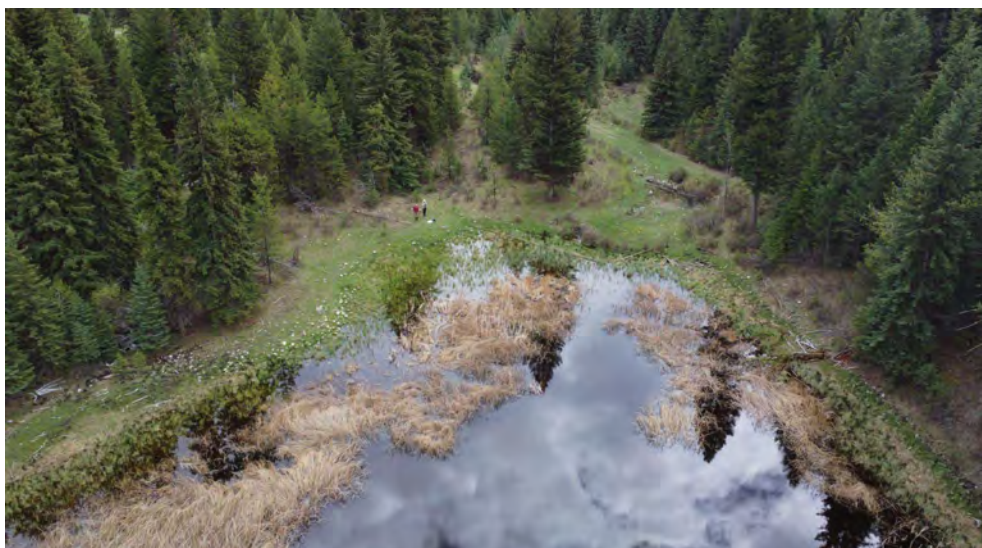
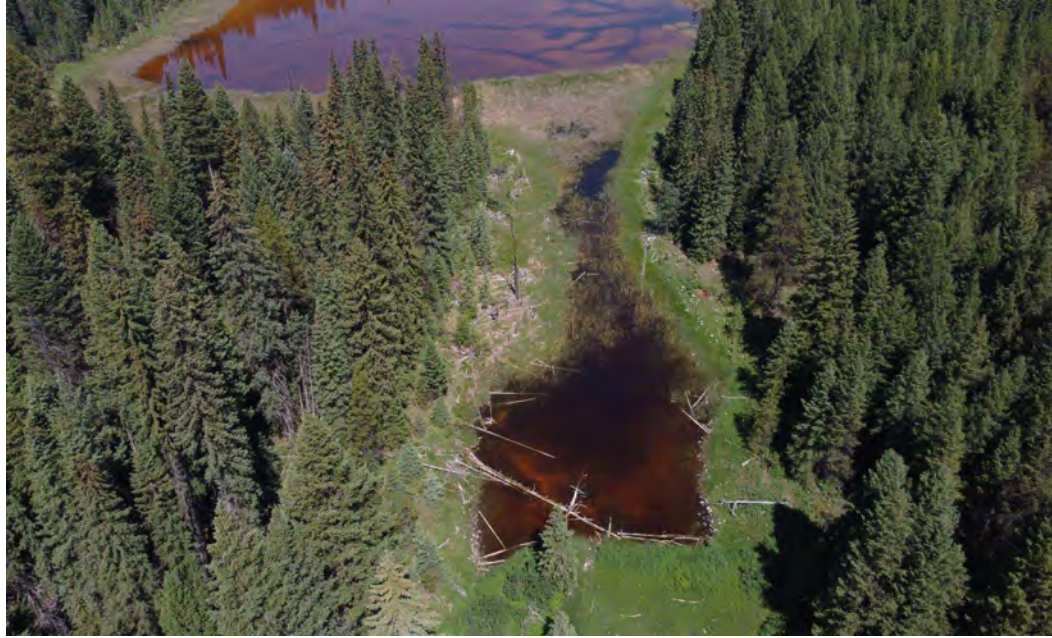
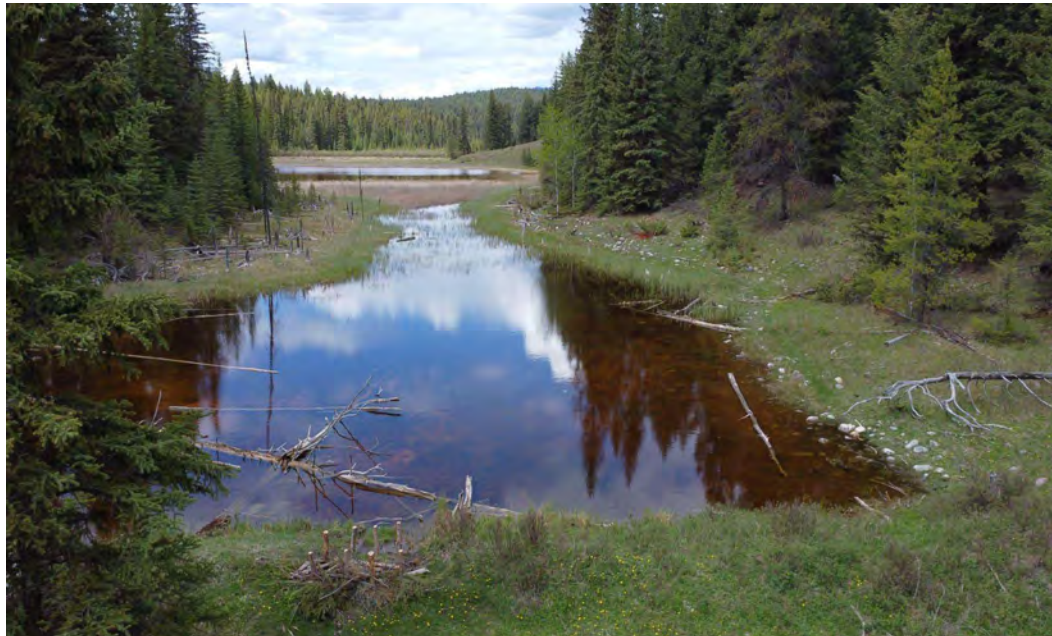
Despite this, given the limited positive effects of BDAs in this wetland due to lack of aboveground water source and overall low water levels, if we were considering wetland restoration sites with the knowledge we know have, we would not choose to build BDAs in this wetland. This site was one of the first we picked, with limited knowledge of the wetlands in this system, and so we did the best we could with the information we had at the time. After further years of work in this area, however, we don't think this is the best wetland system to build BDAs in and would not build in similar wetlands again.

*Figure 28. Pond above the downstream BDA at CWSP Site Beaver Channels. Drone image taken pre-restoration, in June 2023.*

*Figure 29. Pond above the downstream BDA at CWSP Site Beaver Channels. Drone image taken post-restoration, in May 2025.*

*Figure 30. Pond above the upstream BDA at CWSP Site Beaver Channels. Drone image taken pre-restoration, in June 2023.*

*Figure 31. Pond above the upstream BDA at CWSP Site Beaver Channels. Drone image taken post-restoration, in May 2025.*

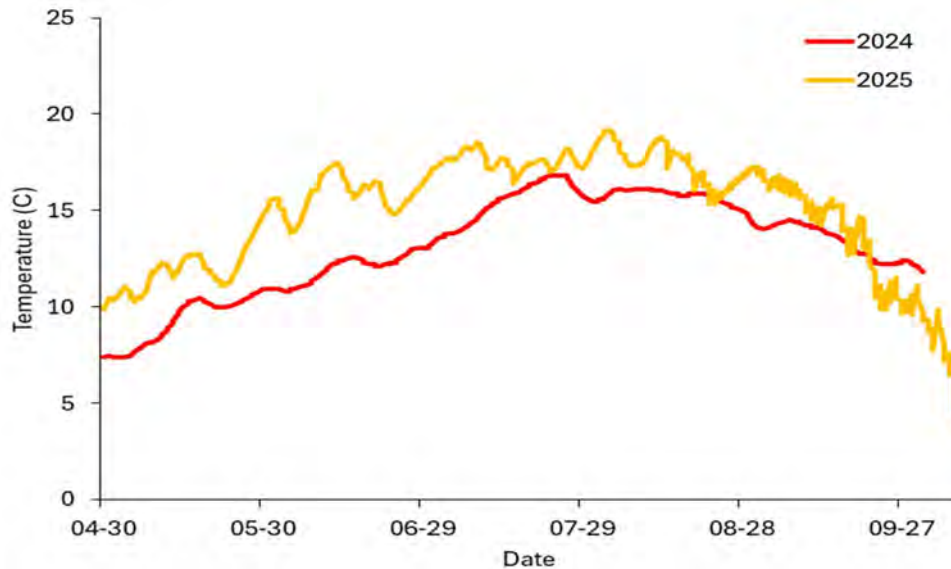
The installed water level loggers also recorded water temperature every four hours. Temperatures above the downstream BDA (16.81 °C in 2024; 19.18 °C in 2025) were slightly cooler in both years than those above the upstream BDA (22.05 °C in 2024; 21.66 °C in 2025). Temperature measurements are displayed in Figures 32 and 33. This temperature difference between open water areas may be related to their substrates and amount of submerged aquatic

Figure 32. Water temperature recorded from April to October 2024 and 2025 in the Beaver Channels wetland above the Downstream BDA.

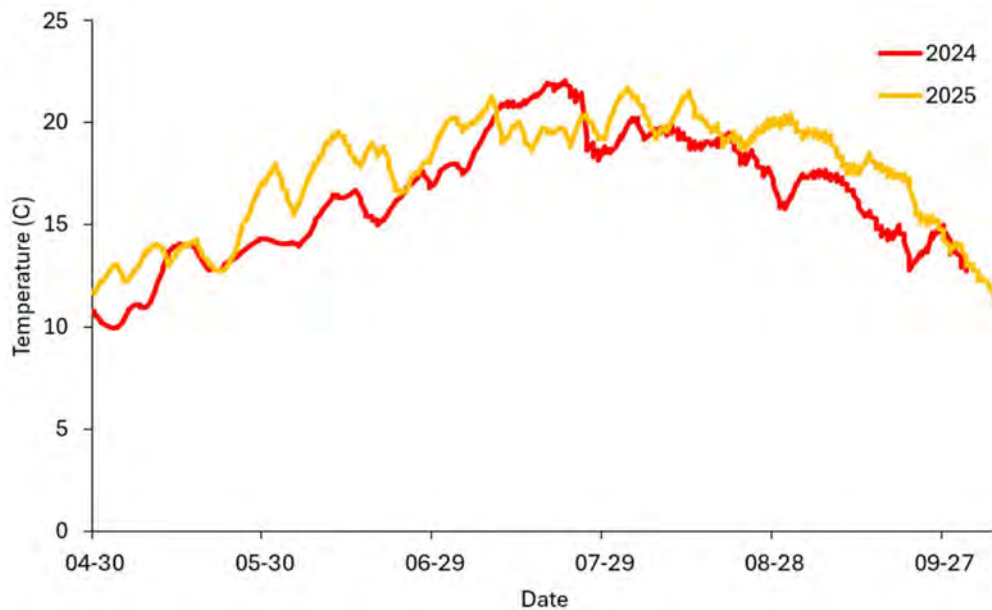
vegetation. The downstream wetland area has darkly colored rich organic sediment which supports lots of submerged aquatic vegetation that provides cover in the wetland. The upstream wetland area has very pale, inorganic sediments and lacks submerged aquatic vegetation. Compared to other wetlands monitored by CWSP, these water temperatures are quite warm (e.g. at the Double Dam site, the maximum temperature in 2025 was 16°C); we hypothesise this is due to the lack of stream inflow to the Beaver Channels wetland areas, as stream water temperatures tend to be cooler.

Figure 33. Water temperature recorded from April to October 2024 and 2025 in the Beaver Channels wetland above the Upstream BDA.

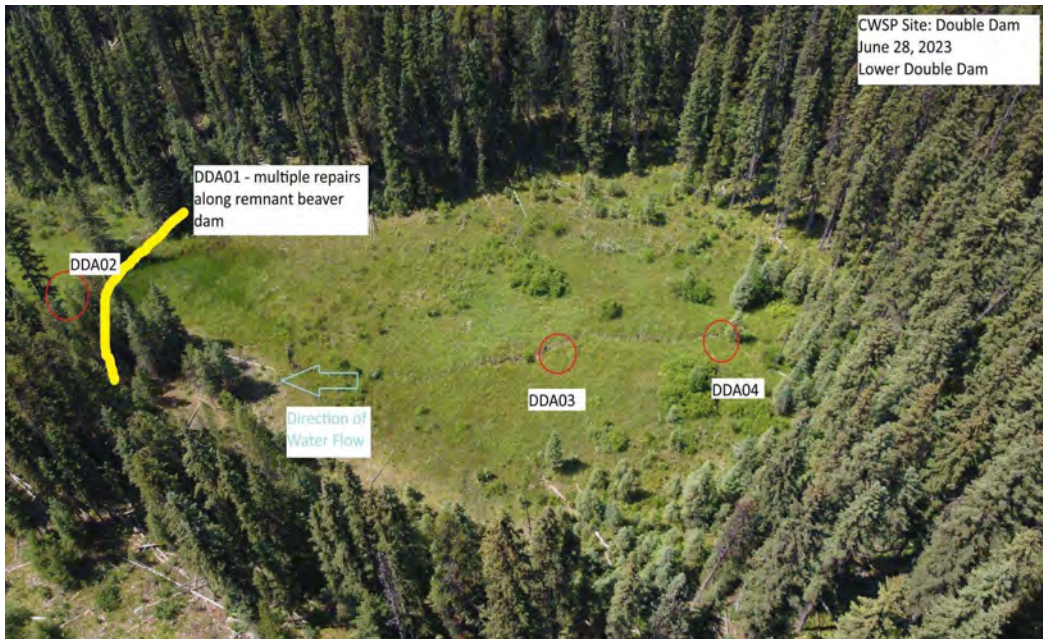
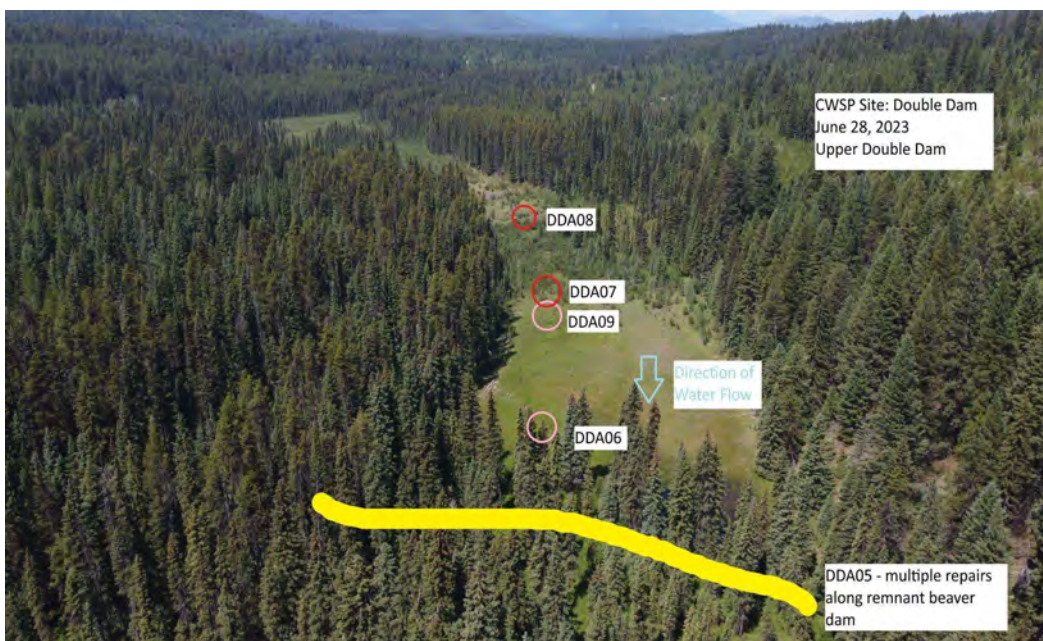
CWSP built six BDAs and two PALs and repaired two present but damaged natural beaver dams in the site Double Dam in September 2025 (Table 3, Figure 34 and 35). We built all of these structures on September 10<sup>th</sup>, 2025. The stream supplying Double Dam went dry in approximately mid-August 2025 (discussed further in Section 3.3.1), so all work completed in this wetland occurred ‘in the dry’, as there was no water remaining in the wetland in the locations where we built structures. In constructing these dams, we plan to increase open water flooded area by 4500 m<sup>2</sup> and improve wetland habitat across 10.89 ha. However, as this wetland was dry, the constructed BDAs did not fill before the end of the season, and so we will be surveying this wetland in spring 2026 to determine how much flooding occurred.

Figure 34. Drone photograph showing the locations of the proposed structures within CWSP Site “Double Dam”.

Figure 35. Drone photograph showing the locations of the proposed structures within CWSP Site “Double Dam”.
