# Kootenay Connect: 7CW Columbia Wetlands: Summary (2023-2026) and Yr 7 Upland Wetlands Restoration Report

March 31, 2026

Columbia Wetlands Stewardship Partners

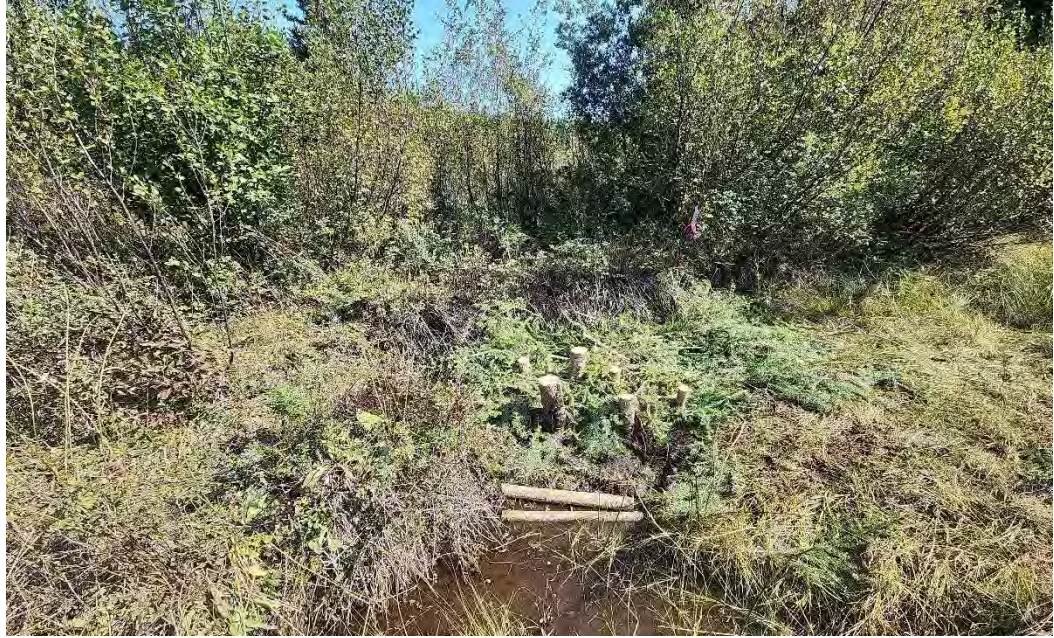
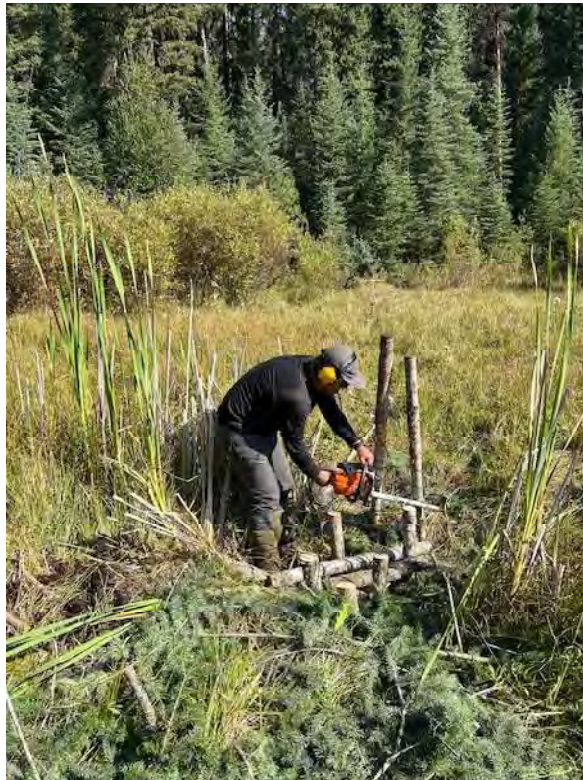
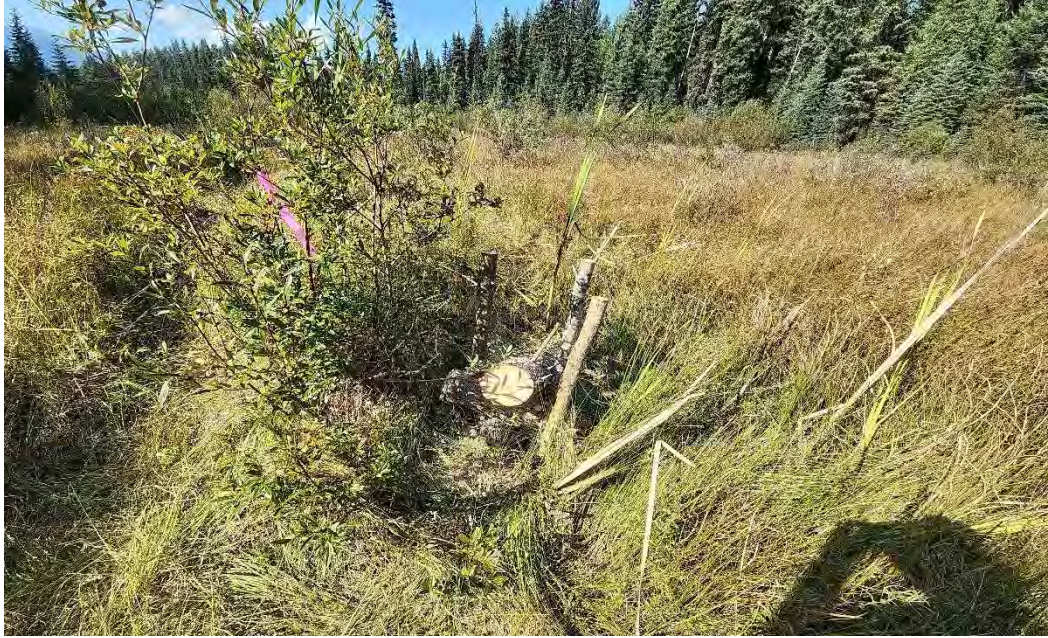
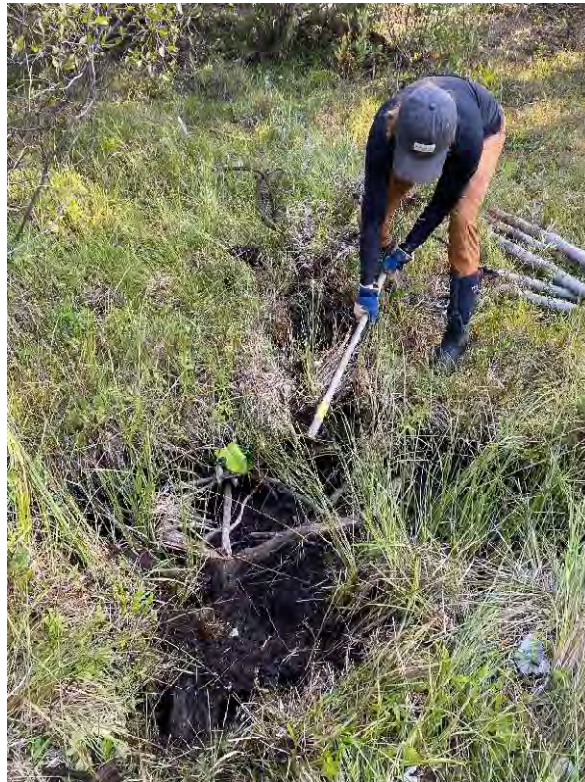
*Figure 36. Beaver Dam Analogue was constructed by hand during restoration work at the Double Dam site, September 2025.*

*Figure 37. A crew member shortening the posts on one of the Beaver Dam Analogues in September 2025.*

*Figure 38. Post Assisted Log Structure was constructed by hand during restoration work at the Double Dam site, September 2025.*

*Figure 39. A staff member working during the initial stages of BDA construction at Double Dam restoration site, September 2025.*

This work was conducted by hand, with a team of staff and volunteers from CWSP, Cirque Consulting, and Living Lakes Canada (Figures 36 to 39). One of the advantages of BDAs as a restoration technique is it is low-tech and does not require machinery, so site disturbance is reduced.

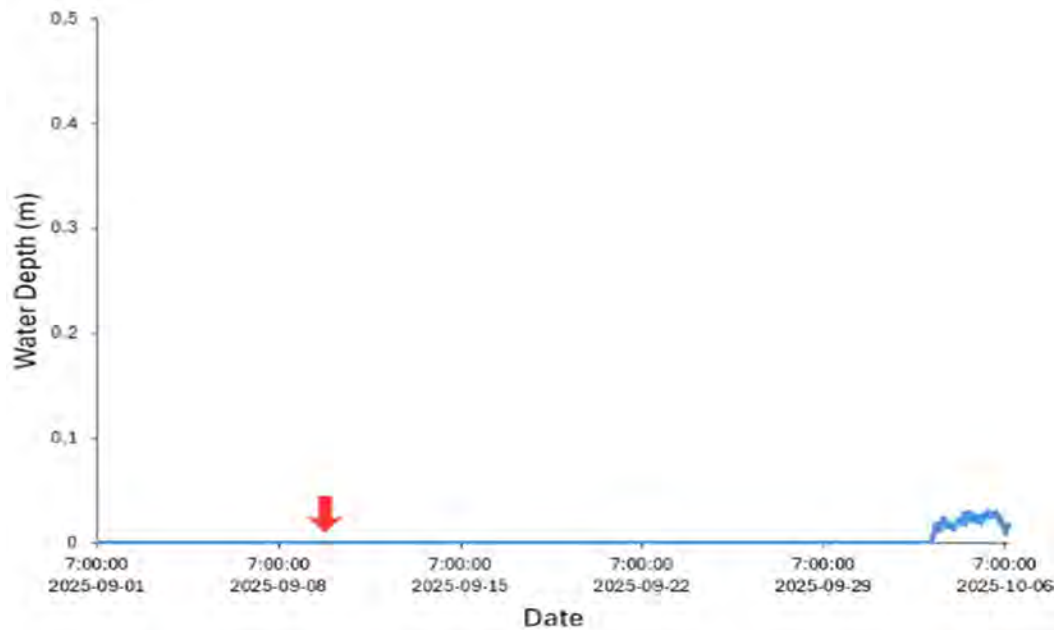
As we are working in small streams and wetlands, there are concerns that while building BDAs, downstream flow may be interrupted. Thus, we installed a water level logger downstream of the construction site to monitor the stream flow before, during, and after construction (Figure 40). Prior to and during construction there was no water in the stream, and water depth did not become detectable until October 3<sup>rd</sup>, 2025, though during an October 6<sup>th</sup> site visit we noted that while there was standing water within the streambed, the stream was not flowing.

Figure 40. Water depth data from the water level logger (HOBO U-20) installed ~ 50 m downstream of the project site at Double Dam. The red arrow indicates when construction began on September 10<sup>th</sup>, 2025.

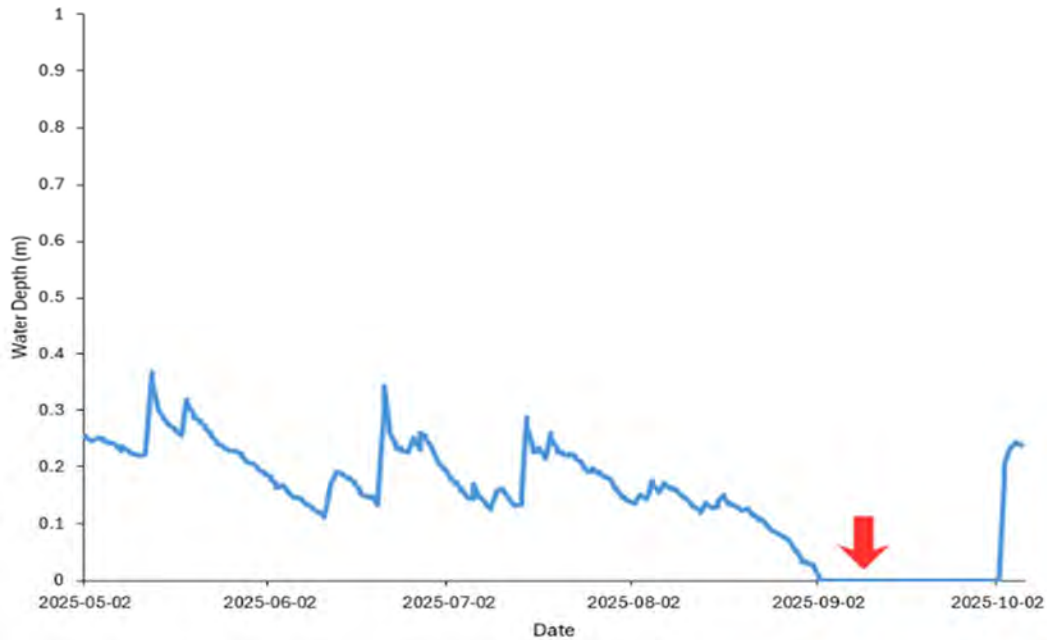
Between May 1<sup>st</sup> and September 3<sup>rd</sup> (when the water level dropped to 0 m) the average water depth was 0.18 m (Figure 41). The water levels were very 'flashy', showing several very quick increases and then slower decreases, which were likely to be due to snow melt or rainfall, both of which result in a short-term increase in water inflow. This area was dry (water depth = 0.0 m) between September 3<sup>rd</sup> and October 2<sup>nd</sup> and experienced a rapid increase to over 0.20 m deep

on October 3<sup>rd</sup>. This water remained in the wetland until the water level logger was collected four days later. Due to the lack of stream flow, it was not possible to immediately see the effects of water impoundment behind DDA-01; this logger will be re-installed in April 2026 to record next season's water levels.

Figure 41. Water depth data from the water level logger (HOBO U-20) installed ~ 2 m upstream of DDA-01 in Double Dam. The red arrow indicates when construction began on September 10<sup>th</sup>, 2025.

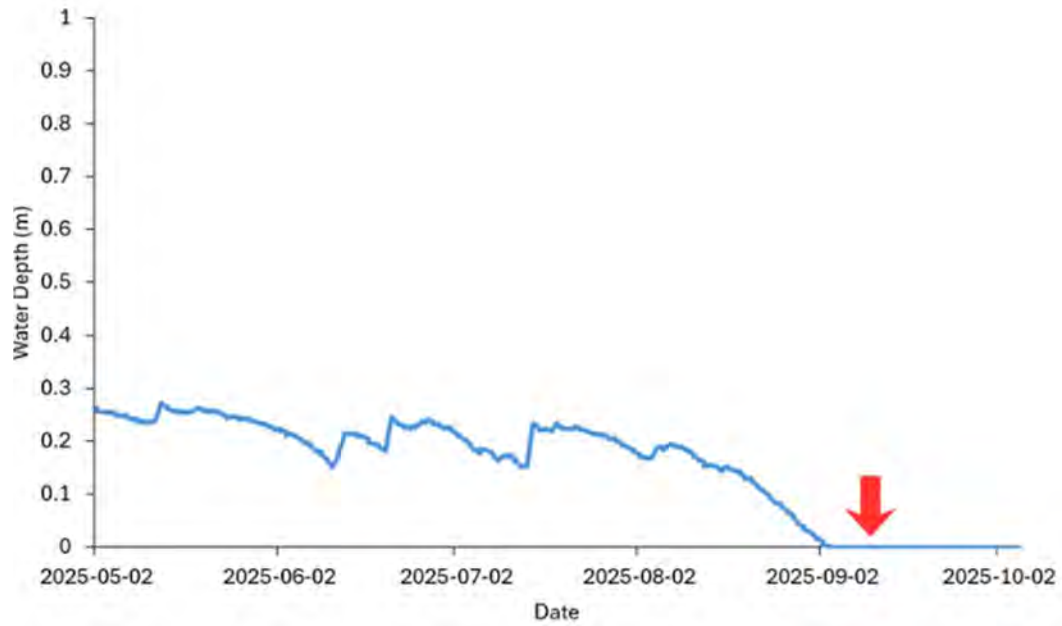
At the second logger upstream of DDA-05, between May 1<sup>st</sup> and September 4<sup>th</sup> (when the water level dropped to 0 m) the average water depth was 0.19 m, with a maximum depth of 0.272 m on May 13<sup>th</sup> (Figure 42). Compared to water levels upstream of DDA-01 (Figure 41), the upper pond was less 'flashy'; increases in water depth were observed at the same time but resulted in much smaller increases in depth. This is likely because this logger is installed in an area of open water, which causes water to disperse more slowly and across a greater area (as opposed to the in-stream location of the downstream HOBO). There was no water recorded at the location of the HOBO between September 3<sup>rd</sup> and October 6<sup>th</sup> (logger collection date), and the open water area was visibly dry (Figure 43). Due to the lack of stream flow, it was not possible to immediately see the effects of water impoundment behind DDA-05; this logger will be installed in April 2026 to record next season's water levels.

Figure 42. Water depth data from the water level logger (HOBO U-20) installed ~ 2 m upstream of DDA-05 in Double Dam. The red arrow indicates when construction began on September 10<sup>th</sup>, 2025.

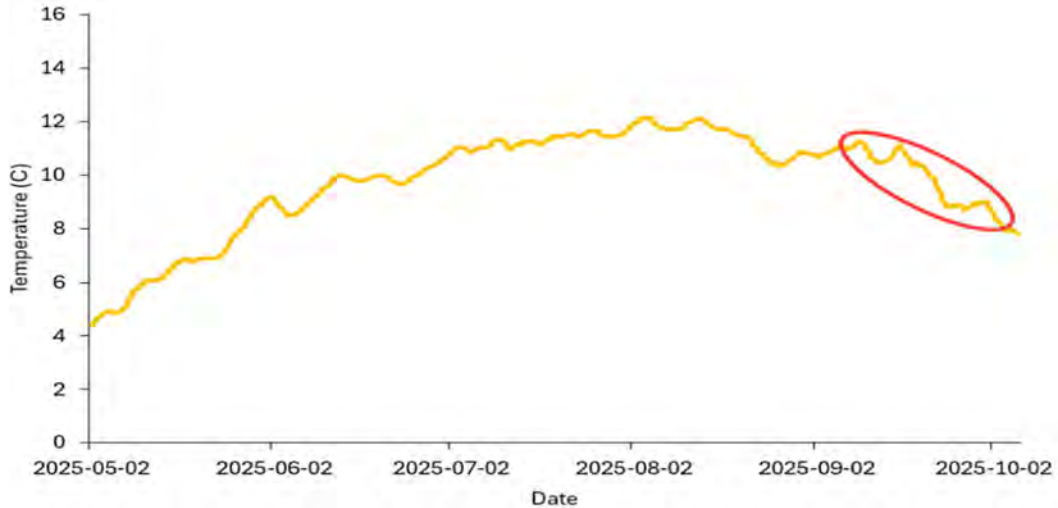
The installed water level loggers also recorded temperature every four hours. The logger installed upstream of DDA-01 recorded a maximum temperature of 12°C on multiple days between August 3<sup>rd</sup> and 13<sup>th</sup>, while the minimum recorded temperature was 4.42°C recorded on May 2<sup>nd</sup> (Figure 44). The logger installed upstream of DDA-05 recorded a maximum temperature

Figure 44. Temperature data from the water level logger (HOBO U-20) installed upstream of DDA-01 in Double Dam wetland. This logger was installed from May 1<sup>st</sup> to October 6<sup>th</sup>, 2025, to monitor stream temperatures pre- and post-construction. The red circle indicates the period when water levels were 0 m and so the temperature recorded is air temperature and not water temperature.

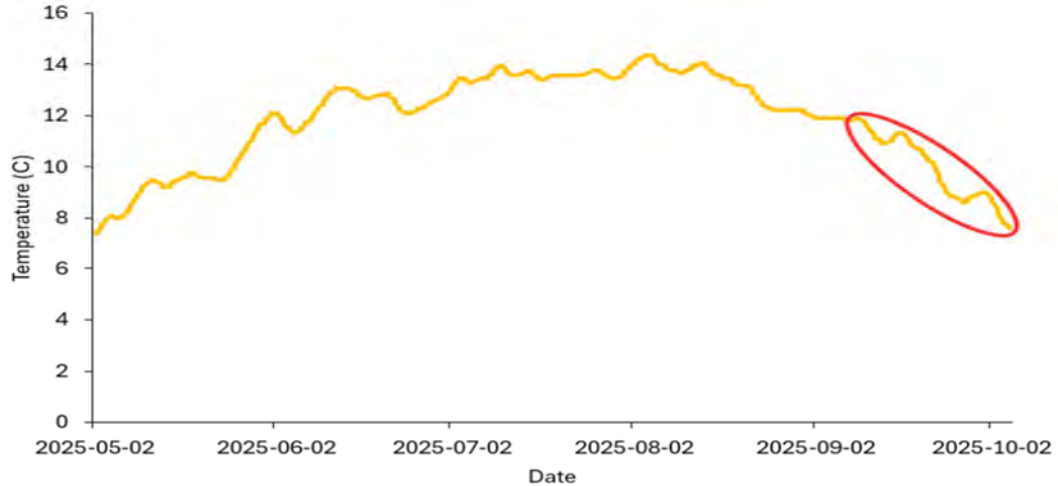
of 14°C recorded on August 4<sup>th</sup> and 5<sup>th</sup> and a minimum recorded temperature of 7.38°C on May 2<sup>nd</sup> (Figure 45). Water temperatures recorded in this location were on average higher than at the logger above DDA-01, as this logger was in an open water pool while the other was in the stream channel with flowing water.

Figure 45. Temperature data from the water level logger (HOBO U-20) installed in open water pool upstream of DDA-05 in Double Dam. This logger was installed from May 1<sup>st</sup> to October 6<sup>th</sup>, 2025, to monitor stream temperatures pre- and post-construction. The red circle indicates the period when water levels were 0 m and so the temperature recorded is air temperature and not water temperature.

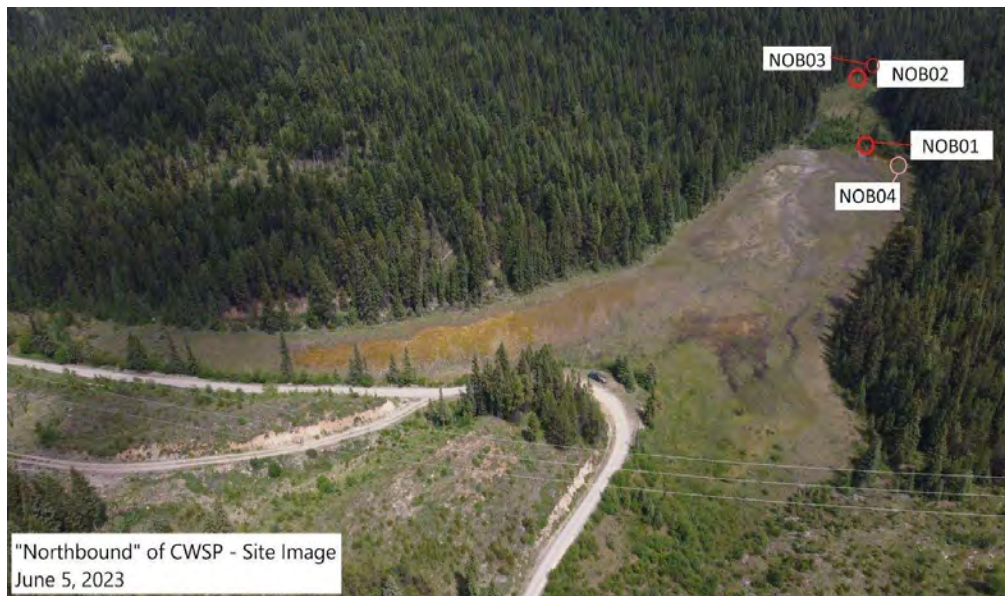
CWSP built three BDAs and one PAL on September 11<sup>th</sup>, 2025, in the Northbound wetland site (Table 4, Figure 46). Northbound and Big Dam are located along the same stream, with Big Dam being downstream of Northbound. Thus, fewer structures were constructed in each individual wetland because the two sites were considered collectively. In constructing these dams, we increased water depth by 0.2 m above NOB01 and 0.3 m above NOB02, increased flooded area by 620 m<sup>2</sup>, and improved wetland habitat across 5.49 ha.

Figure 46. Drone photograph showing the locations of the proposed structures within CWSP Site "Northbound".

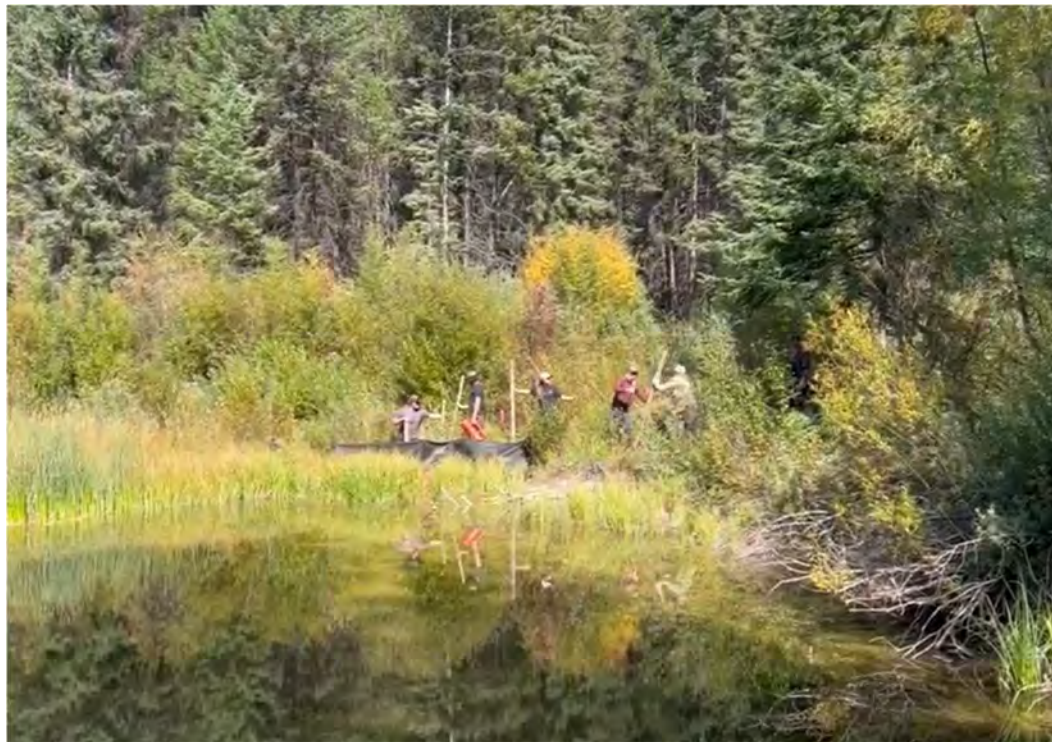
*Figure 47. Staff and volunteers constructing a Beaver Dam Analogue at the Northbound wetland restoration site in September 2025. A temporary mesh barrier is visible, functioning both as a turbidity curtain and to isolate the construction area.*

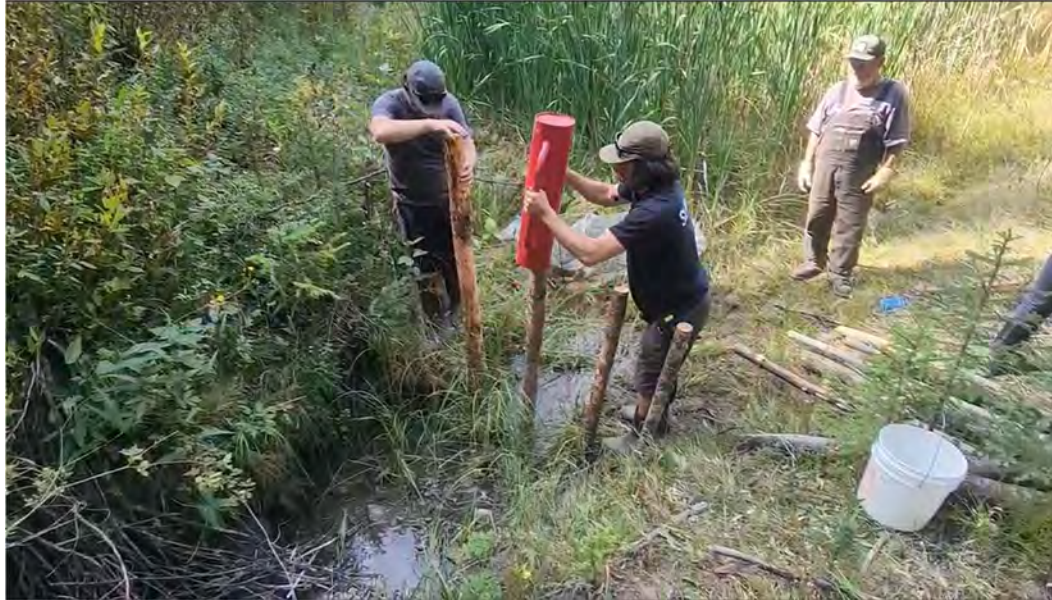
*Figure 48. Crew uses a 'post pounder' to secure posts into the ground in Northbound wetland during BDA construction in September 2025.*

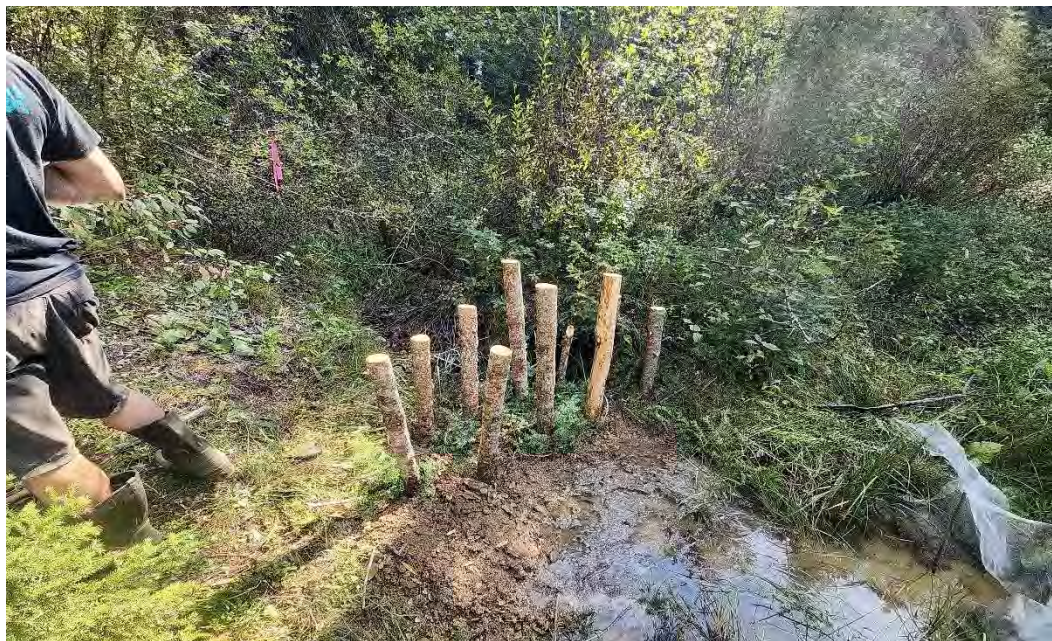
As the stream was still flowing, we also constructed our BDAs slowly while monitoring stream flow and allowed the area behind the dams to fill slowly before building more dams (Figure 48 and 49). As with the Double Dam site, we also wanted to monitor downstream flow; as Big Dam is downstream of Northbound, we installed a water level logger downstream of that second wetland to monitor both wetlands; these data are discussed in section 3.5.

*Figure 49. Crews monitor the BDA's performance as water pools behind it, ensuring proper function before increasing its height or installing additional structures in Northbound wetland. September 2025.*

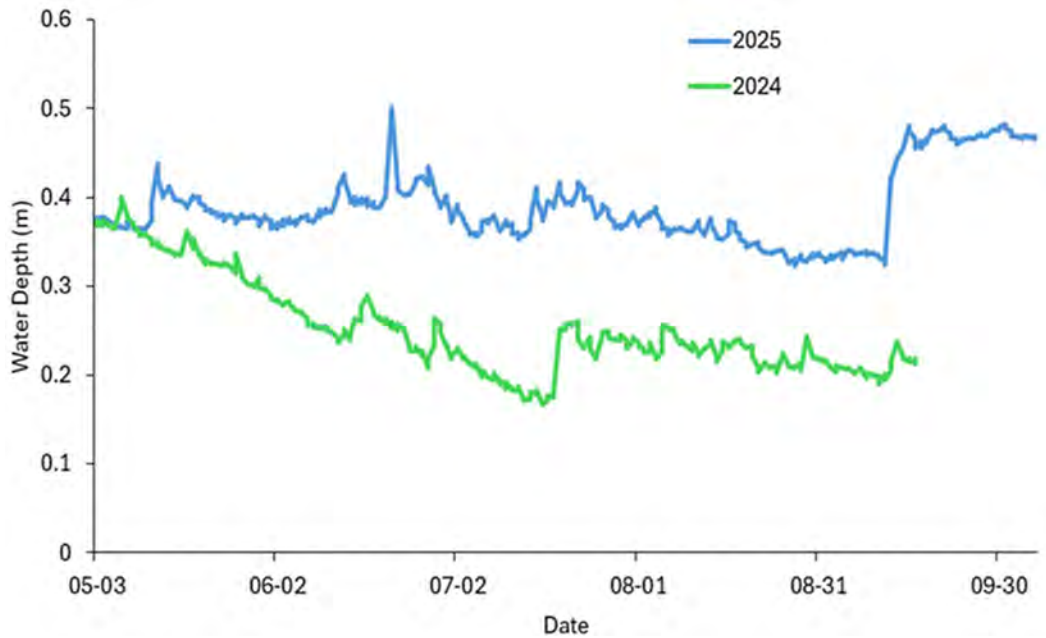
The open water area upstream of the remnant dam at NOB-01 was deeper in 2025 than in 2024, which differs from other trends observed in wetlands that CWSP monitors. The water level increase after construction is evident, with an increase of approximately 0.2 m, similar to peak water depth observed during freshet (Figure 50).

Figure 50. Water depth data from the water level logger (HOBO U-20) installed ~ 2 m upstream of NOB-01. This water level logger was installed from May 1<sup>st</sup> to October 6<sup>th</sup>, 2025, to monitor water depth pre- and post-construction in Northbound wetland.

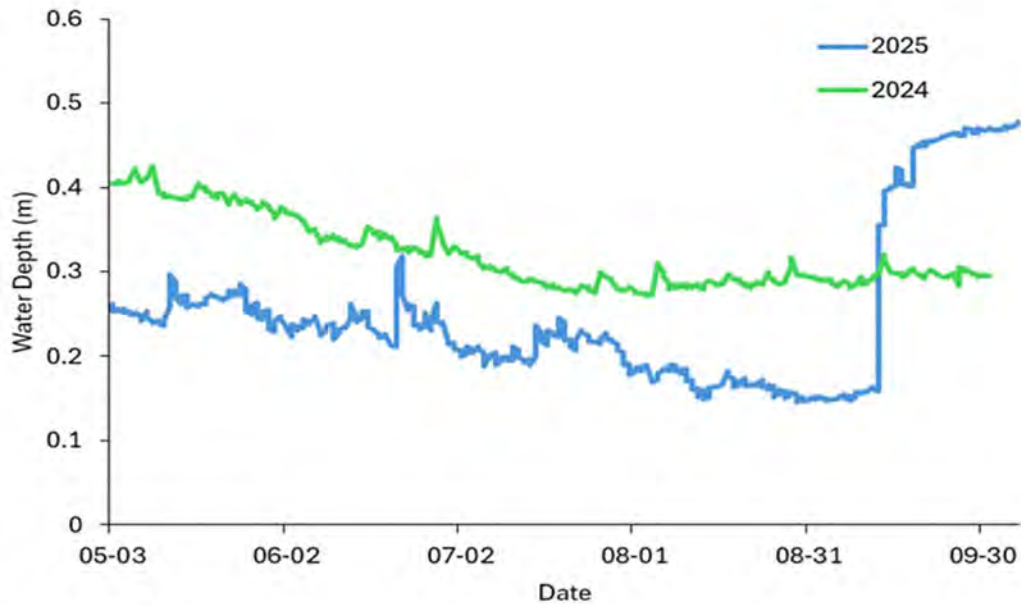
Similarly to all other wetlands monitored by CWSP in this area, the water levels above NOB-02 were lower in 2025 than in 2024 - we hypothesise that this is due to less precipitation in this area. Like NOB-01, the water level increase after construction in this area of the wetland can be easily observed (Figure 51). The water level at the installed HOBO increases by approximately 0.3 m, which exceeds the water levels observed during freshet.

Figure 51. Water depth data from the water level logger (HOBO U-20) installed ~ 2 m upstream of NOB-02. This water level logger was installed from May 1<sup>st</sup> to October 6<sup>th</sup>, 2025, to monitor water depth pre- and post-construction in Northbound wetland.

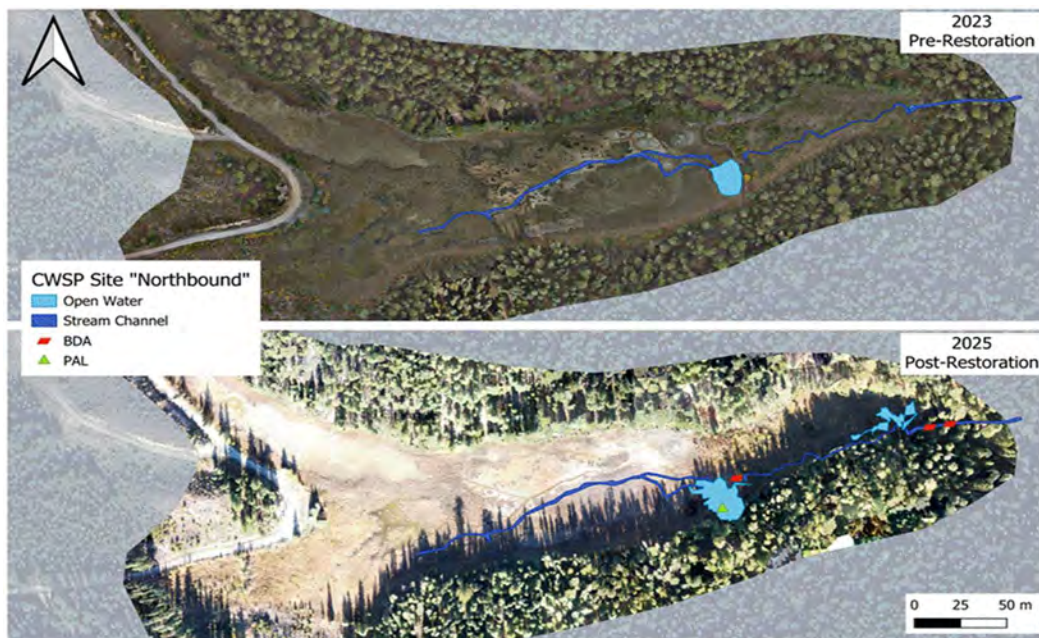
We mapped flooded areas in both Summer 2023 (pre-restoration) and Fall 2025 (post-restoration) at the Northbound site to determine the extent of open water flooding due to the installed BDA and PAL structures (Figure 54). There are other flooded areas within this wetland (e.g., northern arm), but this analysis is only focused on areas upstream of constructed BDAs. The pre-restoration estimate of flooded areas near proposed BDA structures was ~ 290 m<sup>2</sup>. After the installation of BDA and PAL structures, the new estimate of flooded area is 620 m<sup>2</sup>. We anticipate that more flooding will be observed during high water, so flooded area mapping will be repeated in Spring of 2026, and will include all areas of open water in this wetland.

Figure 54. Areas of open water/flooding were mapped in the field using GIS applications (Avenza, ArcGIS Field Maps). Only flooded areas immediately upstream of a BDA are shown.

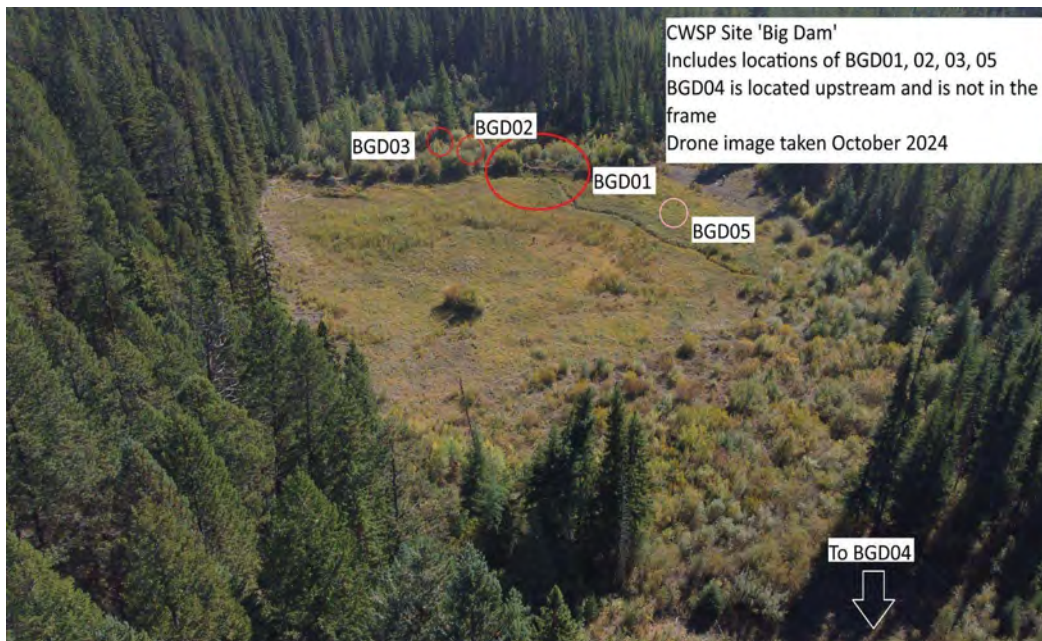
CWSP built four BDAs and one PAL on September 12<sup>th</sup>, 2025, in the Big Dam wetland site (Table 5, Figure 55). Big Dam is downstream of Northbound, so we treated these two wetland sites as part of the same riverscape, building BDAs in both sites as part of the same whole system approach. In constructing these dams, we increased water depth by 0.26 m above BGD01, increased open water area by 1035 m<sup>2</sup>, and improved wetland habitat across 4 ha.

Figure 55. Drone photograph showing the locations of the proposed structures within CWSP Site “Big Dam”.

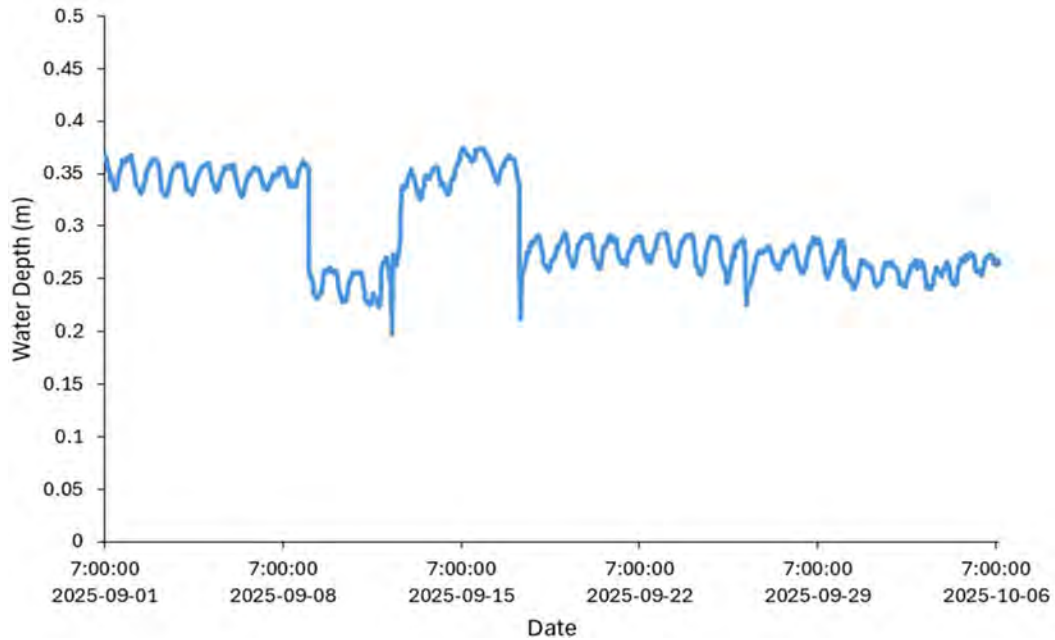
The water level logger installed downstream of the site monitored stream water depths pre-, during, and post-construction. Pre-construction, the logger recorded an average water depth of 0.35m. During construction, an average water depth of 0.25 m was recorded. This is a decrease of 0.10 m in depth, which is an approximately 29% decrease, which we did not consider a significant reduction in flow. In the week post-construction, the average water depth was 0.32 m, a decrease of 0.03 m from the pre-construction average. Water levels decreased on September 17<sup>th</sup> and remained lower, on average, than pre-construction measurements. We do not think that

this was due to our activities and is likely a natural late season decrease in water availability (Figure 56).

Figure 56. Water depth data from the water level logger (HOBO U-20) installed ~ 50 m downstream of the 'Big Dam' restoration site. This position is therefore downstream of both 'Northbound' and 'Big Dam'. This water level logger was installed from September 1<sup>st</sup> to October 6<sup>th</sup>, 2025, to monitor downstream flows before, during, and after BDA construction.

This stream remained flowing through both sites, and so we took the same precautions as detailed in Section 3.4 Northbound during construction. At one point during construction, we observed stream flow visibly decreasing, and so halted construction and removed the top section of the BDA upstream to allow the stream to recover. With these precautions, the stream remained flowing and the stream channel remained wetted throughout.

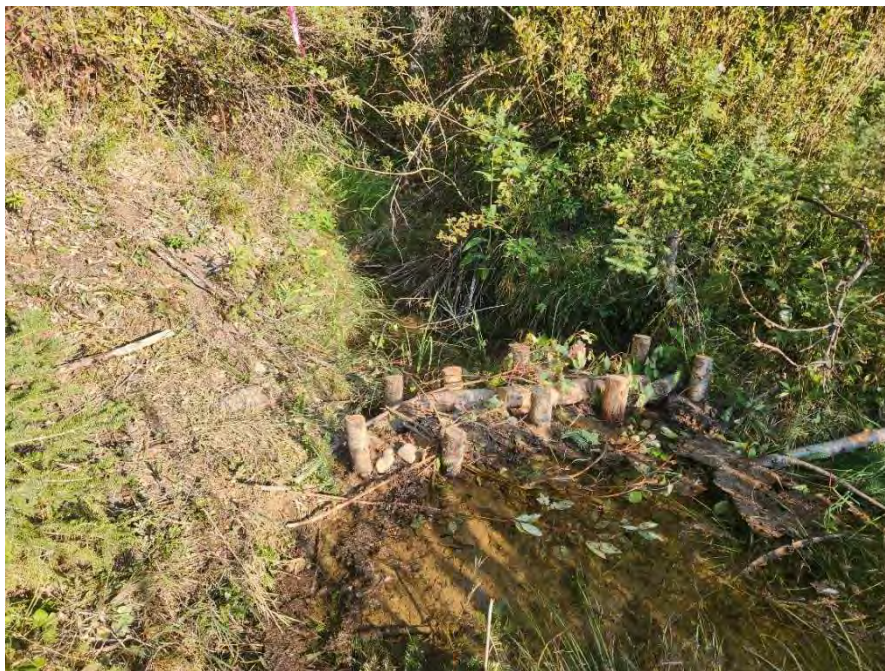
Figure 57. A completed Beaver Dam Analogue that was constructed at Big Dam in September 2025.

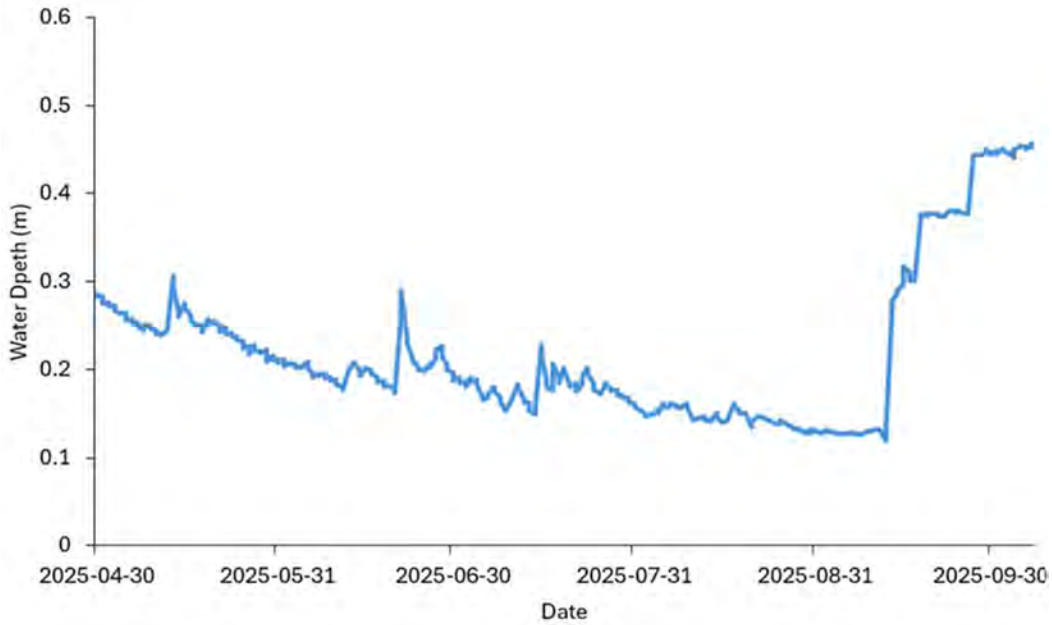
Between April 30<sup>th</sup> and September 7<sup>th</sup> (i.e. pre-construction) the average water depth was 0.19 m (Figure 19). Between September 13<sup>th</sup> and October 7<sup>th</sup> (i.e. post-construction) the average water depth was 0.39 m, with a maximum depth of 0.45 m. This is an increase of approximately 0.26 m in the area immediately upstream of the remnant beaver dam. Due to the low flow of this stream, the water levels slowly increased after construction. Deeper water depths were not reached until October when more flow had returned to the system.

Figure 59. Water depth data from the water level logger (HOBO U-20) installed ~ 2 m upstream of BGD-01. This water level logger was installed from April 30<sup>th</sup> to October 6<sup>th</sup>, 2025, to monitor water depth pre- and post-construction in Big Dam.

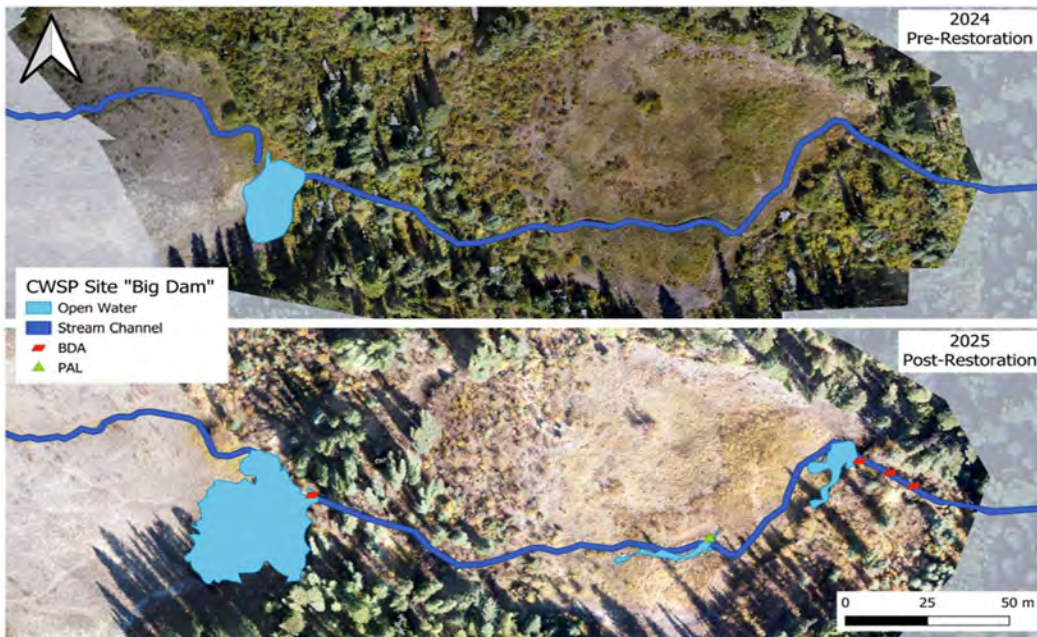
From drone imagery we estimated the 2024 open water flooded area to be 380 m<sup>2</sup>. The post-restoration flooded area mapping shows that the current flooded area has increased to 1415 m<sup>2</sup> (Figure 61). We anticipate that there will be more flooding in spring 2026, when water levels are at peak volume.

Figure 61. Areas of open water/flooding in Big Dam wetland were mapped in the field or based on drone imagery.

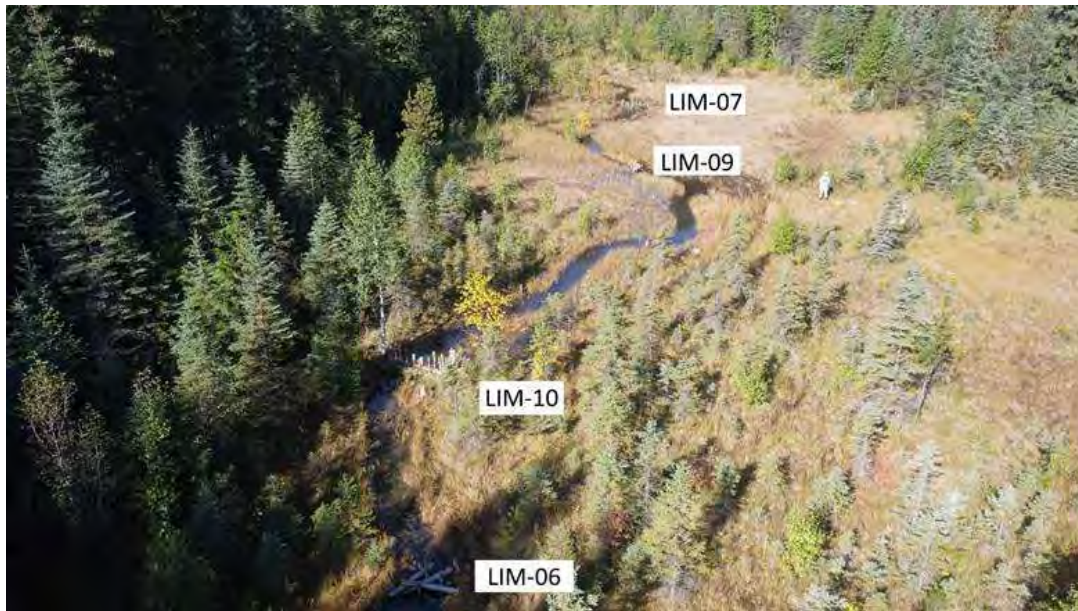
CWSP built seven BDAs and three PALs on September 8<sup>th</sup> and 9<sup>th</sup> 2025 in the Limbo wetland site (Table 6, Figures 62 to 64). In constructing these dams, we increased water depth by 0.24 m above LIM01, increased open water flooded area by 1684 m<sup>2</sup>, and improved wetland habitat across 1.03 ha. Limbo was the wetland with the largest stream that we built BDAs within in 2025, and therefore water levels and flooded areas in this wetland responded faster than they did in any of our other sites (Figure 64).

Figure 64: Post-construction drone image in Limbo showing PAL LIM-06, BDA LIM-10, PAL LIM-09, and BDA LIM-07, and associated flooding.

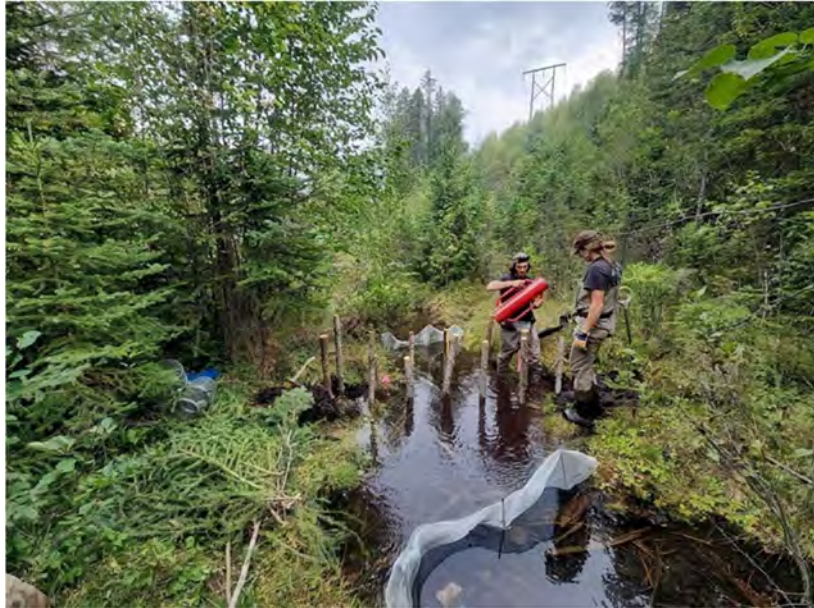
*Figure 65: In-stream isolation (fine-mesh window screening secured with rebar posts and rocks) set up around LIM-08 on September 8th, 2025. This image was taken after fish salvage was finished and crews began to install vertical wooden posts in Limbo wetland.*

The stream flowing through this wetland remained flowing throughout 2025, and the wetland itself retained open water areas and saturated ground. Therefore, construction in this wetland happened ‘in the wet’ and required mitigation for turbidity increases, danger to fish, and danger to amphibians resulting from construction. We isolated each construction area using wire mesh installed within the stream to prevent fish and other wildlife from entering the work area (Figure 65). A temporary coffer dam was installed downstream to mitigate turbidity increases

caused by sediment disturbance during in-stream work. Water quality was monitored upstream and downstream throughout the construction period, and the isolated section was electrofished to remove fish prior to construction.

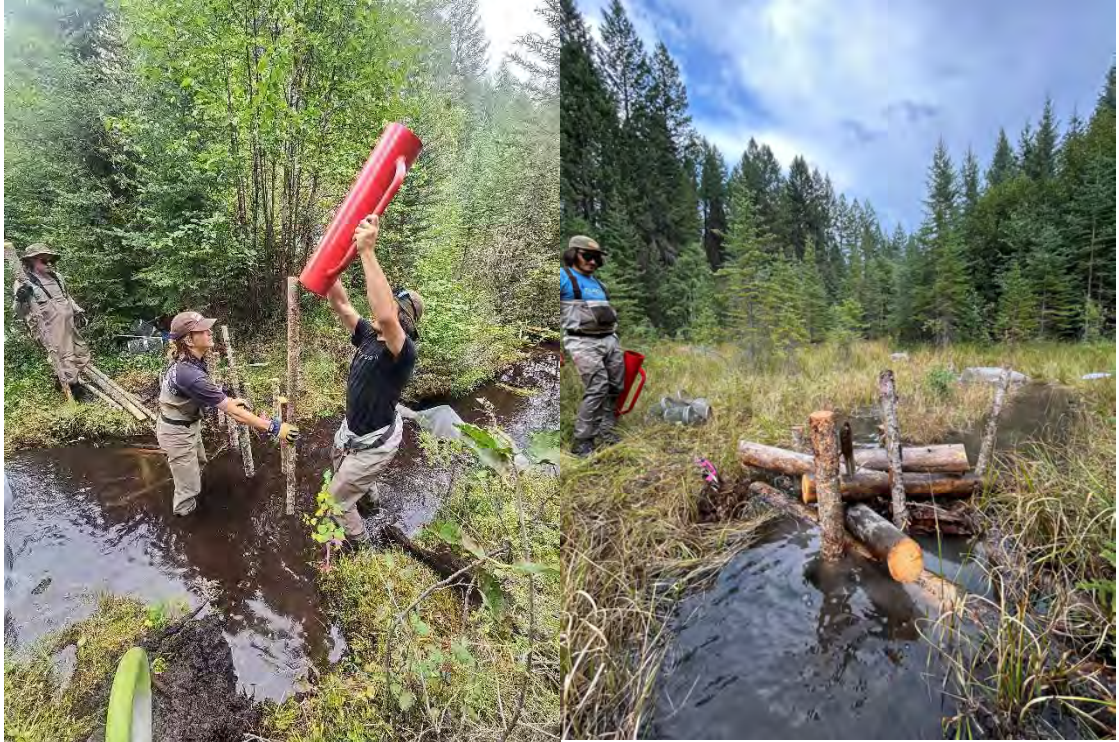
*Figure 67: Pounding posts into the Limbo stream for BDA structure; PAL post-construction.*

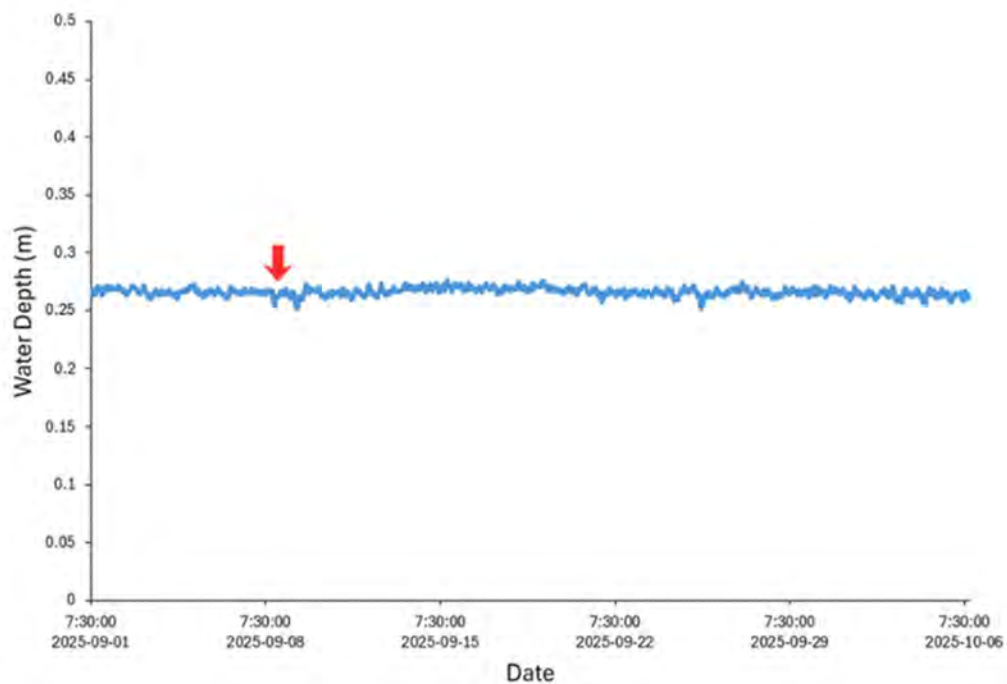
As we are working in small streams and wetlands, there are concerns that while building BDAs, downstream flow may be interrupted. Thus, we installed a water level logger downstream of the construction site to monitor the stream flow before, during, and after construction (Figure 69). The average water depth recorded by the downstream HOBO logger the week before construction (September 1<sup>st</sup> – September 7<sup>th</sup>) was 0.27 m. The largest reduction in water depth during construction on September 8<sup>th</sup> and 9<sup>th</sup> was 0.02m, indicating that construction had a negligible effect on this stream, as did water depth returning to pre-construction average after construction.

Figure 69: Water depth data from the water level logger (HOBO U-20) installed ~ 50 m downstream of the project site in Limbo wetland. This water level logger was installed from September 1st to October 7th, 2025, to monitor downstream flows before, during, and after BDA construction. The red arrow indicates when construction began on September 8<sup>th</sup>, 2025.

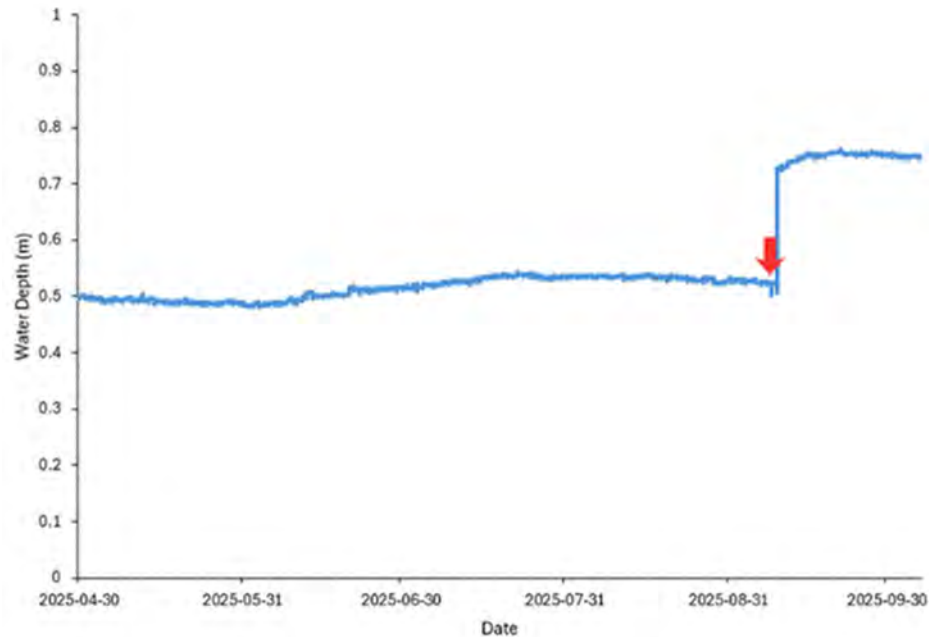
Between April 30<sup>th</sup> and September 7<sup>th</sup> (i.e. pre-construction) the average water depth was 0.51 m. Variation was small, with the maximum depth recorded being 0.54 m and the minimum 0.48 m. Between September 10<sup>th</sup> and October 7<sup>th</sup> (i.e. post-construction) the average water depth

was 0.749 m, showing an increase in water depth of 0.24 m. Variation in water depth in this period was also low, varying between 0.76 m and 0.73 m (Figure 70).

Figure 70: Water depth data from the water level logger (HOBO U-20) installed ~ 2 m upstream of LIM-01 in Limbo Wetland. This water level logger was installed from April 30th to October 7th, 2025, to monitor water depth pre- and post-construction. The red arrow indicates when construction began on September 8<sup>th</sup>, 2025.

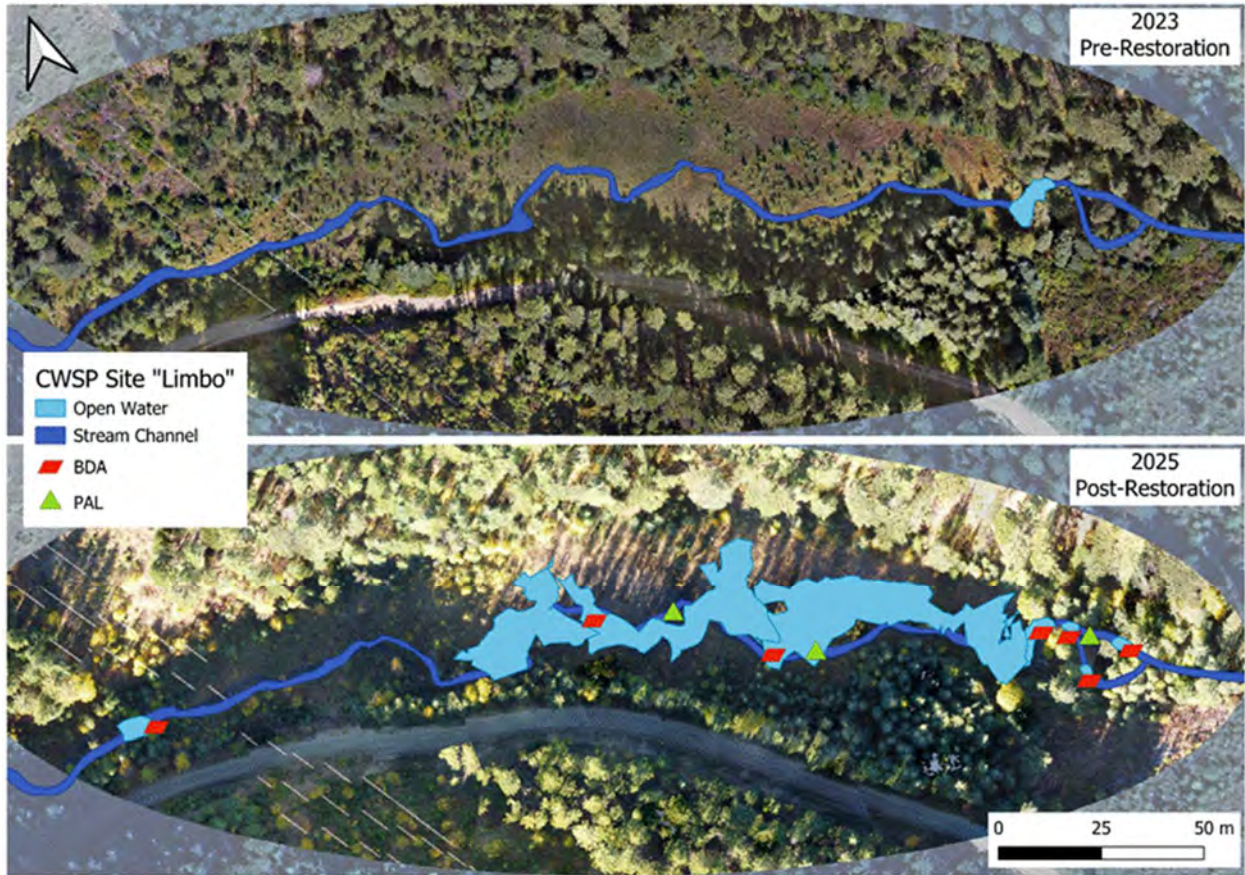
We mapped open water flooded areas in Summer 2023 (pre-restoration) and Fall 2025 (post-restoration) to visualise the increase in flooding post-construction (Figure 71). The pre-restoration estimate of open water areas within this wetland was ~ 58 m<sup>2</sup>. After the installation of BDA and PAL structures, the new estimate of open water area is 1,742 m<sup>2</sup>. Water also extended out into the vegetated areas providing water to the hydrophytic vegetation. We predict that more open water will be observed during high water, so flooded area mapping will be repeated in Spring of 2026.

Figure 71: Areas of open water/flooding in Limbo Wetland were mapped in the field using GIS applications (Avenza, ArcGIS Field Maps).
