# Kootenay Connect: 7CW Columbia Wetlands: Summary (2023-2026) and Yr 7 Upland Wetlands Restoration Report

March 31, 2026

Columbia Wetlands Stewardship Partners

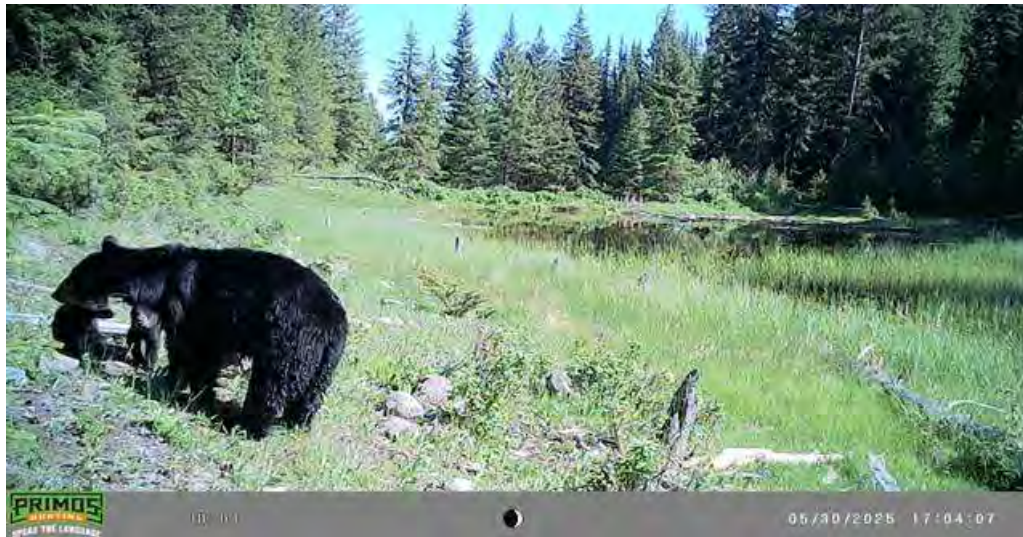
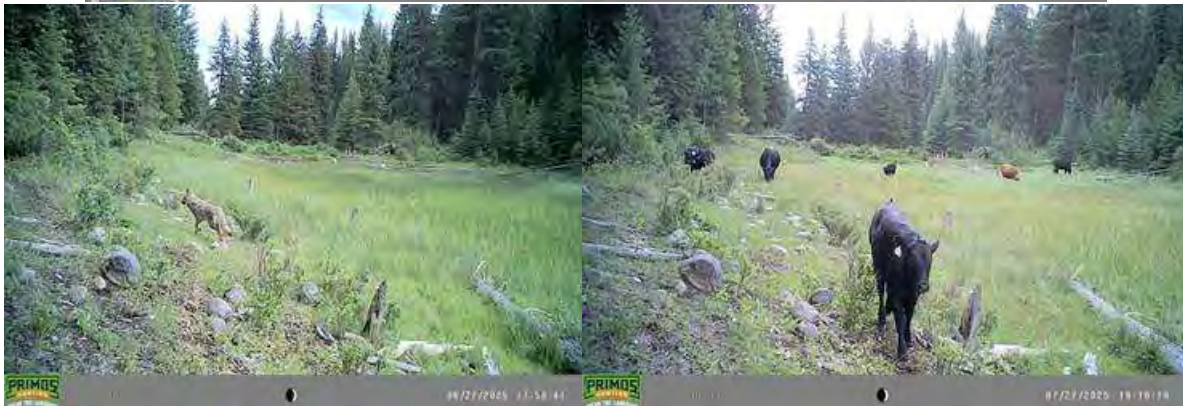
The site Beaver Channels had almost the same number of camera detection events, however the majority of these were domestic cows (68 of 150 camera events). Cows were frequently photographed within the wetted area of the wetland, and during site visits we observed heavy trampling of mud and vegetation, damaging the wetland edges.

Figure 85: An American black bear and her two cubs (top) were captured playing at the Beaver Channels wetland on May 30th, 2025. Also, a coyote (bottom left) on June 27th, 2025, and a herd of cows grazing on July 27th, 2025 (bottom right).

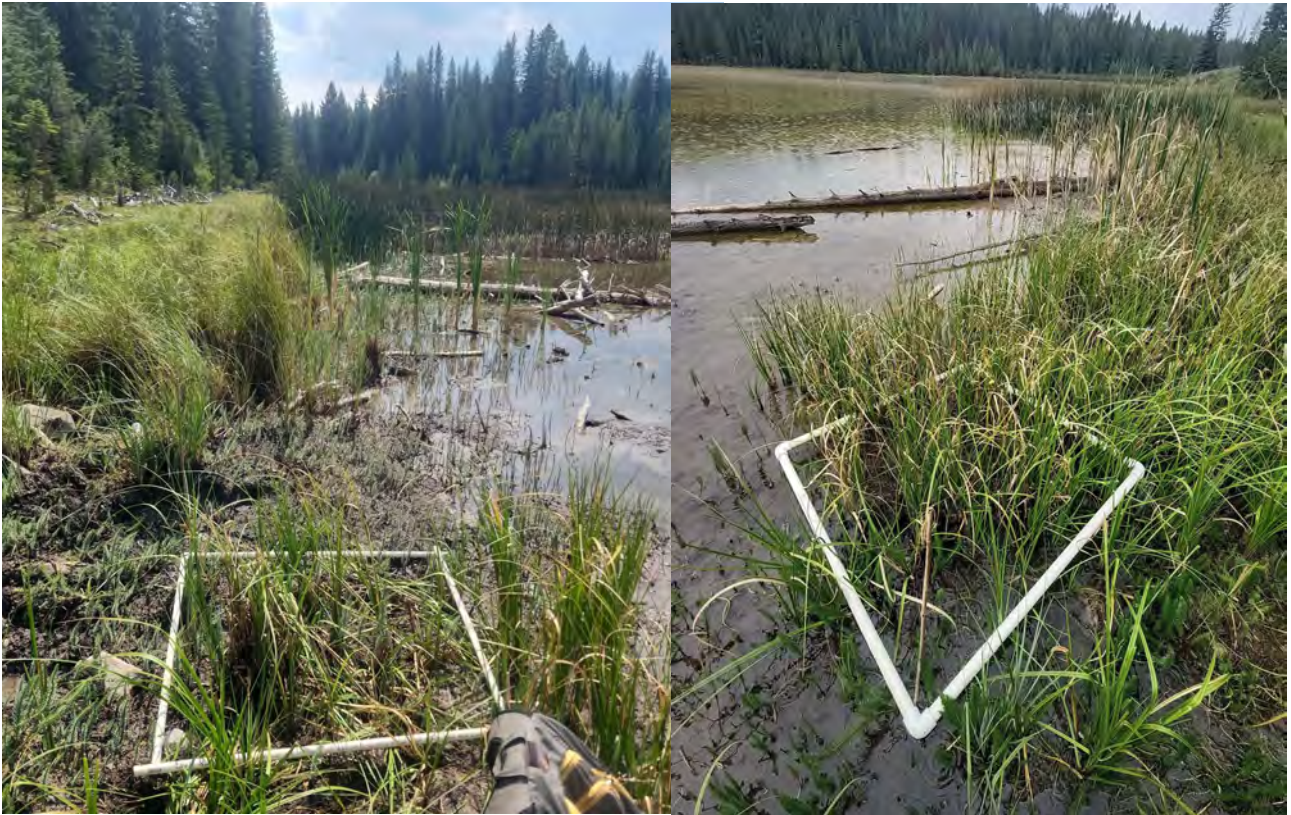
In 2024 we observed 19 species in our vegetation plots and 30 in 2025. While it is hard to draw definitive conclusions from only two years of data, and only one year of data post-construction, even within this short time frame we observed differences in our vegetation plots. Two plots in the Beaver Channels wetland were wetted in 2024 and three were in 2025; in 2024, one of these plots was 20% open water, while in 2025 it was 70% open water. The other wetted

plot in 2024 did not have an open water cover, but in 2025 was 70% open water; the third wetted plot in 2025 was 45% open water, from a dry plot with 65% open ground in 2024 (Figure 89).

Figure 89: A) Beaver Channels Plot 5 on August 6th 2024, dominated by *Carex utriculata* and open ground, with open water adjacent; B) the same plot on August 6th 2025, *C. utriculata* is still the dominant vegetation, but is now growing in open water an average of 0.11 m deep.

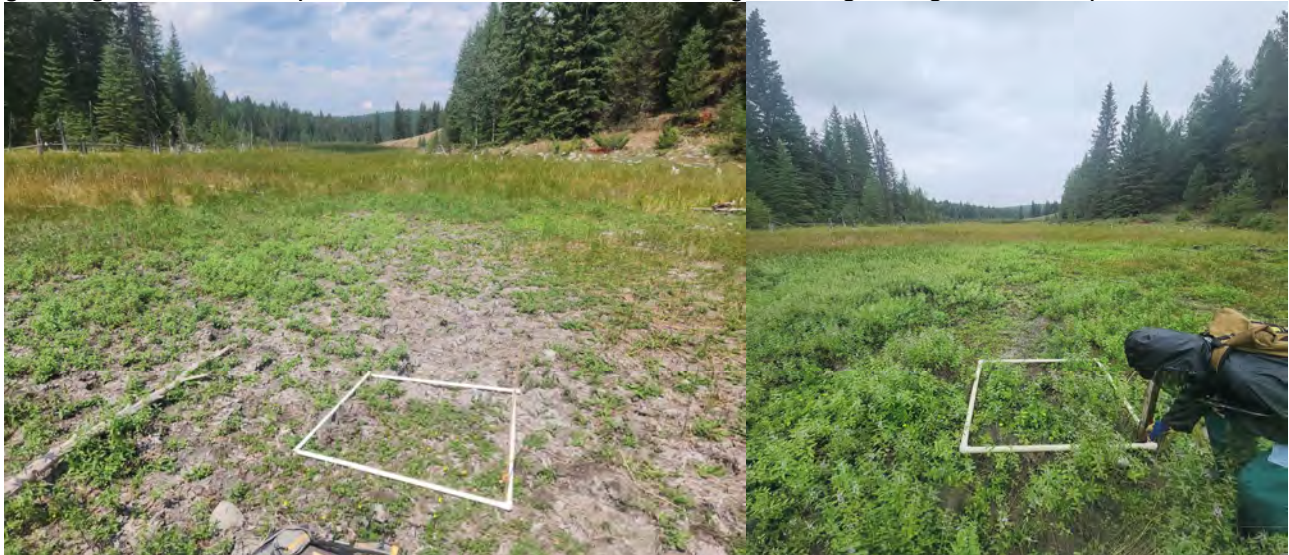
While no other plots showed an increase in water depth, one plot did show a dramatic change in vegetation; this was unexpected, as we did not think that a single growing season would be enough for vegetation to change. In 2024, Plot 04 was surveyed to be 50% *Potentilla anserina* (Common Silverweed), 5% *Mentha arvensis* (Wild Mint), 1% *Plantago major* (Common Plantain), and 45% Open Ground. In 2025, it was surveyed to be 30% *Mentha arvensis*, 1% *Schoenoplectus acutus* (Hard-stemmed Bulrush), 20% *Potentilla anserina*, 2.5% *Hippuris vulgaris* (Common Mare's-tail), 2.5% Unidentified seedling, and 40% Open Ground (Figure 90). This is an increase of two wetland species, and a loss of one dryland species. This plot was located in the area of

the wetland directly behind one of our constructed BDAs, that remained flooded until the end of June, when it had previously been dry much earlier. Clearly this longer inundation period changed growing conditions for plants and resulted in different vegetation growing within this plot.

Figure 90: A) Plot 4 in 2024, showing open ground and low growing *Potentilla anserina* as the dominant cover; B) Plot 4 in 2025, showing taller growing *Mentha arvensis* and *Potentilla anserina* as the dominant cover. The differences extend beyond the plot, with vegetated ground cover visibly increasing around the plot.

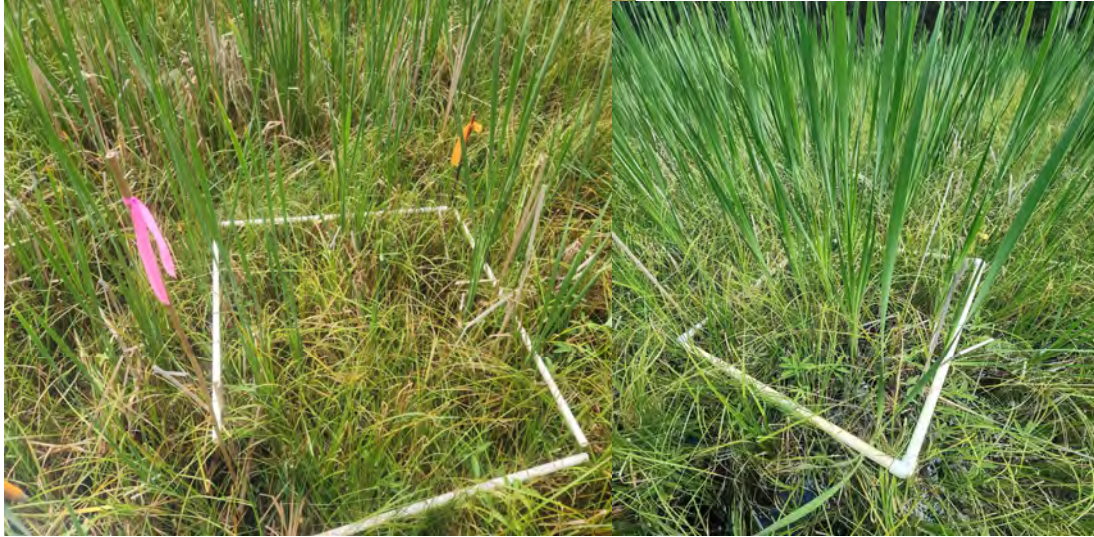
In S-Land we observed 49 species in our vegetation plots in 2024 and 2025. While it is hard to draw definitive conclusions from only two years of data, and only one year of data post-construction, even within this short time frame we observed differences in our vegetation plots. In 2024, four of ten plots were wetted, with water depths ranging from 0.04 m to 0.50 m; in 2025, nine of ten plots were wetted, with water depths ranging from 0.07 m to 0.83 m. In 2024, two of ten plots had open water cover of 30% and 50%, while in 2025 seven had open water cover (Figure 91).

*Figure 91: Plot in 2024, with Carex aquatilis, C. utriculata, and Typha latifolia, and no open water; the same plot in 2025, with the same species mix and also measurable open water.*
